ECO INSPECTION CERTIFICATE

121 Points Vehicle Inspection Certificate

Inspection Date :
2019-05-10

Maruti Suzuki Wagon R LXI CNG, 2012

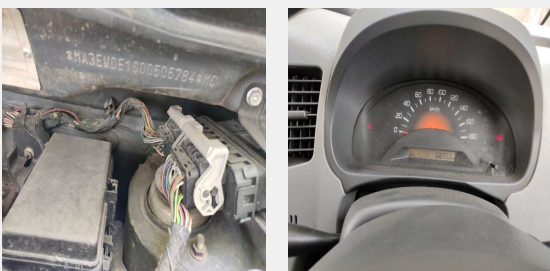
IMAGES

INSPECTION CHECKPOINTS	SCORE(X/10)	REMARKS/COMMENTS	OPTIONAL SPEND EST. (RS)
STEERING PERFORMANCE	7		0
BRAKE PERFORMANCE	7		0
CLUTCH PERFORMANCE	7		0
ENGINE NOISE	6	AVERAGE CONDITION	0
IGNITION SYSTEM	7		0
SUSPENSION PERFORMANCE	6	AVERAGE CONDITION	0
SUSPENSION FRONT SHOCKS	6	AVERAGE CONDITION	0
SUSPENSION REAR SHOCKS	6	AVERAGE CONDITION	0
TRANSMISSION ENGAGE	7		0
CRUISE CONTROL (YES)	0	NA	0
REAR PARKING SENSORS (YES)	0	NA	0
REAR VIEW CAMERA (YES)	0	NA	0

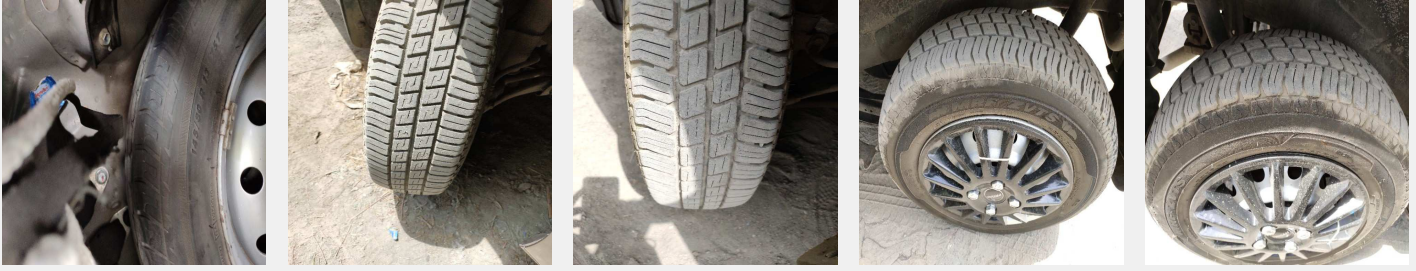
IMAGES

INSPECTION CHECKPOINTS	SCORE(X/10)	REMARKS/COMMENTS	OPTIONAL SPEND EST. (RS)
TYRES	7		0
SPARE TYRE (YES)	6	AVERAGE CONDITION	0
WHEEL ASSEMBLY (STEEL RIM)	7		0

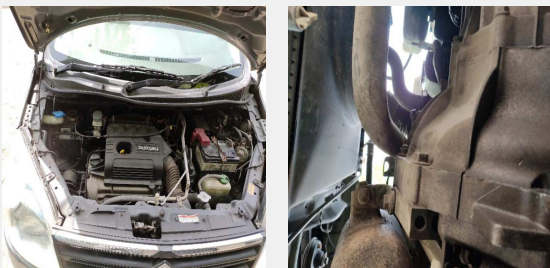
IMAGES

INSPECTION CHECKPOINTS	SCORE(X/10)	REMARKS/COMMENTS	OPTIONAL SPEND EST. (RS)
LH APRON	7		0
RH APRON	7		0
RADIATOR	6	AVERAGE CONDITION	0
WIRING	6	AVERAGE CONDITION	0
BATTERY	6	AVERAGE CONDITION	0
BRAKE FLUID LEVEL	7		0
ENGINE OIL	7		0
COOLANT LEVEL	7		0
BRAKE & COOLANT HOSE PIPES	6	AVERAGE CONDITION	0
UNDERCARRIAGE	6	AVERAGE CONDITION	0
EXHAUST SYSTEM	6	AVERAGE CONDITION	0

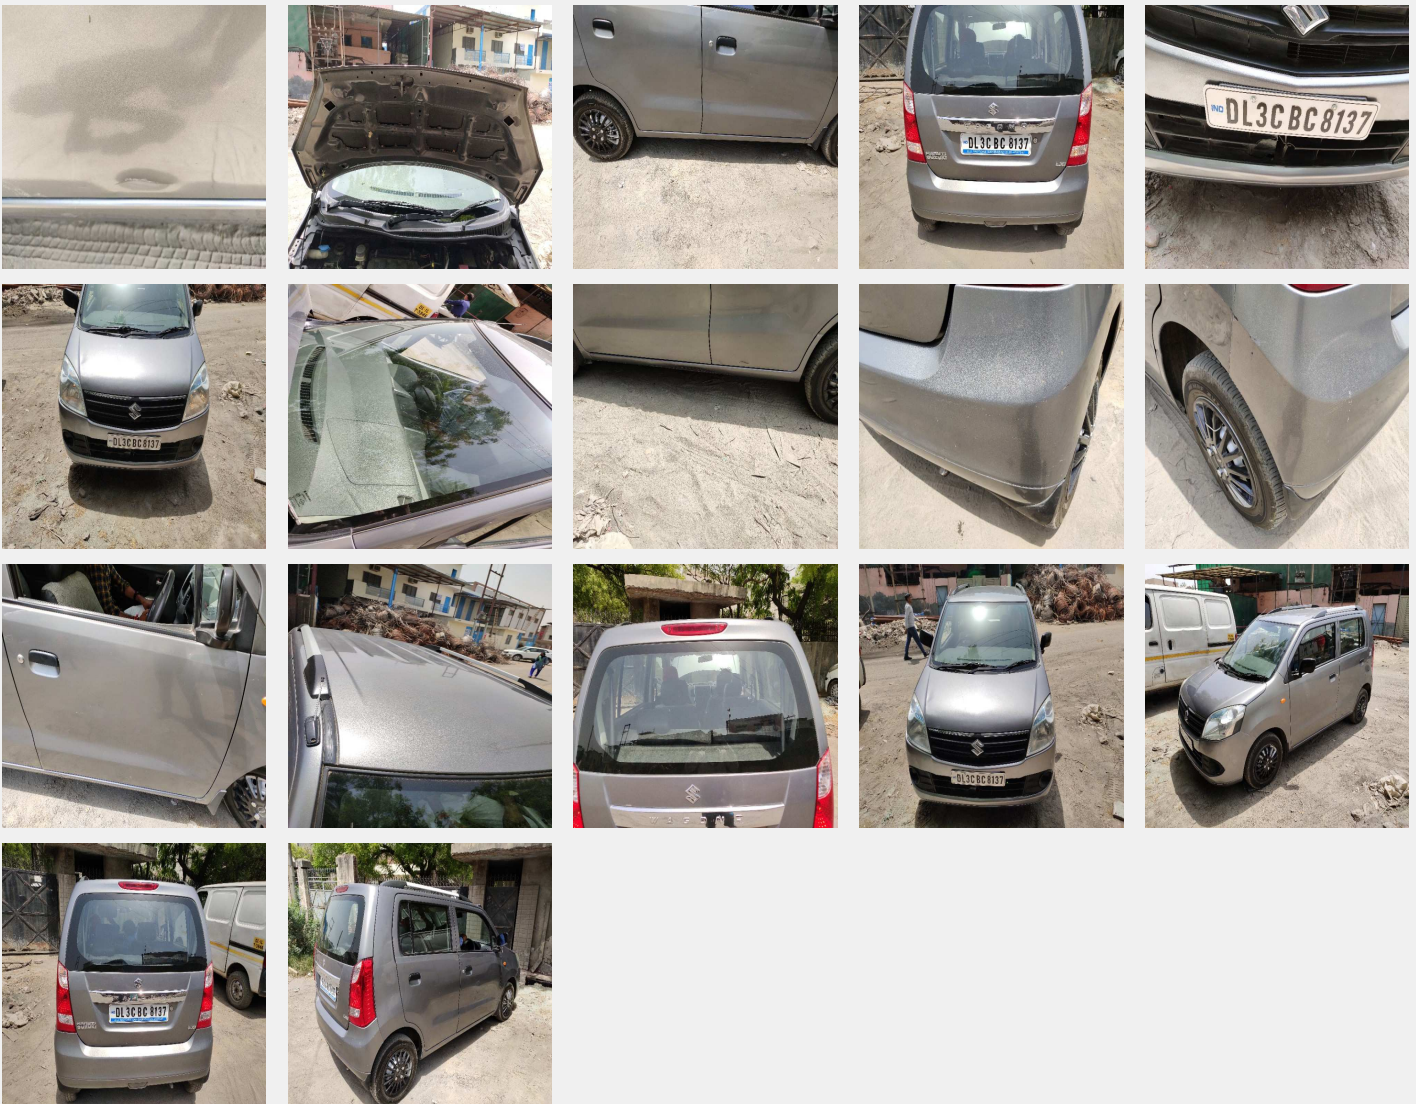
IMAGES

INSPECTION CHECKPOINTS	SCORE(X/10)	REMARKS/COMMENTS	OPTIONAL SPEND EST. (RS)
BODY RUST	7		0
ROOF (REGULAR)	7		0
PAINT CONDITION	7		0
GRILLE	4	BROKEN NEED TO BE CHANGE	1000
FOG LAMPS	0	NA	0

all body scratches minor dent and front grille broken need to change
