# ECO INSPECTION CERTIFICATE

Order ID : 72642

121 Points Vehicle Inspection Certificate

## Hyundai Accent EXECUTIVE, 2013

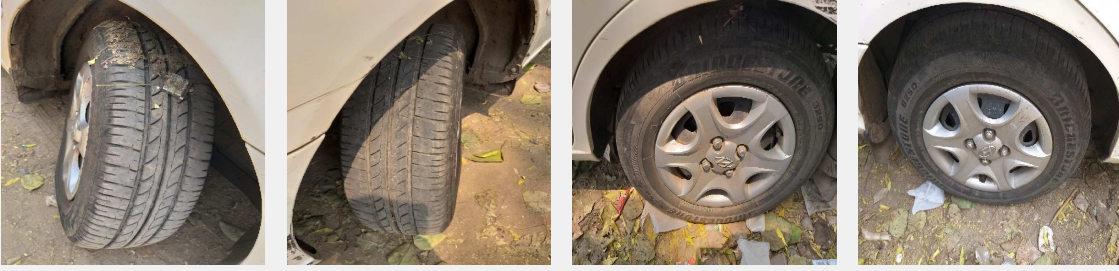
IMAGES

INSPECTION CHECKPOINTS	SCORE(X/10)	REMARKS/COMMENTS	OPTIONAL SPEND EST. (RS)
TYRES	7	GOOD	0
SPARE TYRE (NO)	10		0
WHEEL ASSEMBLY (STEEL RIM)	6	FAIR	0

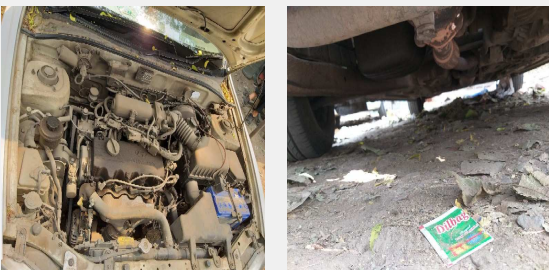
IMAGES

INSPECTION CHECKPOINTS	SCORE(X/10)	REMARKS/COMMENTS	OPTIONAL SPEND EST. (RS)
LH APRON	6	FAIR	0
RH APRON	6	FAIR	0
RADIATOR	6	FAIR	0
WIRING	6	FAIR	0
BATTERY	6	FAIR	0
BRAKE FLUID LEVEL	6	FAIR	0
ENGINE OIL	6	FAIR	0
COOLANT LEVEL	6	FAIR	0
BRAKE & COOLANT HOSE PIPES	6	FAIR	0
UNDERCARRIAGE	6	FAIR	0
EXHAUST SYSTEM	6	FAIR	0

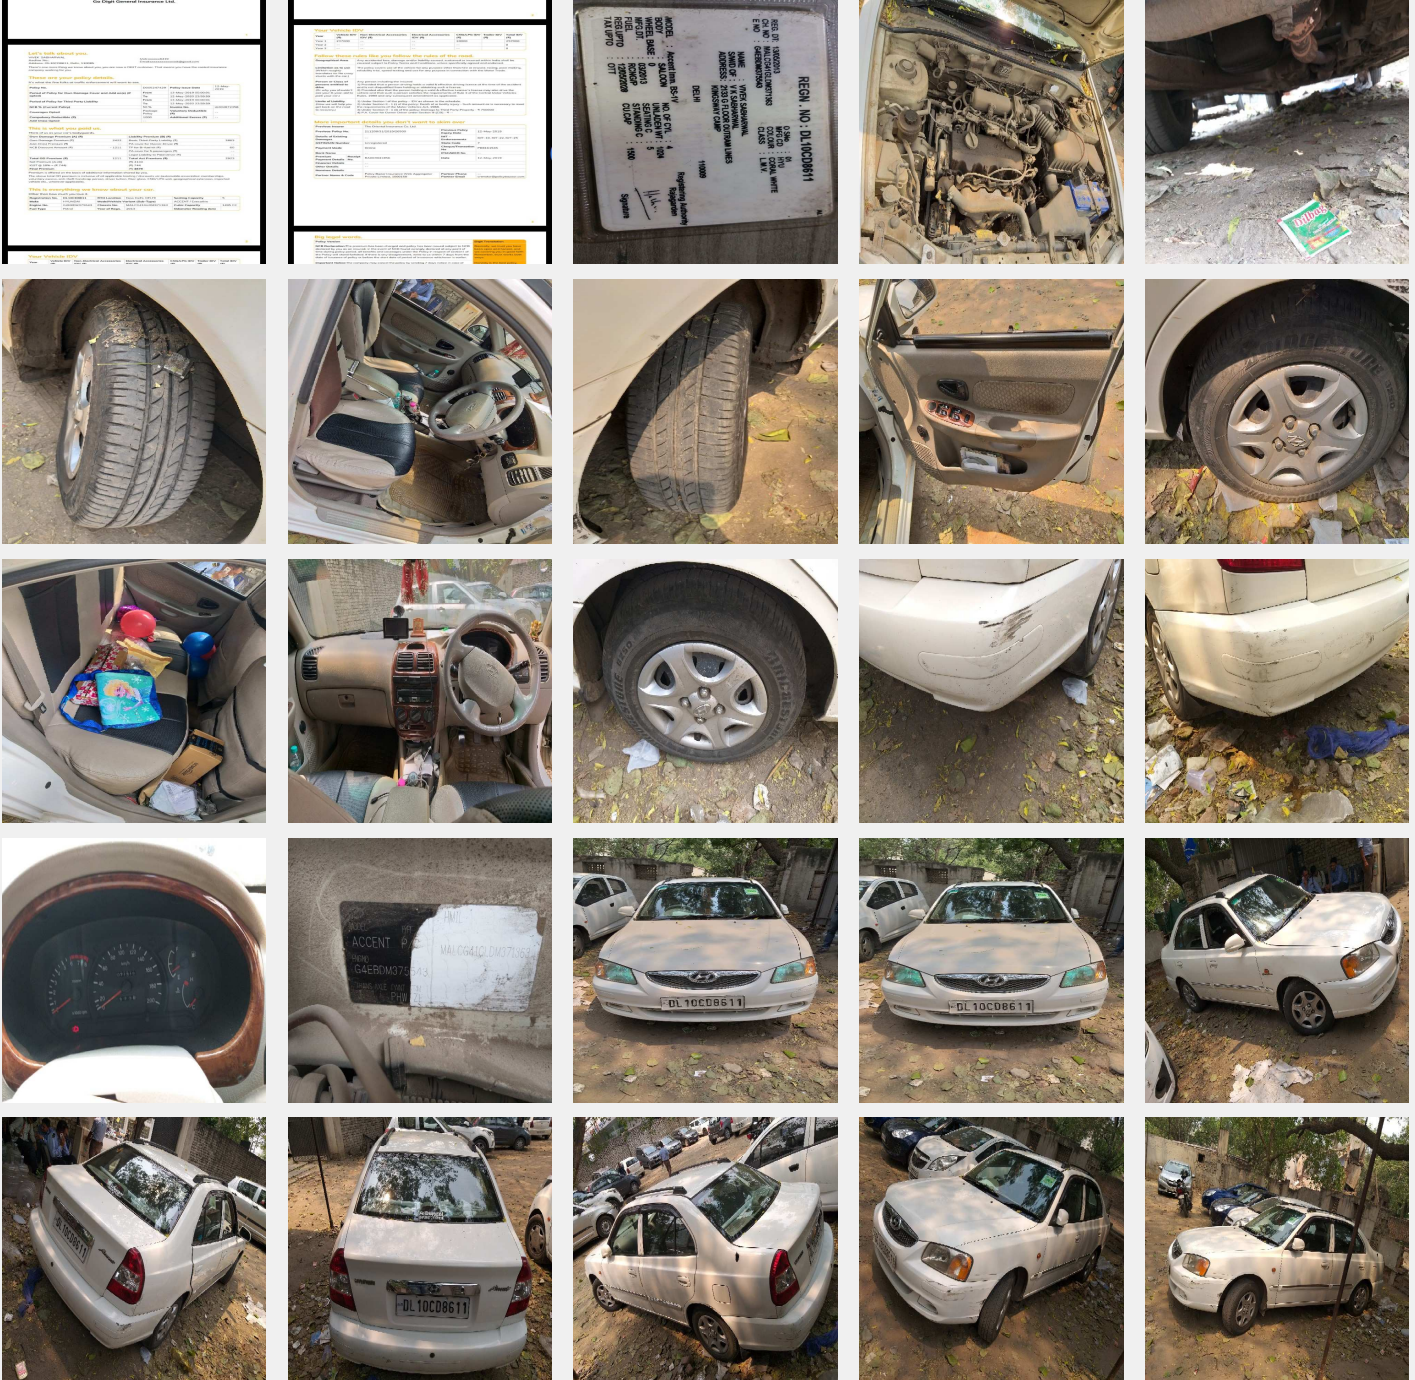
IMAGES

fair condition,, minor scratch,, tappet packing major leakage,,tapper noise
