ECO INSPECTION CERTIFICATE

121 Points Vehicle Inspection Certificate

Ordered By : Caravan Car	Inspection Date : 2019-05-14	Location : GOREGAON WEST	Inspected By

Honda Civic 1.8 V AT, 2009

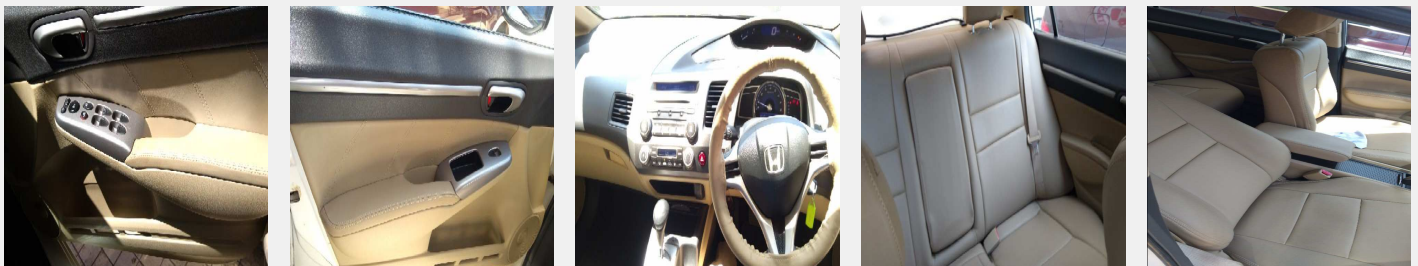
IMAGES

INSPECTION CHECKPOINTS	SCORE(X/10)	REMARKS/COMMENTS	OPTIONAL SPEND EST. (RS)
DOOR PANEL	6	AVERAGE CONDITION	0
DOOR HINGES	6	NO DAMAGE	0
CARPET & FLOOR MAT	6	AVERAGE	0
SEAT & SEAT BELT	7	GOOD CONDITION	0
DASHBOARD & INSTRUMENT PANEL	7	GOOD CONDITION	0
HORN	7	GOOD CONDITION	0
SPEAKERS & MUSIC SYSTEM	7	GOOD CONDITION	0
HANDBRAKE	7	GOOD CONDITION	0
PEDALS	7	GOOD CONDITION	0
CENTRAL LOCK	7	GOOD CONDITION	0
A/C VENTS & HEATER	7	GOOD CONDITION	0
CUP HOLDERS	7	GOOD CONDITION	0
NAVIGATION (NO)	10		0
ODOMETER	7	GOOD CONDITION	0
HAZARD LIGHT	6	NO DAMAGE	0
STEERING-MOUNTED CONTROLS	0	N/A	0
POWER WINDOWS (YES)	5	SWITCH BOARD NEED TO CHANGE	3000

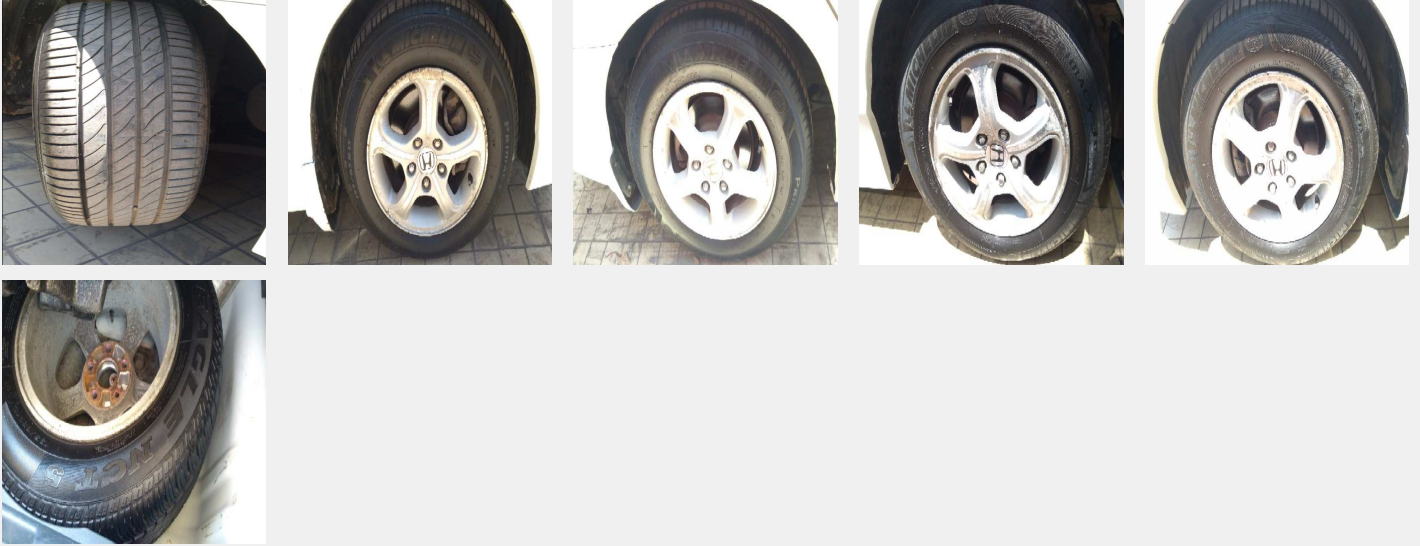
IMAGES

INSPECTION CHECKPOINTS	SCORE(X/10)	REMARKS/COMMENTS	OPTIONAL SPEND EST. (RS)
TYRES	7	GOOD TREAD CONDITION	0
SPARE TYRE (YES)	8	GOOD CONDITION	0
WHEEL ASSEMBLY (ALLOY RIM)	6	NO DAMAGE	0

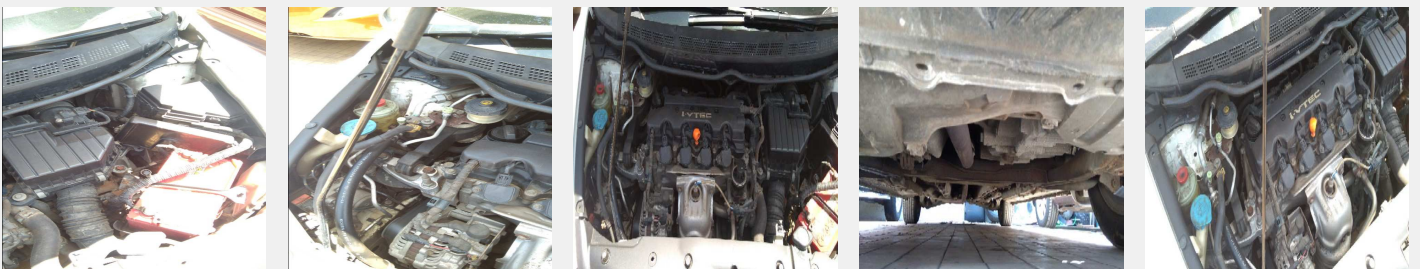
IMAGES

INSPECTION CHECKPOINTS	SCORE(X/10)	REMARKS/COMMENTS	OPTIONAL SPEND EST. (RS)
LH APRON	6	AVERAGE CONDITION	0
RH APRON	6	AVERAGE CONDITION	0
RADIATOR	7	WORKING GOOD	0
WIRING	6	NO DAMAGE	0
BATTERY	6	AVERAGE CONDITION	0
BRAKE FLUID LEVEL	7	MAXIMUM	0
ENGINE OIL	6	AVERAGE CONDITION	0
COOLANT LEVEL	7	MAXIMUM	0
BRAKE & COOLANT HOSE PIPES	6	NO DAMAGE	0
UNDERCARRIAGE	6	NO DAMAGE	0
EXHAUST SYSTEM	6	WORKING FINE	0

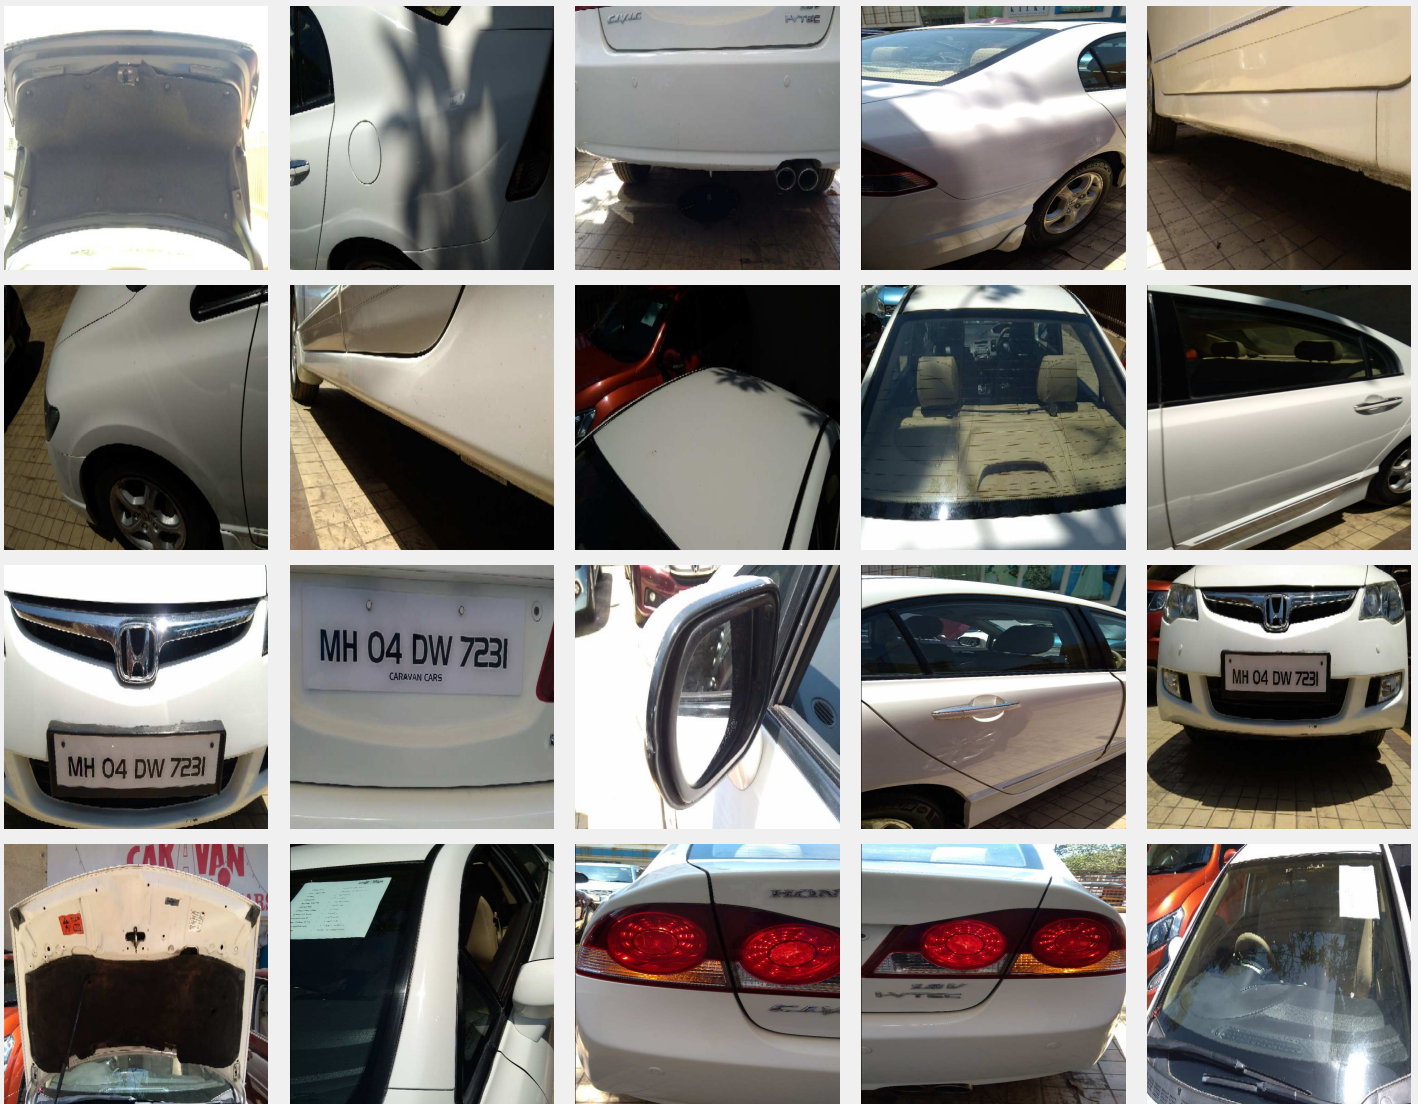
IMAGES

INSPECTION CHECKPOINTS	SCORE(X/10)	REMARKS/COMMENTS	OPTIONAL SPEND EST. (RS)
BODY RUST	6	NO RUST	0
ROOF (REGULAR)	7	GOOD CONDITION	0
PAINT CONDITION	7	GOOD	0
FOG LAMPS	5	RH LAMP NEED TO REPLACE	400
LUGGAGE COMPARTMENT LIGHT	0	N/A	0
