# ECO INSPECTION CERTIFICATE

121 Points Vehicle Inspection Certificate

Ordered By : Jasjeet Singh	Inspection Date : 2019-05-14	Location : DELHI	Inspected By

## Volkswagen Vento Highline Petrol, 2011

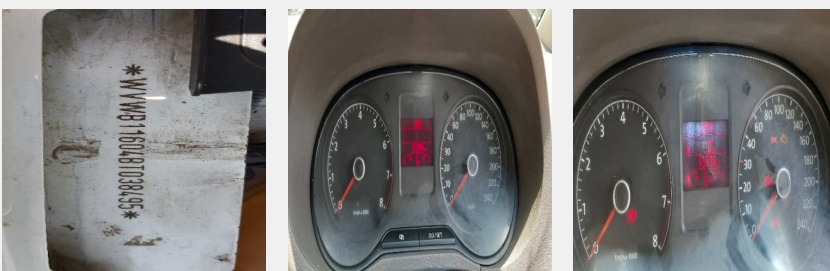
INSPECTION CHECKPOINTS	SCORE(X/10)	REMARKS/COMMENTS	OPTIONAL SPEND EST. (RS)
STEERING PERFORMANCE	7		0
BRAKE PERFORMANCE	7		0
CLUTCH PERFORMANCE	7		0
ENGINE NOISE	7		0
IGNITION SYSTEM	7		0
SUSPENSION PERFORMANCE	7		0
SUSPENSION FRONT SHOCKS	7		0
SUSPENSION REAR SHOCKS	7		0
TRANSMISSION ENGAGE	7		0
CRUISE CONTROL (NO)	10		0
REAR PARKING SENSORS (YES)	8		0
REAR VIEW CAMERA (NO)	10		0

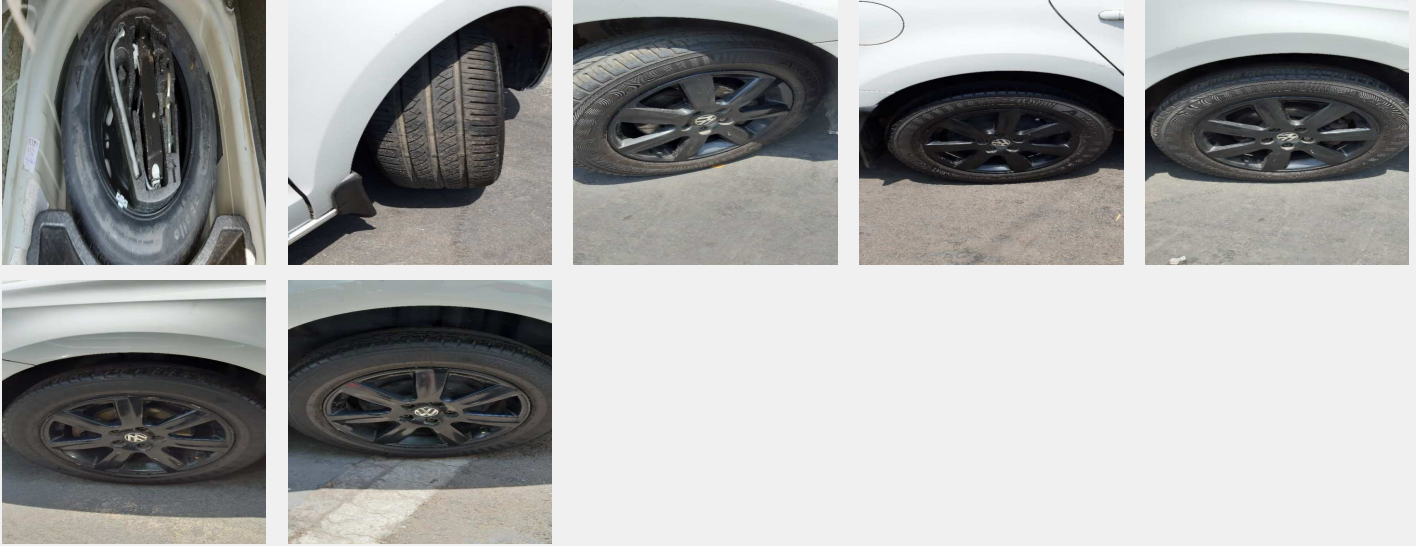
INSPECTION CHECKPOINTS	SCORE(X/10)	REMARKS/COMMENTS	OPTIONAL SPEND EST. (RS)
TYRES	7		0
SPARE TYRE (YES)	7		0
WHEEL ASSEMBLY (ALLOY RIM)	8		0

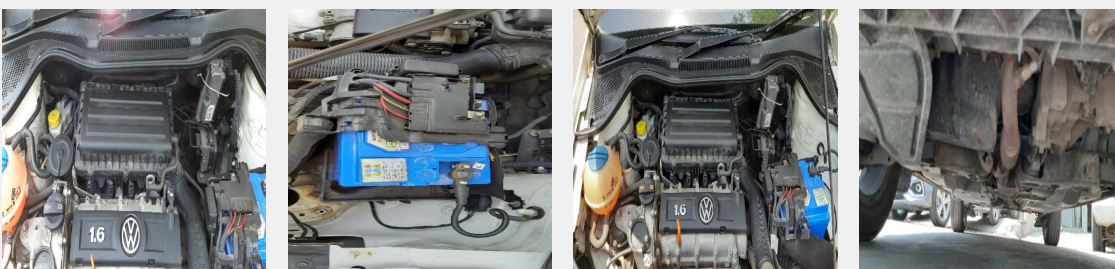
INSPECTION CHECKPOINTS	SCORE(X/10)	REMARKS/COMMENTS	OPTIONAL SPEND EST. (RS)
LH APRON	7		0
RH APRON	7		0
RADIATOR	7		0
WIRING	7		0
BATTERY	7		0
BRAKE FLUID LEVEL	7		0
ENGINE OIL	7		0
COOLANT LEVEL	7		0
BRAKE & COOLANT HOSE PIPES	7		0
UNDERCARRIAGE	7		0
EXHAUST SYSTEM	7		0

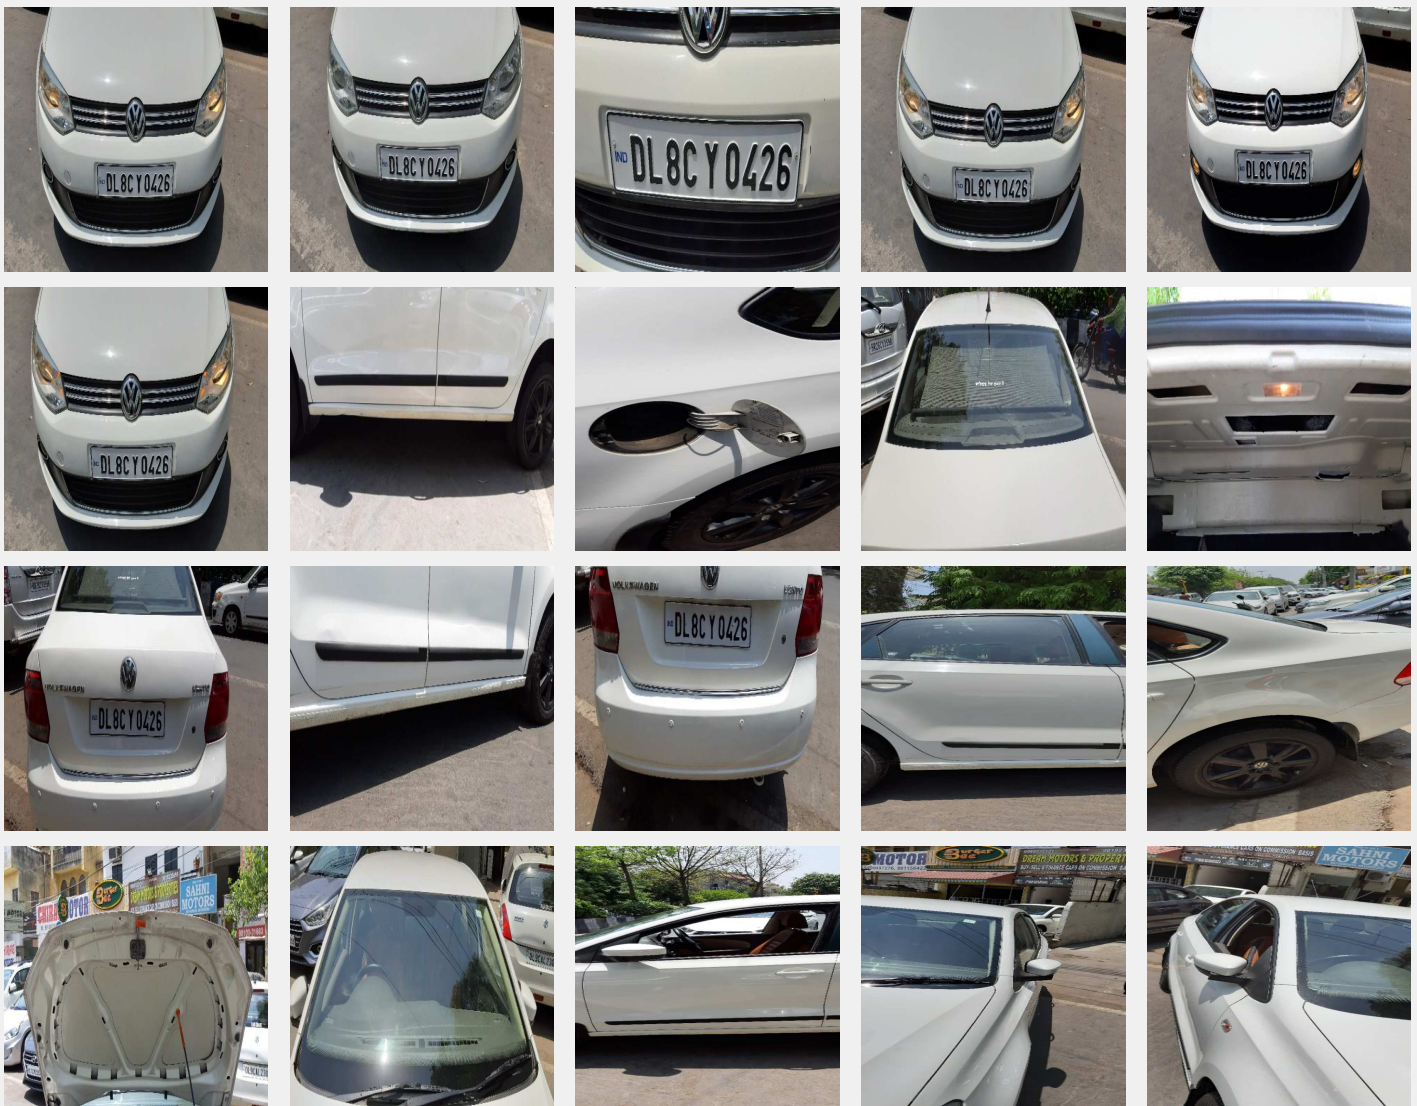
INSPECTION CHECKPOINTS	SCORE(X/10)	REMARKS/COMMENTS	OPTIONAL SPEND EST. (RS)
RH FRONT DOOR	8		0
RH FENDER	7		0
BODY RUST	7		0
ROOF (REGULAR)	7		0
PAINT CONDITION	8		0

all body condition is good all lights properly working
