ECO INSPECTION CERTIFICATE

121 Points Vehicle Inspection Certificate

Ordered By : Dharmendra Yadav	Inspection Date : 2019-05-14	Location : AHMEDABAD	Inspected By

Maruti Suzuki Eco 7 STR, 2012

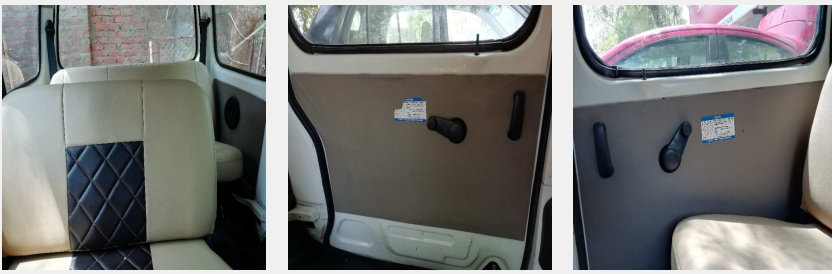
IMAGES

INSPECTION CHECKPOINTS	SCORE(X/10)	REMARKS/COMMENTS	OPTIONAL SPEND EST. (RS)
DOOR PANEL	8	GOOD CONDITION	0
DOOR HINGES	8	GOOD CONDITION	0
CARPET & FLOOR MAT	8	GOOD CONDITION	0
SEAT & SEAT BELT	8	GOOD CONDITION	0
DASHBOARD & INSTRUMENT PANEL	8	GOOD CONDITION	0
HORN	8	GOOD CONDITION	0
SPEAKERS & MUSIC SYSTEM	8	GOOD CONDITION	0
HANDBRAKE	8	GOOD CONDITION	0
STEERING-MOUNTED CONTROLS	8	GOOD CONDITION	0
PEDALS	8	GOOD CONDITION	0
CENTRAL LOCK	8	GOOD CONDITION	0
A/C VENTS & HEATER	8	GOOD CONDITION	0
CUP HOLDERS	8	GOOD CONDITION	0
NAVIGATION (NO)	10		0
ODOMETER	8	GOOD CONDITION	0
POWER WINDOWS (NO)	10		0
HAZARD LIGHT	8	GOOD CONDITION	0

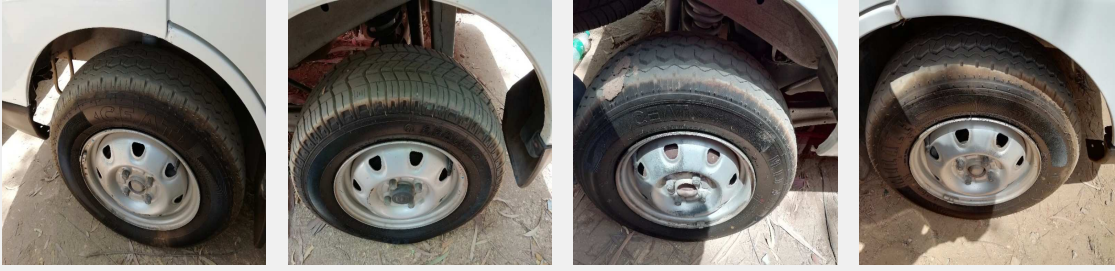
IMAGES

INSPECTION CHECKPOINTS	SCORE(X/10)	REMARKS/COMMENTS	OPTIONAL SPEND EST. (RS)
TYRES	8	GOOD CONDITION	0
SPARE TYRE (YES)	8	GOOD CONDITION	0
WHEEL ASSEMBLY (STEEL RIM)	8	GOOD CONDITION	0

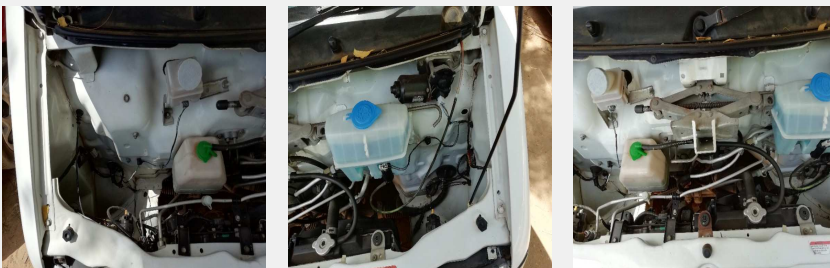
IMAGES

INSPECTION CHECKPOINTS	SCORE(X/10)	REMARKS/COMMENTS	OPTIONAL SPEND EST. (RS)
LH APRON	8	GOOD CONDITION	0
RH APRON	8	GOOD CONDITION	0
RADIATOR	8	GOOD CONDITION	0
WIRING	8	GOOD CONDITION	0
BATTERY	8	GOOD CONDITION	0
BRAKE FLUID LEVEL	8	GOOD CONDITION	0
ENGINE OIL	8	GOOD CONDITION	0
COOLANT LEVEL	8	GOOD CONDITION	0
BRAKE & COOLANT HOSE PIPES	8	GOOD CONDITION	0
UNDERCARRIAGE	8	GOOD CONDITION	0
EXHAUST SYSTEM	8	GOOD CONDITION	0
