# ECO INSPECTION CERTIFICATE

Order ID : 72440

121 Points Vehicle Inspection Certificate

## Maruti Suzuki Swift ZDI, 2014

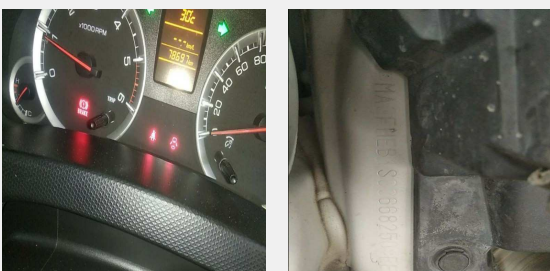
INSPECTION CHECKPOINTS	SCORE(X/10)	REMARKS/COMMENTS	OPTIONAL SPEND EST. (RS)
STEERING PERFORMANCE	9		0
BRAKE PERFORMANCE	8		0
CLUTCH PERFORMANCE	9		0
ENGINE NOISE	7		0
IGNITION SYSTEM	8		0
SUSPENSION PERFORMANCE	8		0
SUSPENSION FRONT SHOCKS	7		0
SUSPENSION REAR SHOCKS	9		0
TRANSMISSION ENGAGE	8		0
CRUISE CONTROL (YES)	9		0
REAR PARKING SENSORS (NO)	10		0
REAR VIEW CAMERA (NO)	10		0

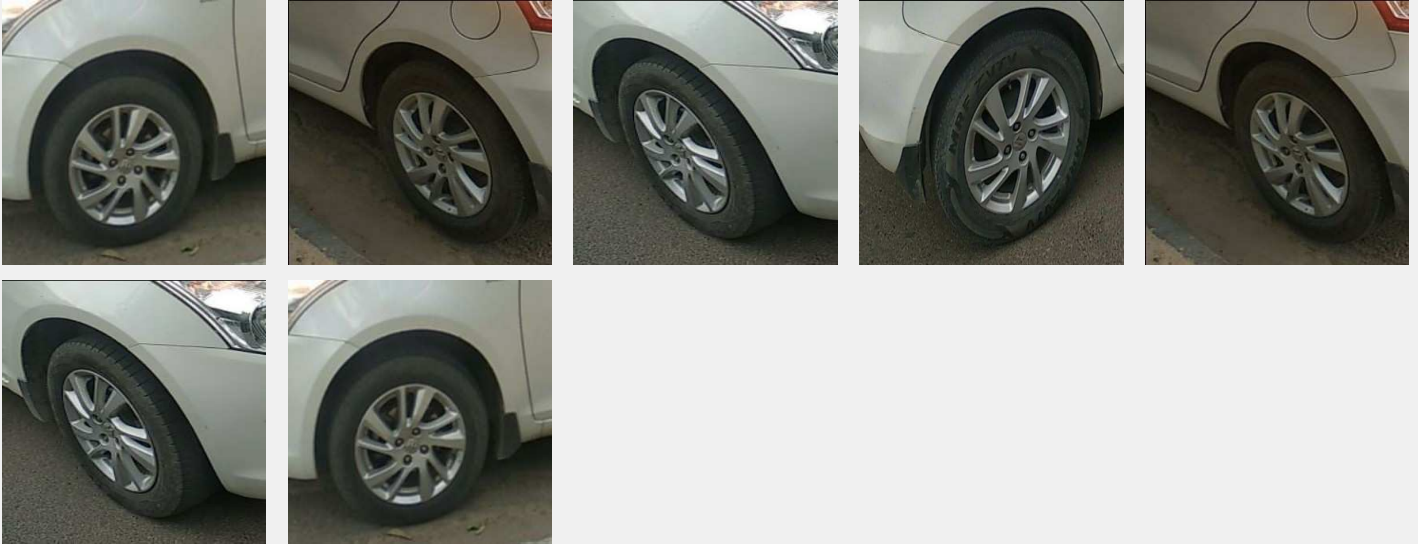
INSPECTION CHECKPOINTS	SCORE(X/10)	REMARKS/COMMENTS	OPTIONAL SPEND EST. (RS)
TYRES	8		0
SPARE TYRE (YES)	9		0
WHEEL ASSEMBLY (ALLOY RIM)	8		0

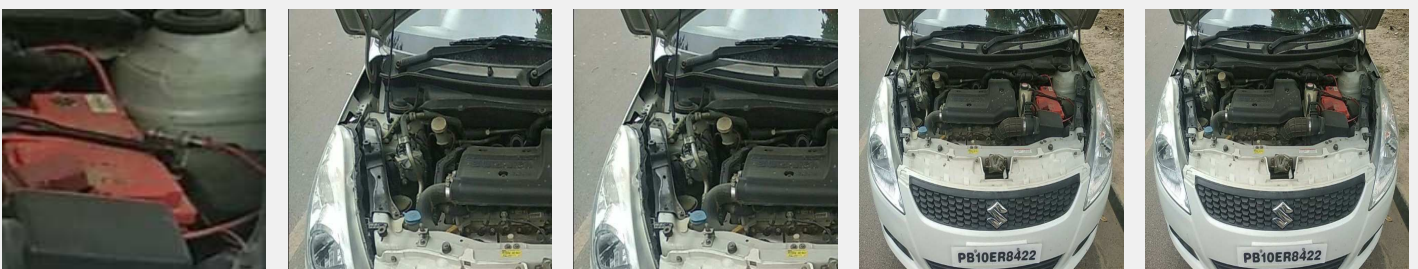
INSPECTION CHECKPOINTS	SCORE(X/10)	REMARKS/COMMENTS	OPTIONAL SPEND EST. (RS)
LH APRON	8		0
RH APRON	9		0
RADIATOR	8		0
WIRING	9		0
BATTERY	9		0
BRAKE FLUID LEVEL	8		0
ENGINE OIL	9		0
COOLANT LEVEL	8		0
BRAKE & COOLANT HOSE PIPES	9		0
UNDERCARRIAGE	8		0
EXHAUST SYSTEM	8		0

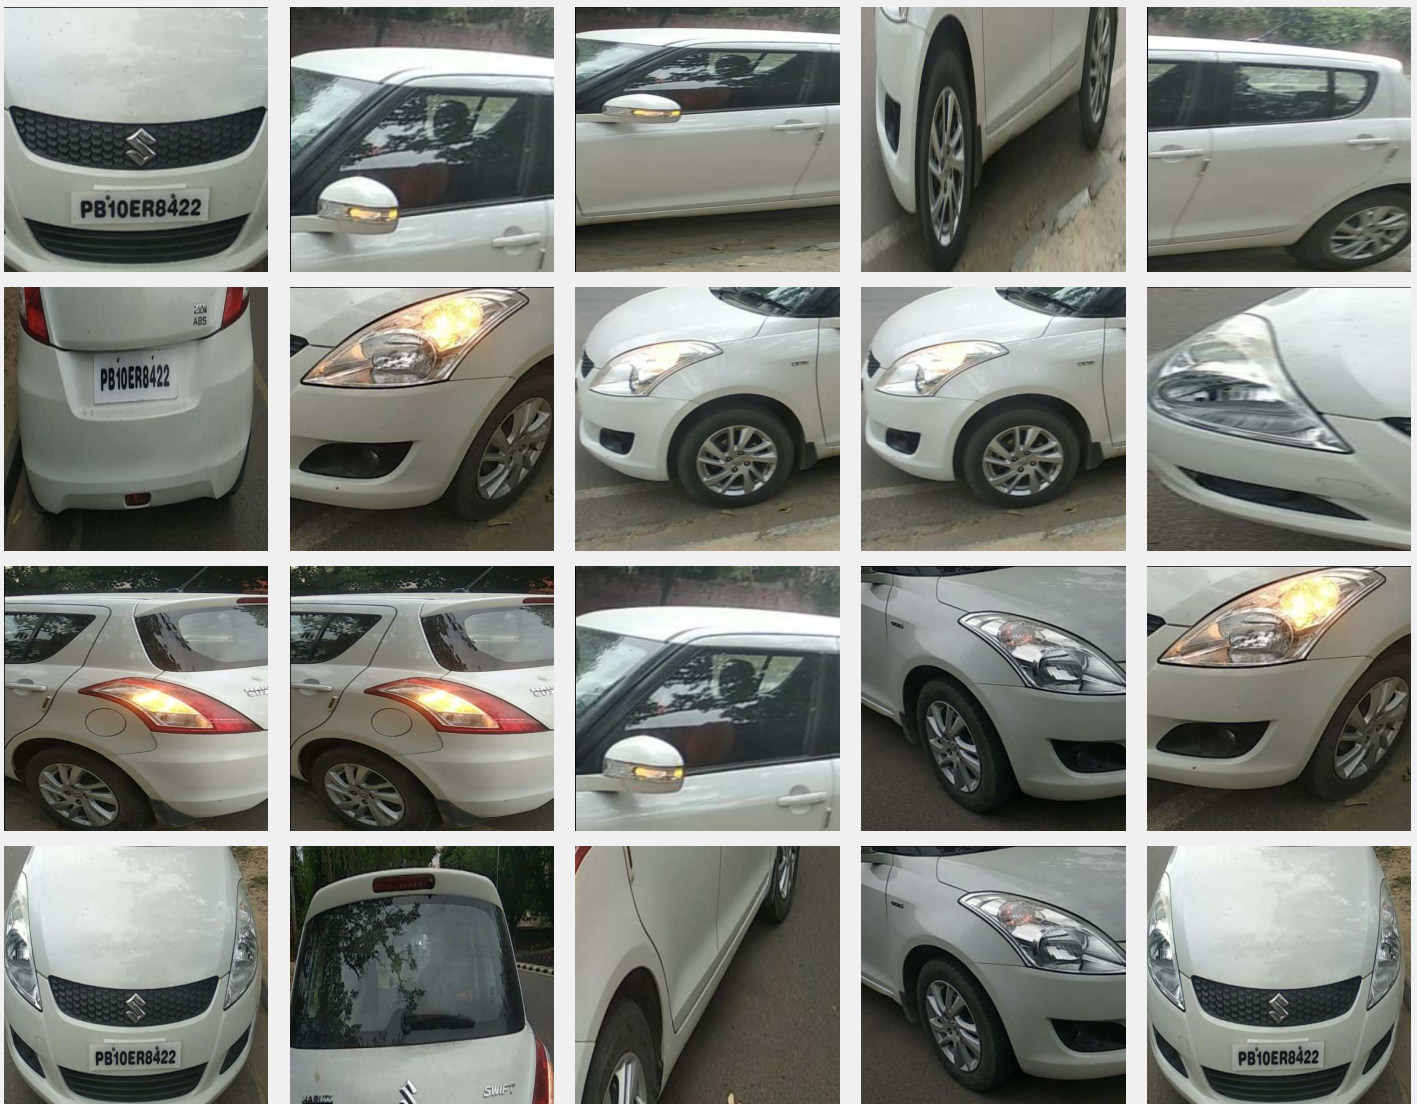
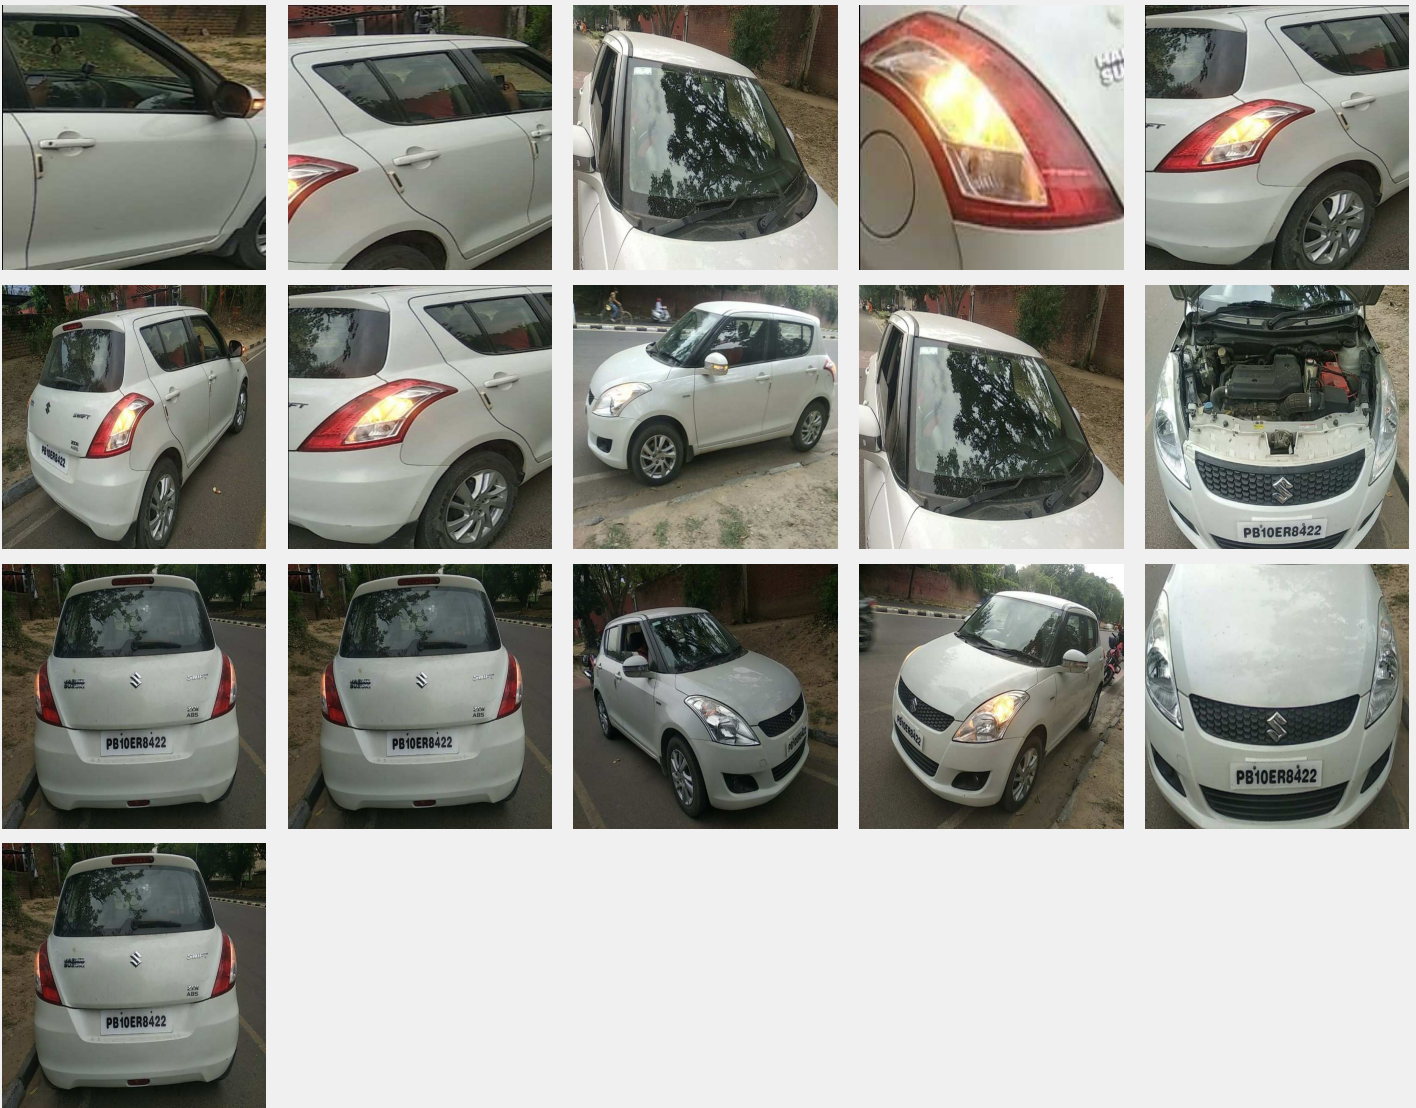
INSPECTION CHECKPOINTS	SCORE(X/10)	REMARKS/COMMENTS	OPTIONAL SPEND EST. (RS)
LICENSE PLATE	8		0
FRONT BUMPER	9		0
HEAD LIGHTS	8		0
GRILLE	9		0
TURN SIGNAL	8		0
FOG LAMPS	8		0
HOOD	8		0
PILLAR	8		0
FRONT WINDSHIELD	9		0
SIDE VIEW MIRRORS	8		0
LH FENDER	8		0
LH FRONT DOOR	9		0
LH REAR DOOR	7		0
LH RUNNING BOARD	9		0
LH QUARTER PANEL	8		0
FUEL LID	9		0
REAR WINDSHIELD	8		0
REAR BUMPER	9		0
TAIL LIGHT	8		0
TRUNK LID/TAIL GATE	8		0
LUGGAGE COMPARTMENT LIGHT	8		0
RH QUARTER PANEL	8		0
RH RUNNING BOARD	9		0
RH REAR DOOR	8		0

INSPECTION CHECKPOINTS	SCORE(X/10)	REMARKS/COMMENTS	OPTIONAL SPEND EST. (RS)
RH FRONT DOOR	9		0
RH FENDER	8		0
BODY RUST	8		0
ROOF (REGULAR)	9		0
PAINT CONDITION	7		0
