# ECO INSPECTION CERTIFICATE

Order ID : 72234

121 Points Vehicle Inspection Certificate

## Volkswagen Vento HIGHLINE DIESEL, 2012

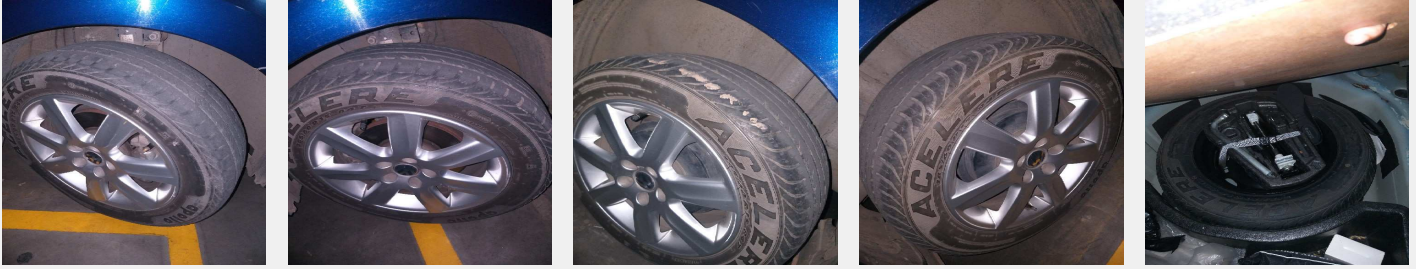
IMAGES

INSPECTION CHECKPOINTS	SCORE(X/10)	REMARKS/COMMENTS	OPTIONAL SPEND EST. (RS)
TYRES	7	GOOD	0
SPARE TYRE (YES)	7	GOOD	0
WHEEL ASSEMBLY (ALLOY RIM)	7	GOOD	0

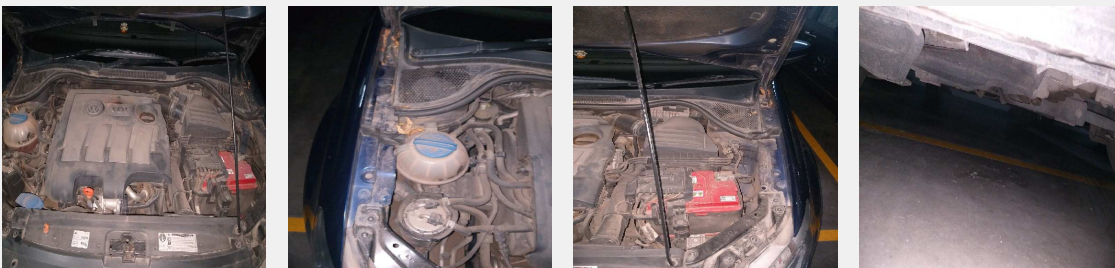
IMAGES

INSPECTION CHECKPOINTS	SCORE(X/10)	REMARKS/COMMENTS	OPTIONAL SPEND EST. (RS)
LH APRON	8	GOOD	0
RH APRON	8	GOOD	0
RADIATOR	8	GOOD	0
WIRING	8	GOOD	0
BATTERY	8	GOOD	0
BRAKE FLUID LEVEL	8	MAXIMUM	0
ENGINE OIL	8	MAXIMUM	0
COOLANT LEVEL	8	MAXIMUM	0
BRAKE & COOLANT HOSE PIPES	8	GOOD	0
UNDERCARRIAGE	8	GOOD	0
EXHAUST SYSTEM	8	GOOD	0

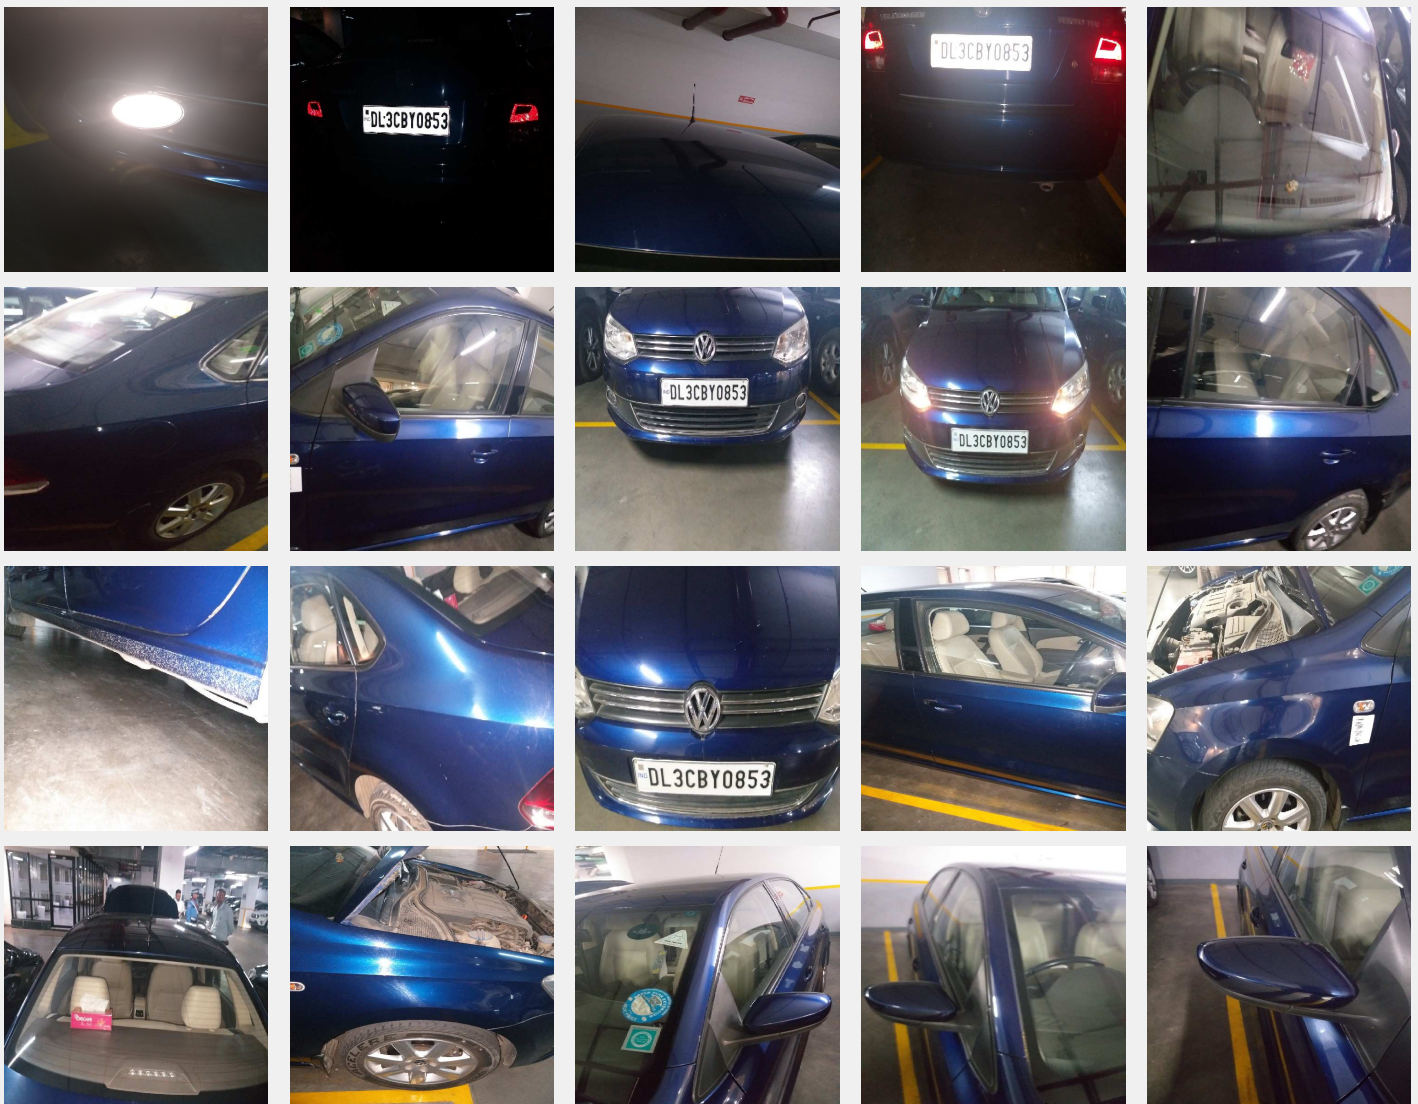
## IMAGES

INSPECTION CHECKPOINTS	SCORE(X/10)	REMARKS/COMMENTS	OPTIONAL SPEND EST. (RS)
RH FRONT DOOR	8	GOOD	0
RH FENDER	8	GOOD	0
BODY RUST	8	GOOD	0
ROOF (REGULAR)	8	GOOD	0
PAINT CONDITION	8	GOOD	0

minor scratches
