ECO INSPECTION CERTIFICATE

Order ID : 73067

121 Points Vehicle Inspection Certificate

Royal Enfield Thunderbird 350CC, 2015

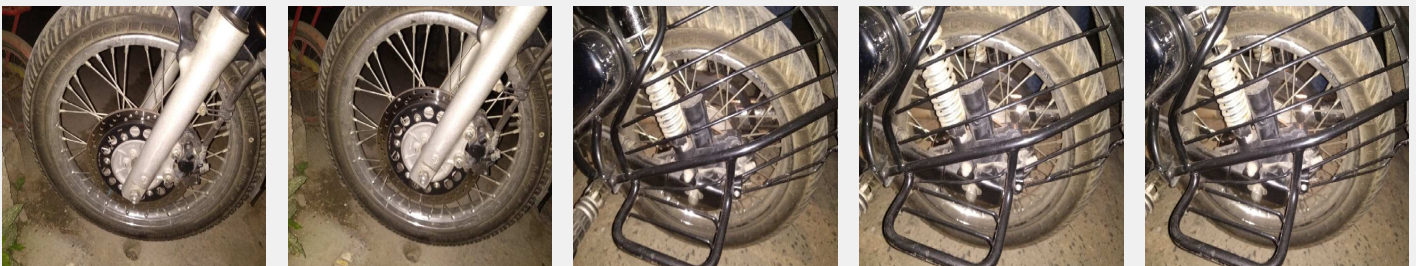
INSPECTION CHECKPOINTS	SCORE(X/10)	REMARKS/COMMENTS	OPTIONAL SPEND EST. (RS)
FRONT TYRE CONDITION & AIR PRESSURE	8		0
REAR TYRE CONDITION & AIR PRESSURE	8		0
WHEEL SPOKES FRONT	8		0
WHEEL SPOKES REAR	8		0
WHEEL RIM FRONT	8		0
WHEEL RIM REAR	8		0
WHEEL BEARINGS FRONT	8		0
WHEEL BEARINGS REAR	8		0
WHEEL SEALS FRONT	8		0
WHEEL SEALS REAR	8		0
BRAKE FUNCTION FRONT	8		0
BRAKE FUNCTION REAR	8		0
BRAKES CONDITION FRONT	8		0
BRAKES CONDITION REAR	8		0

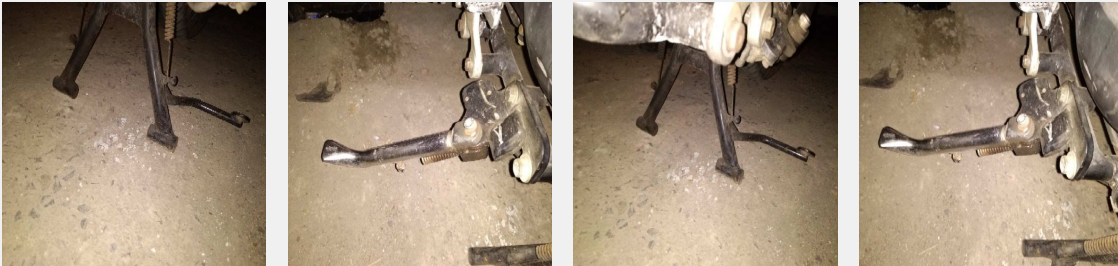
INSPECTION CHECKPOINTS	SCORE(X/10)	REMARKS/COMMENTS	OPTIONAL SPEND EST. (RS)
CENTRE STAND CONDITION	8		0
CENTRE STAND RETENTION	8		0
SIDE STAND CONDITION	8		0
SIDE STAND RETENTION	8		0

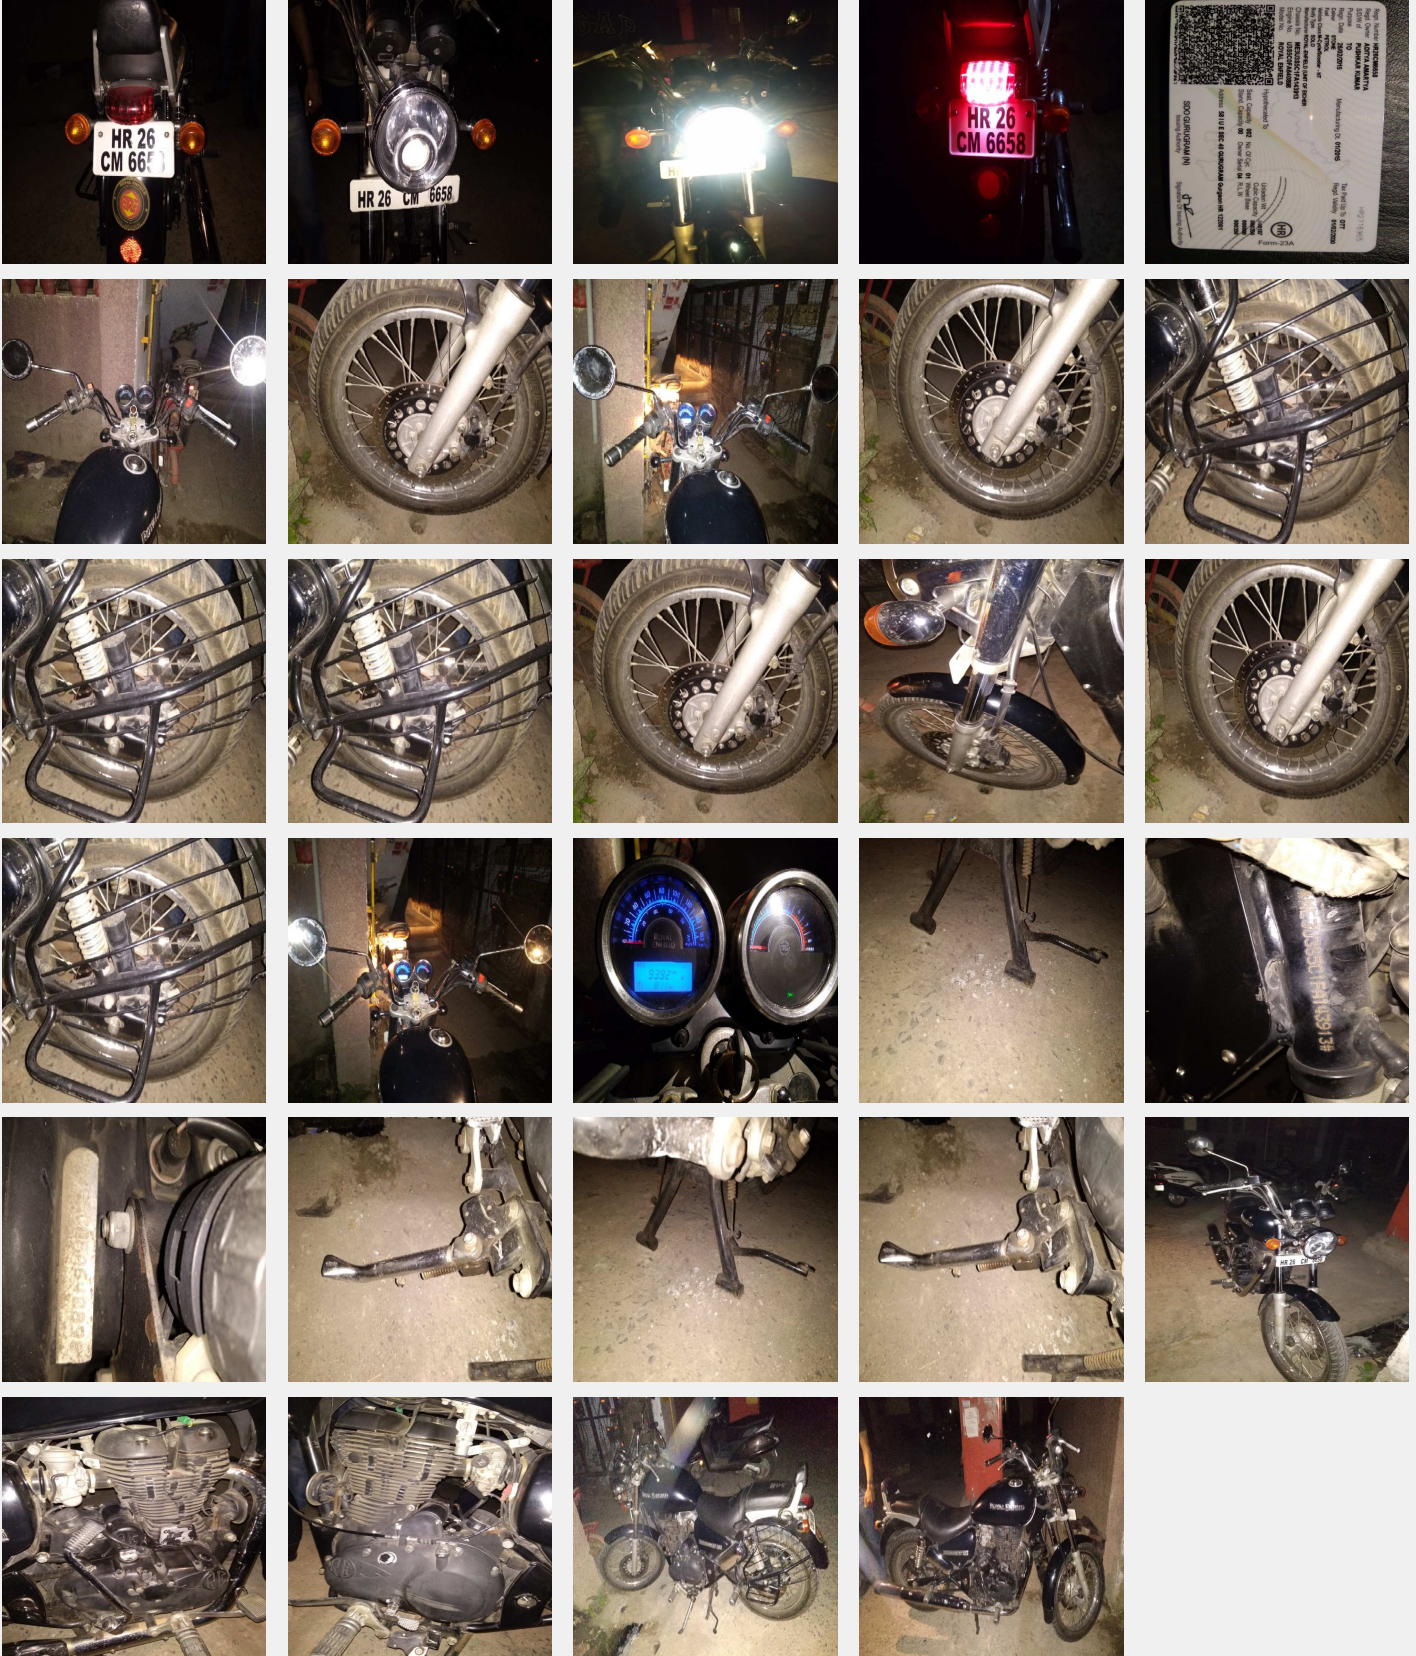
all body minor scratches
