# ECO INSPECTION CERTIFICATE

121 Points Vehicle Inspection Certificate

Ordered By : Rahul	Inspection Date : 2019-05-16	Location : GHAZIABAD
-----------------------	---------------------------------	-------------------------

## Maruti Suzuki Swift LDI, 2016

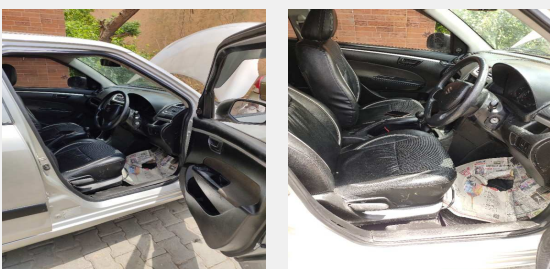
## IMAGES

INSPECTION CHECKPOINTS	SCORE(X/10)	REMARKS/COMMENTS	OPTIONAL SPEND EST. (RS)
DOOR PANEL	7		0
DOOR HINGES	7		0
CARPET & FLOOR MAT	7		0
SEAT & SEAT BELT	7		0
DASHBOARD & INSTRUMENT PANEL	7		0
HORN	7		0
HANDBRAKE	7		0
PEDALS	7		0
A/C VENTS & HEATER	7		0
CUP HOLDERS	7		0
ODOMETER	7		0
POWER WINDOWS (YES - FRONT ONLY)	7		0
HAZARD LIGHT	7		0
SPEAKERS & MUSIC SYSTEM	0	NOT AVAILABLE MUSIC SYSTEM NEED TO NEW MUSIC SYSTEM	5000
STEERING-MOUNTED CONTROLS	0	NA	0
CENTRAL LOCK	5	NOT WORKING NEED TO CHECK AND REPAIR	1000
NAVIGATION (YES)	0	NA	0

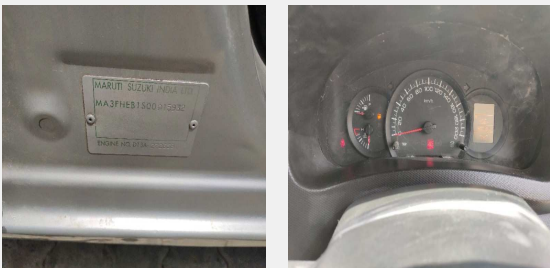
IMAGES

INSPECTION CHECKPOINTS	SCORE(X/10)	REMARKS/COMMENTS	OPTIONAL SPEND EST. (RS)
STEERING PERFORMANCE	6	AVERAGE CONDITION	0
CLUTCH PERFORMANCE	7		0
ENGINE NOISE	6	AVERAGE CONDITION	0
IGNITION SYSTEM	7		0
SUSPENSION PERFORMANCE	7		0
SUSPENSION FRONT SHOCKS	7		0
SUSPENSION REAR SHOCKS	7		0
TRANSMISSION ENGAGE	7		0
BRAKE PERFORMANCE	4	BRAKE HARD NEED TO BE REPAIR	2500
CRUISE CONTROL (YES)	0	NA	0
REAR PARKING SENSORS (YES)	0	NA	0
REAR VIEW CAMERA (YES)	0	NA	0

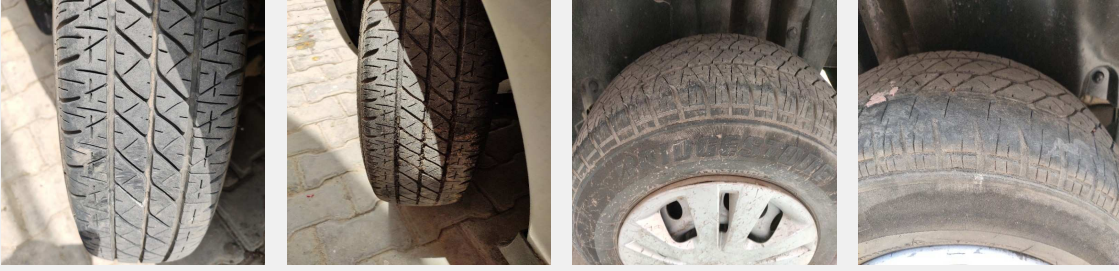
IMAGES

INSPECTION CHECKPOINTS	SCORE(X/10)	REMARKS/COMMENTS	OPTIONAL SPEND EST. (RS)
TYRES	7		0
WHEEL ASSEMBLY (STEEL RIM)	7		0
SPARE TYRE (YES)	0	NOT AVAILABLE SPARE TIRE NEED TO NEW SPARE TIRE	4000

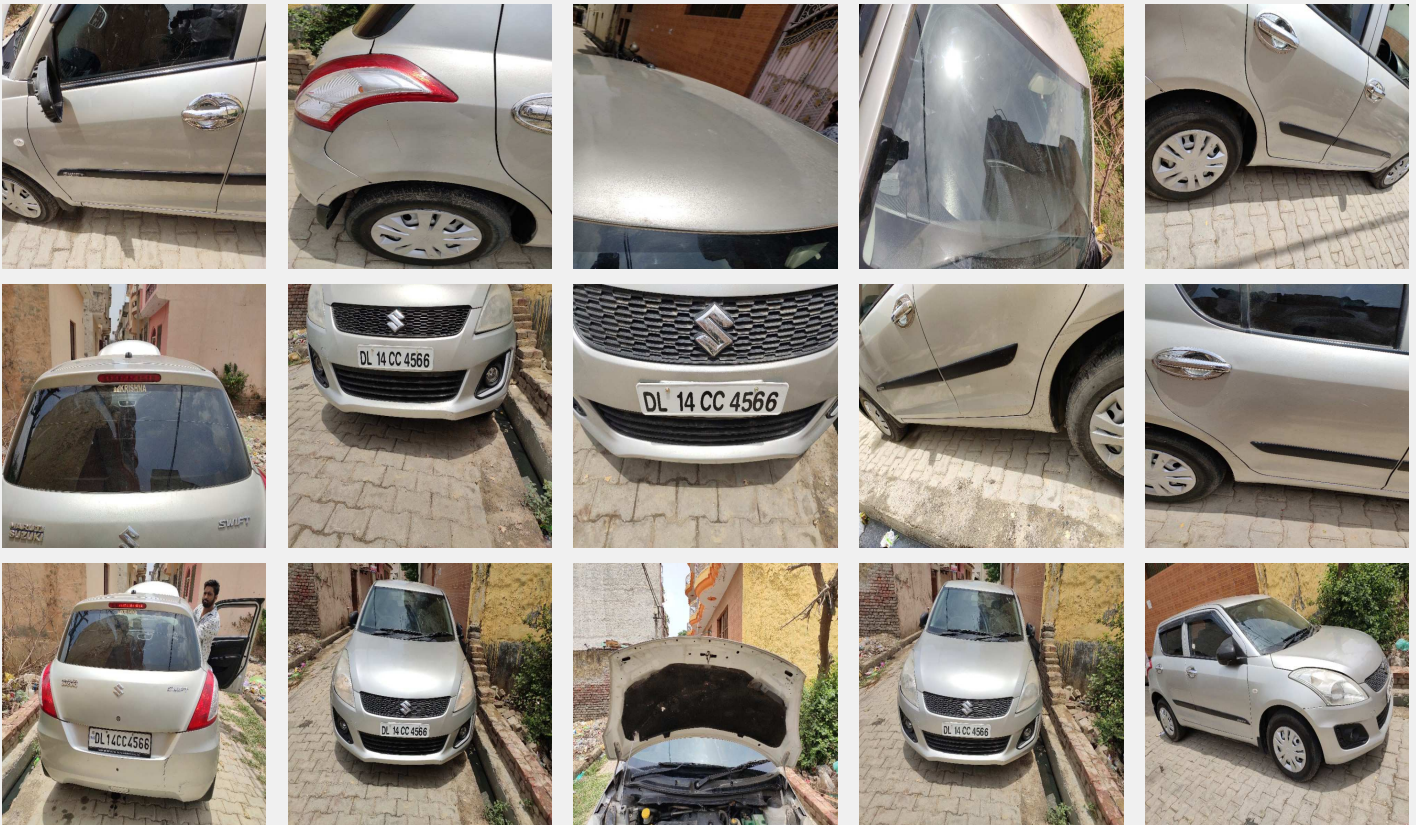
## IMAGES

INSPECTION CHECKPOINTS	SCORE(X/10)	REMARKS/COMMENTS	OPTIONAL SPEND EST. (RS)
LICENSE PLATE	7		0
FRONT BUMPER	6	SCRATCHES	100
HEAD LIGHTS	6	AVERAGE CONDITION	0
GRILLE	7		0
TURN SIGNAL	7		0
HOOD	6	AVERAGE CONDITION	0
PILLAR	6	AVERAGE CONDITION	0
FRONT WINDSHIELD	6	AVERAGE CONDITION	0
LH FENDER	6	AVERAGE CONDITION	0
LH FRONT DOOR	6	SCRATCHES	200
LH REAR DOOR	7		0
LH RUNNING BOARD	7		0
LH QUARTER PANEL	7		0
FUEL LID	7		0
REAR WINDSHIELD	6	AVERAGE CONDITION	0
TAIL LIGHT	7		0
TRUNK LID/TAIL GATE	7		0
LUGGAGE COMPARTMENT LIGHT	7		0
RH QUARTER PANEL	6	SCRATCHES	100
RH RUNNING BOARD	7		0
RH REAR DOOR	6	SCRATCHES	150
RH FRONT DOOR	7		0
RH FENDER	7		0
BODY RUST	7		0

INSPECTION CHECKPOINTS	SCORE(X/10)	REMARKS/COMMENTS	OPTIONAL SPEND EST. (RS)
ROOF (REGULAR)	7		0
PAINT CONDITION	7		0
FOG LAMPS	5	NOT WORKING NEED TO CHECK AND REPAIR	350
SIDE VIEW MIRRORS	4	LEFT SIDE MIRROR BROKEN NEED TO BE CHANGE	800
REAR BUMPER	5	SCRATCHES NEED TO BE REAPIR	500
