# ECO INSPECTION CERTIFICATE

Order ID : 73309

121 Points Vehicle Inspection Certificate

## Hyundai I20 SPORTZ 1.4 CRDI, 2012

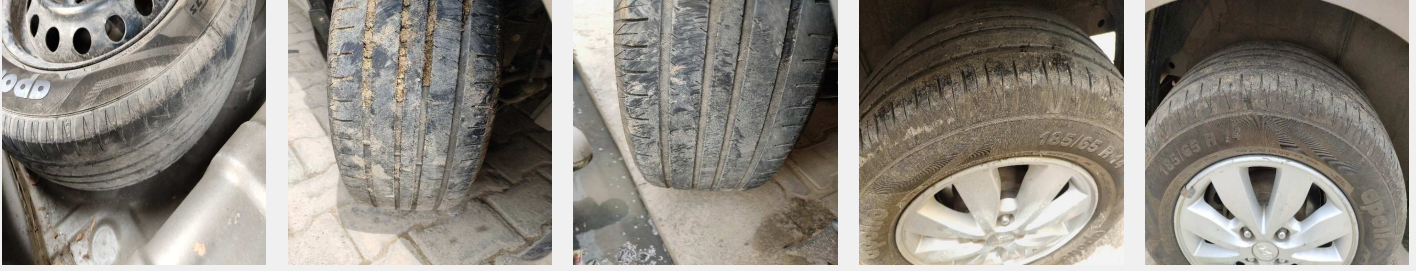
INSPECTION CHECKPOINTS	SCORE(X/10)	REMARKS/COMMENTS	OPTIONAL SPEND EST. (RS)
TYRES	7		0
SPARE TYRE (YES)	7		0
WHEEL ASSEMBLY (ALLOY RIM)	7		0

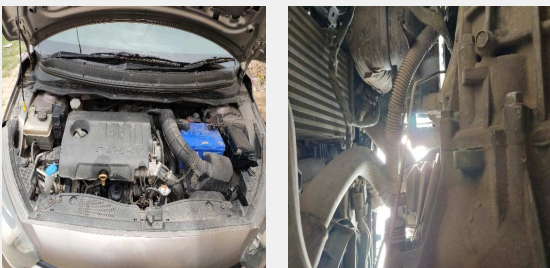
INSPECTION CHECKPOINTS	SCORE(X/10)	REMARKS/COMMENTS	OPTIONAL SPEND EST. (RS)
LH APRON	7		0
RH APRON	7		0
RADIATOR	6	AVERAGE CONDITION	0
WIRING	6	AVERAGE CONDITION	0
BATTERY	7		0
BRAKE FLUID LEVEL	7		0
ENGINE OIL	7		0
COOLANT LEVEL	7		0
BRAKE & COOLANT HOSE PIPES	7		0
UNDERCARRIAGE	7		0
EXHAUST SYSTEM	7		0

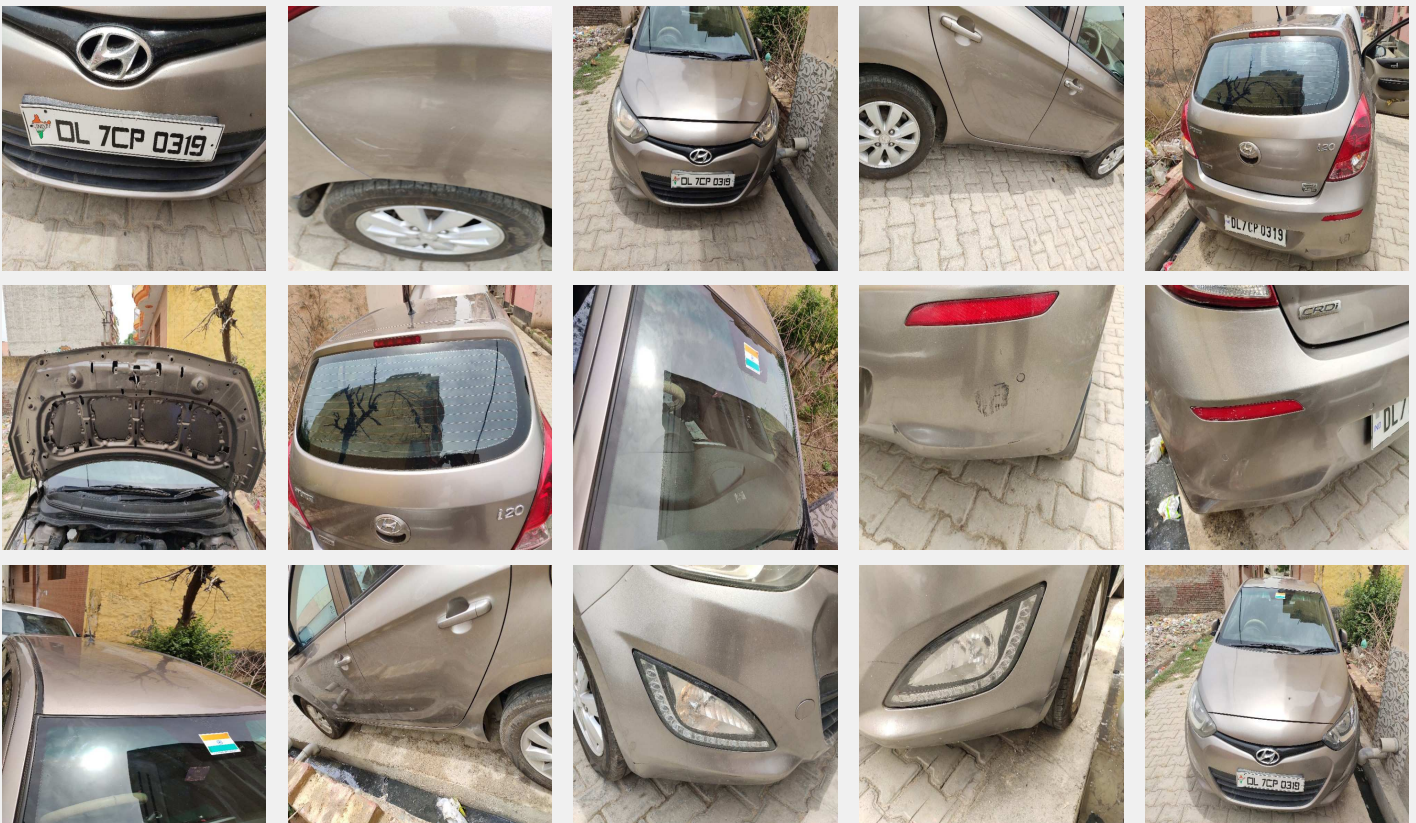
INSPECTION CHECKPOINTS	SCORE(X/10)	REMARKS/COMMENTS	OPTIONAL SPEND EST. (RS)
LICENSE PLATE	7		0
FRONT BUMPER	6	SCRATCHES	150
HEAD LIGHTS	7		0
GRILLE	7		0
TURN SIGNAL	7		0
HOOD	6	AVERAGE CONDITION	0
PILLAR	7		0
FRONT WINDSHIELD	6	AVERAGE CONDITION	0
SIDE VIEW MIRRORS	7		0
LH FENDER	7		0
LH FRONT DOOR	7		0
LH REAR DOOR	7		0
LH RUNNING BOARD	7		0
LH QUARTER PANEL	7		0
FUEL LID	7		0
REAR WINDSHIELD	7		0
REAR BUMPER	6	SCRATCHES	150
TAIL LIGHT	7		0
TRUNK LID/TAIL GATE	7		0
LUGGAGE COMPARTMENT LIGHT	7		0
RH QUARTER PANEL	6	SCRATCHES	100
RH RUNNING BOARD	7		0
RH REAR DOOR	7		0
RH FRONT DOOR	7		0

INSPECTION CHECKPOINTS	SCORE(X/10)	REMARKS/COMMENTS	OPTIONAL SPEND EST. (RS)
RH FENDER	7		0
BODY RUST	7		0
ROOF (REGULAR)	7		0
PAINT CONDITION	7		0
FOG LAMPS	5	LEFT FOG LAMP NOT WORKING NEED TO CHECK AND REPAIR	100

all body minor scratches
