ECO INSPECTION CERTIFICATE

121 Points Vehicle Inspection Certificate

Toyota Fortuner 2.8 4X2 AT, 2017

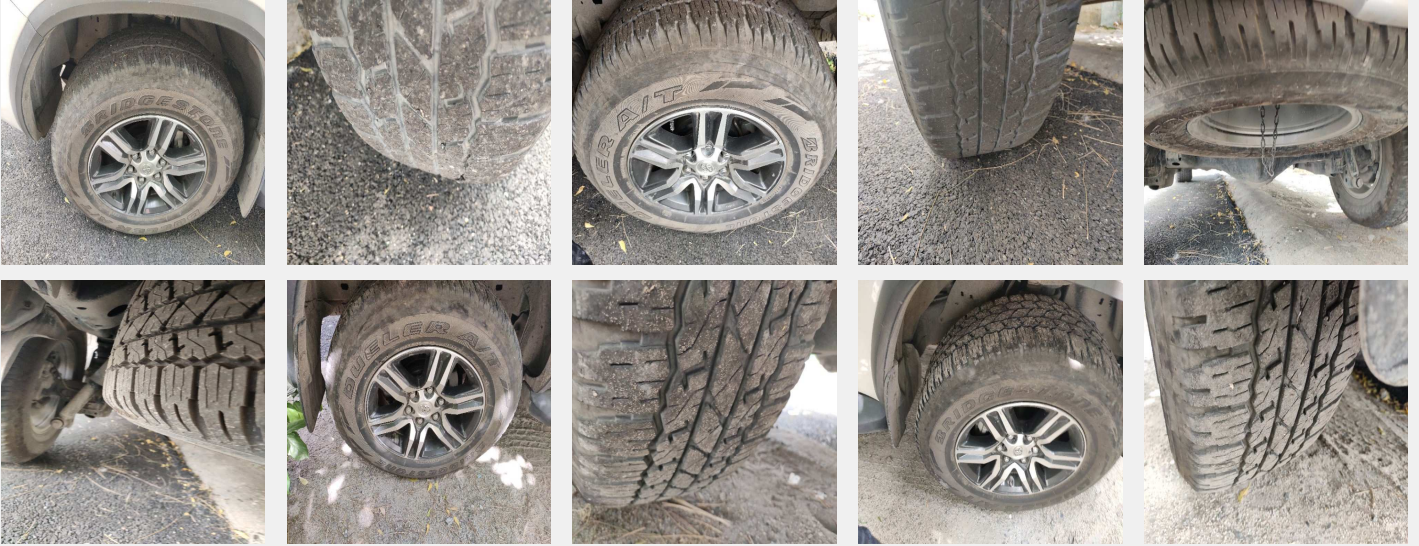
IMAGES

INSPECTION CHECKPOINTS	SCORE(X/10)	REMARKS/COMMENTS	OPTIONAL SPEND EST. (RS)
TYRES	7	GOOD CONDITION	0
SPARE TYRE (YES)	7	GOOD CONDITION	0
WHEEL ASSEMBLY (ALLOY RIM)	7	GOOD CONDITION	0

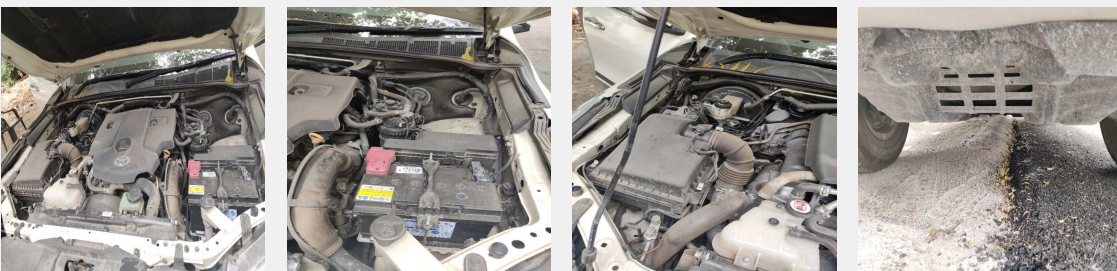
IMAGES

INSPECTION CHECKPOINTS	SCORE(X/10)	REMARKS/COMMENTS	OPTIONAL SPEND EST. (RS)
LH APRON	8	GOOD CONDITION	0
RH APRON	8	GOOD CONDITION	0
RADIATOR	8	GOOD CONDITION	0
WIRING	8	GOOD CONDITION	0
BATTERY	8	GOOD CONDITION	0
BRAKE FLUID LEVEL	8	MAX	0
ENGINE OIL	8	MAX	0
COOLANT LEVEL	8	MAX	0
BRAKE & COOLANT HOSE PIPES	8	GOOD CONDITION	0
UNDERCARRIAGE	8	GOOD CONDITION	0
EXHAUST SYSTEM	8	GOOD CONDITION	0

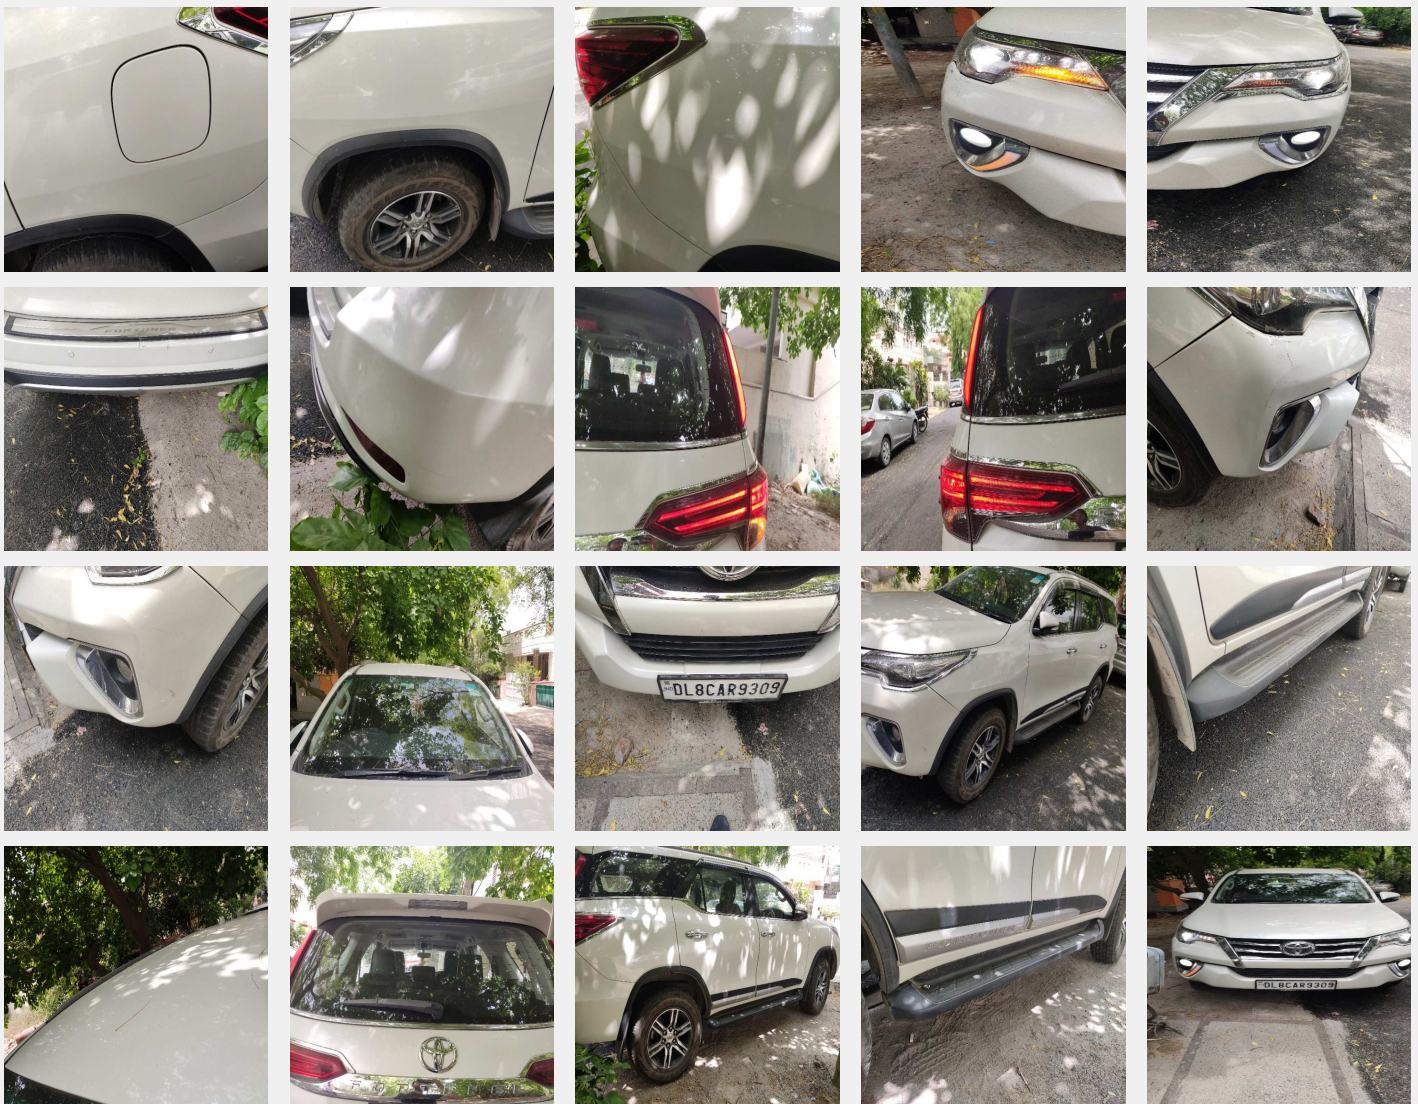
IMAGES

INSPECTION CHECKPOINTS	SCORE(X/10)	REMARKS/COMMENTS	OPTIONAL SPEND EST. (RS)
LICENSE PLATE	8	GOOD CONDITION	0
FRONT BUMPER	6	MINOR SCRATCHES	1000
HEAD LIGHTS	8	GOOD CONDITION	0
GRILLE	8	GOOD CONDITION	0
TURN SIGNAL	8	GOOD CONDITION	0
FOG LAMPS	8	GOOD CONDITION	0
HOOD	8	GOOD CONDITION	0
PILLAR	8	GOOD CONDITION	0
FRONT WINDSHIELD	7	GOOD VISIBILITY	0
SIDE VIEW MIRRORS	8	GOOD CONDITION	0
LH FENDER	6	MINOR SCRATCHES	800
LH FRONT DOOR	8	GOOD CONDITION	0
LH REAR DOOR	8	GOOD CONDITION	0
LH RUNNING BOARD	8	GOOD CONDITION	0
LH QUARTER PANEL	6	MINOR SCRATCHES	800
FUEL LID	8	GOOD CONDITION	0
REAR WINDSHIELD	8	GOOD VIDIBILITY	0
REAR BUMPER	6	MINOR SCRATCHES	1000
TAIL LIGHT	8	GOOD CONDITION	0
TRUNK LID/TAIL GATE	8	GOOD CONDITION	0
LUGGAGE COMPARTMENT LIGHT	8	GOOD CONDITION	0
RH QUARTER PANEL	6	MINOR SCRATCHES	500
RH RUNNING BOARD	8	GOOD CONDITION	0
RH REAR DOOR	8	GOOD CONDITION	0

INSPECTION CHECKPOINTS	SCORE(X/10)	REMARKS/COMMENTS	OPTIONAL SPEND EST. (RS)
RH FRONT DOOR	8	GOOD CONDITION	0
RH FENDER	8	GOOD CONDITION	0
BODY RUST	8	GOOD CONDITION	0
ROOF (REGULAR)	8	GOOD CONDITION	0
PAINT CONDITION	8	GOOD CONDITION	0

minor scratches
