ECO INSPECTION CERTIFICATE

Order ID : 74601

121 Points Vehicle Inspection Certificate

Hyundai I20 MAGNA 1.2, 2009

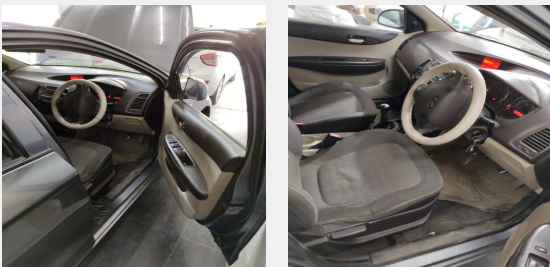
IMAGES

INSPECTION CHECKPOINTS	SCORE(X/10)	REMARKS/COMMENTS	OPTIONAL SPEND EST. (RS)
DOOR PANEL	6	AVERAGE CONDITION	0
DOOR HINGES	6	AVERAGE CONDITION	0
CARPET & FLOOR MAT	6	AVERAGE CONDITION	0
SEAT & SEAT BELT	7		0
DASHBOARD & INSTRUMENT PANEL	7		0
HORN	7		0
SPEAKERS & MUSIC SYSTEM	7		0
HANDBRAKE	7		0
PEDALS	7		0
CENTRAL LOCK	7		0
A/C VENTS & HEATER	6	AVERAGE CONDITION	0
CUP HOLDERS	7		0
ODOMETER	7		0
POWER WINDOWS (YES)	7		0
HAZARD LIGHT	7		0
STEERING-MOUNTED CONTROLS	0	NA	0
NAVIGATION (YES)	0	NA	0

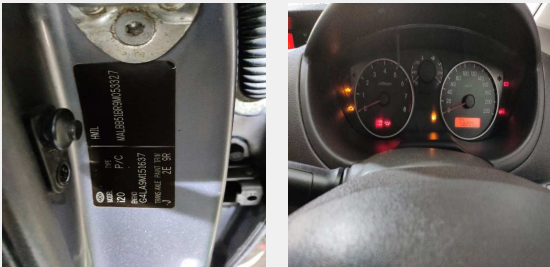
IMAGES

INSPECTION CHECKPOINTS	SCORE(X/10)	REMARKS/COMMENTS	OPTIONAL SPEND EST. (RS)
STEERING PERFORMANCE	6	AVERAGE CONDITION	0
BRAKE PERFORMANCE	6	AVERAGE CONDITION	0
IGNITION SYSTEM	7		0
SUSPENSION PERFORMANCE	6	AVERAGE CONDITION	0
SUSPENSION FRONT SHOCKS	6	AVERAGE CONDITION	0
SUSPENSION REAR SHOCKS	6	AVERAGE CONDITION	0
TRANSMISSION ENGAGE	7		0
CLUTCH PERFORMANCE	4	CLUTCH HARD NEED TO BE OVERHALL	5000
ENGINE NOISE	5	ENGINE NOISE NEED TO CHECK AND REPAIR	4000
CRUISE CONTROL (YES)	0	NA	0
REAR PARKING SENSORS (YES)	0	NA	0
REAR VIEW CAMERA (YES)	0	NA	0

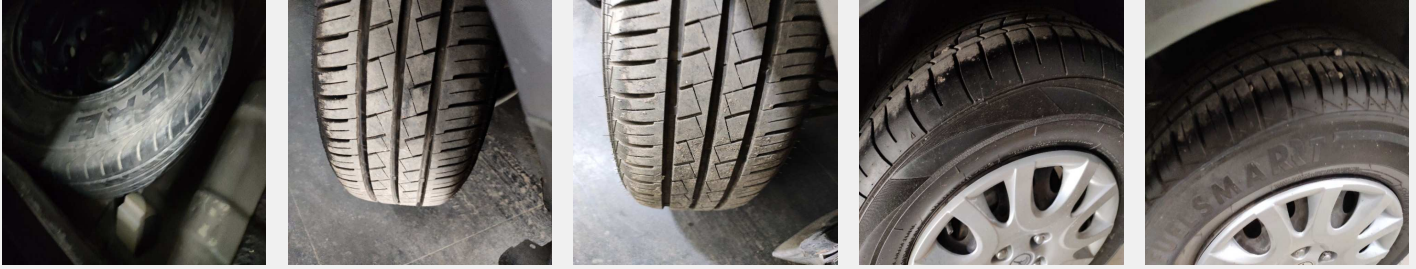
IMAGES

INSPECTION CHECKPOINTS	SCORE(X/10)	REMARKS/COMMENTS	OPTIONAL SPEND EST. (RS)
TYRES	8		0
SPARE TYRE (YES)	7		0
WHEEL ASSEMBLY (STEEL RIM)	6	AVERAGE CONDITION	0

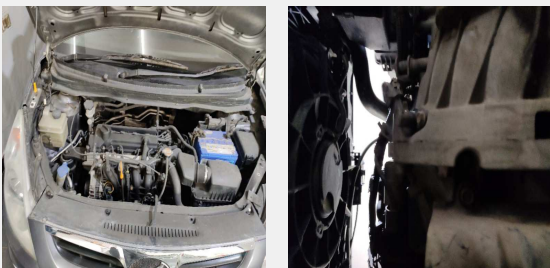
IMAGES

INSPECTION CHECKPOINTS	SCORE(X/10)	REMARKS/COMMENTS	OPTIONAL SPEND EST. (RS)
LH APRON	6	AVERAGE CONDITION	0
RH APRON	6	AVERAGE CONDITION	0
RADIATOR	6	AVERAGE CONDITION	0
WIRING	6	AVERAGE CONDITION	0
BATTERY	7		0
BRAKE FLUID LEVEL	7		0
ENGINE OIL	7		0
COOLANT LEVEL	7		0
BRAKE & COOLANT HOSE PIPES	6	AVERAGE CONDITION	0
UNDERCARRIAGE	7		0
EXHAUST SYSTEM	7		0

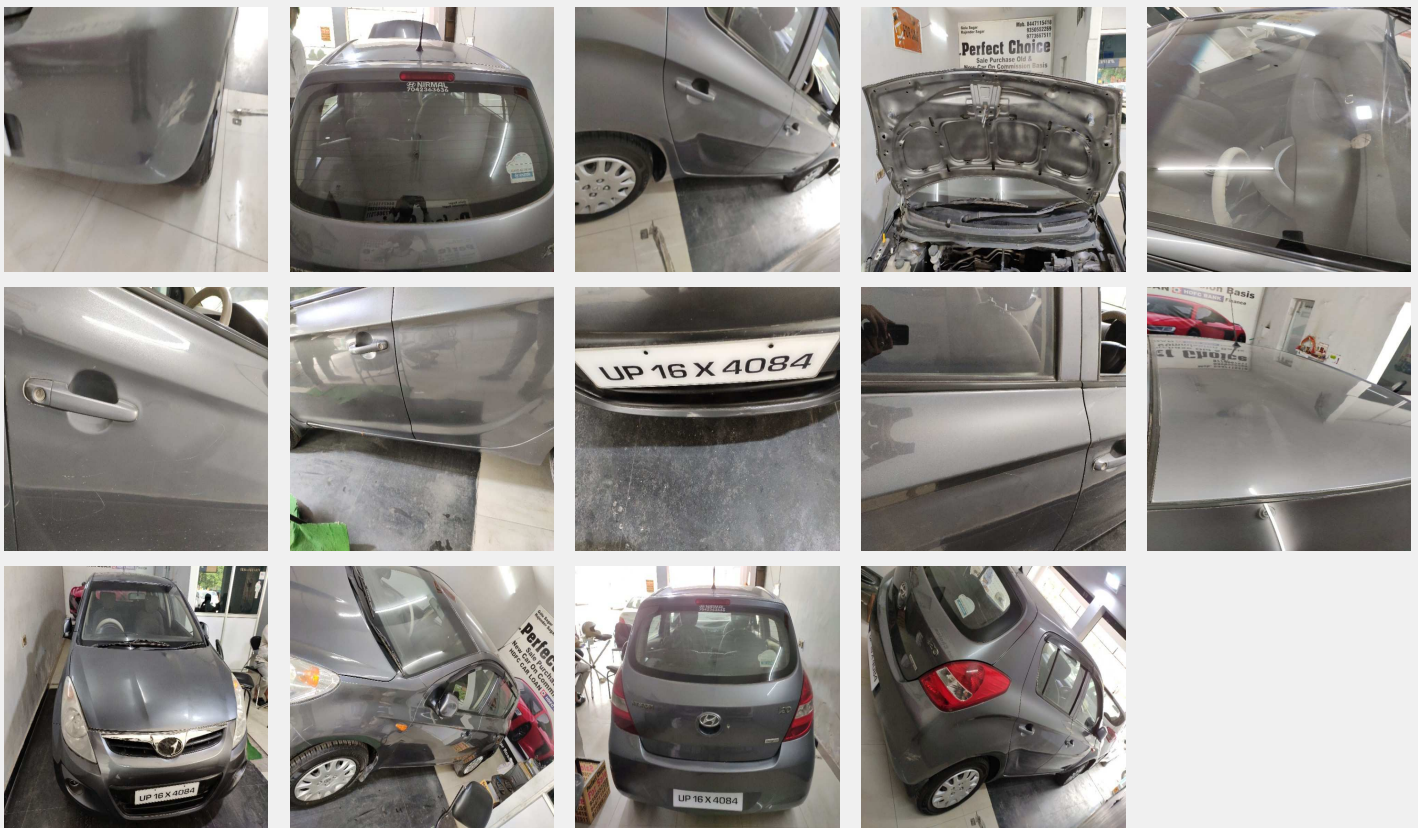
IMAGES

INSPECTION CHECKPOINTS	SCORE(X/10)	REMARKS/COMMENTS	OPTIONAL SPEND EST. (RS)
LICENSE PLATE	7		0
FRONT BUMPER	7		0
GRILLE	7		0
TURN SIGNAL	7		0
HOOD	6	AVERAGE CONDITION	0
PILLAR	6	AVERAGE CONDITION	0
FRONT WINDSHIELD	6	AVERAGE CONDITION	0
SIDE VIEW MIRRORS	6	AVERAGE CONDITION	0
LH FENDER	7		0
LH FRONT DOOR	7		0
LH REAR DOOR	7		0
LH RUNNING BOARD	7		0
LH QUARTER PANEL	7		0
FUEL LID	7		0
REAR WINDSHIELD	6	AVERAGE CONDITION	0
REAR BUMPER	7		0
TRUNK LID/TAIL GATE	7		0
LUGGAGE COMPARTMENT LIGHT	7		0
RH QUARTER PANEL	7		0
RH RUNNING BOARD	7		0
RH REAR DOOR	6	SCRATCHES	200
RH FRONT DOOR	6	SCRATCHES	200
RH FENDER	7		0
BODY RUST	6	AVERAGE CONDITION	0

INSPECTION CHECKPOINTS	SCORE(X/10)	REMARKS/COMMENTS	OPTIONAL SPEND EST. (RS)
ROOF (REGULAR)	6	AVERAGE CONDITION	0
PAINT CONDITION	6	AVERAGE CONDITION	0
HEAD LIGHTS	5	RIGHT HEAD LAMP NOT WORKING NEED TO CHECK AND REPAIR	150
FOG LAMPS	0	NA	0
TAIL LIGHT	5	LEFT TAIL LAMP BROKEN NEED TO BE CHANGE	1200

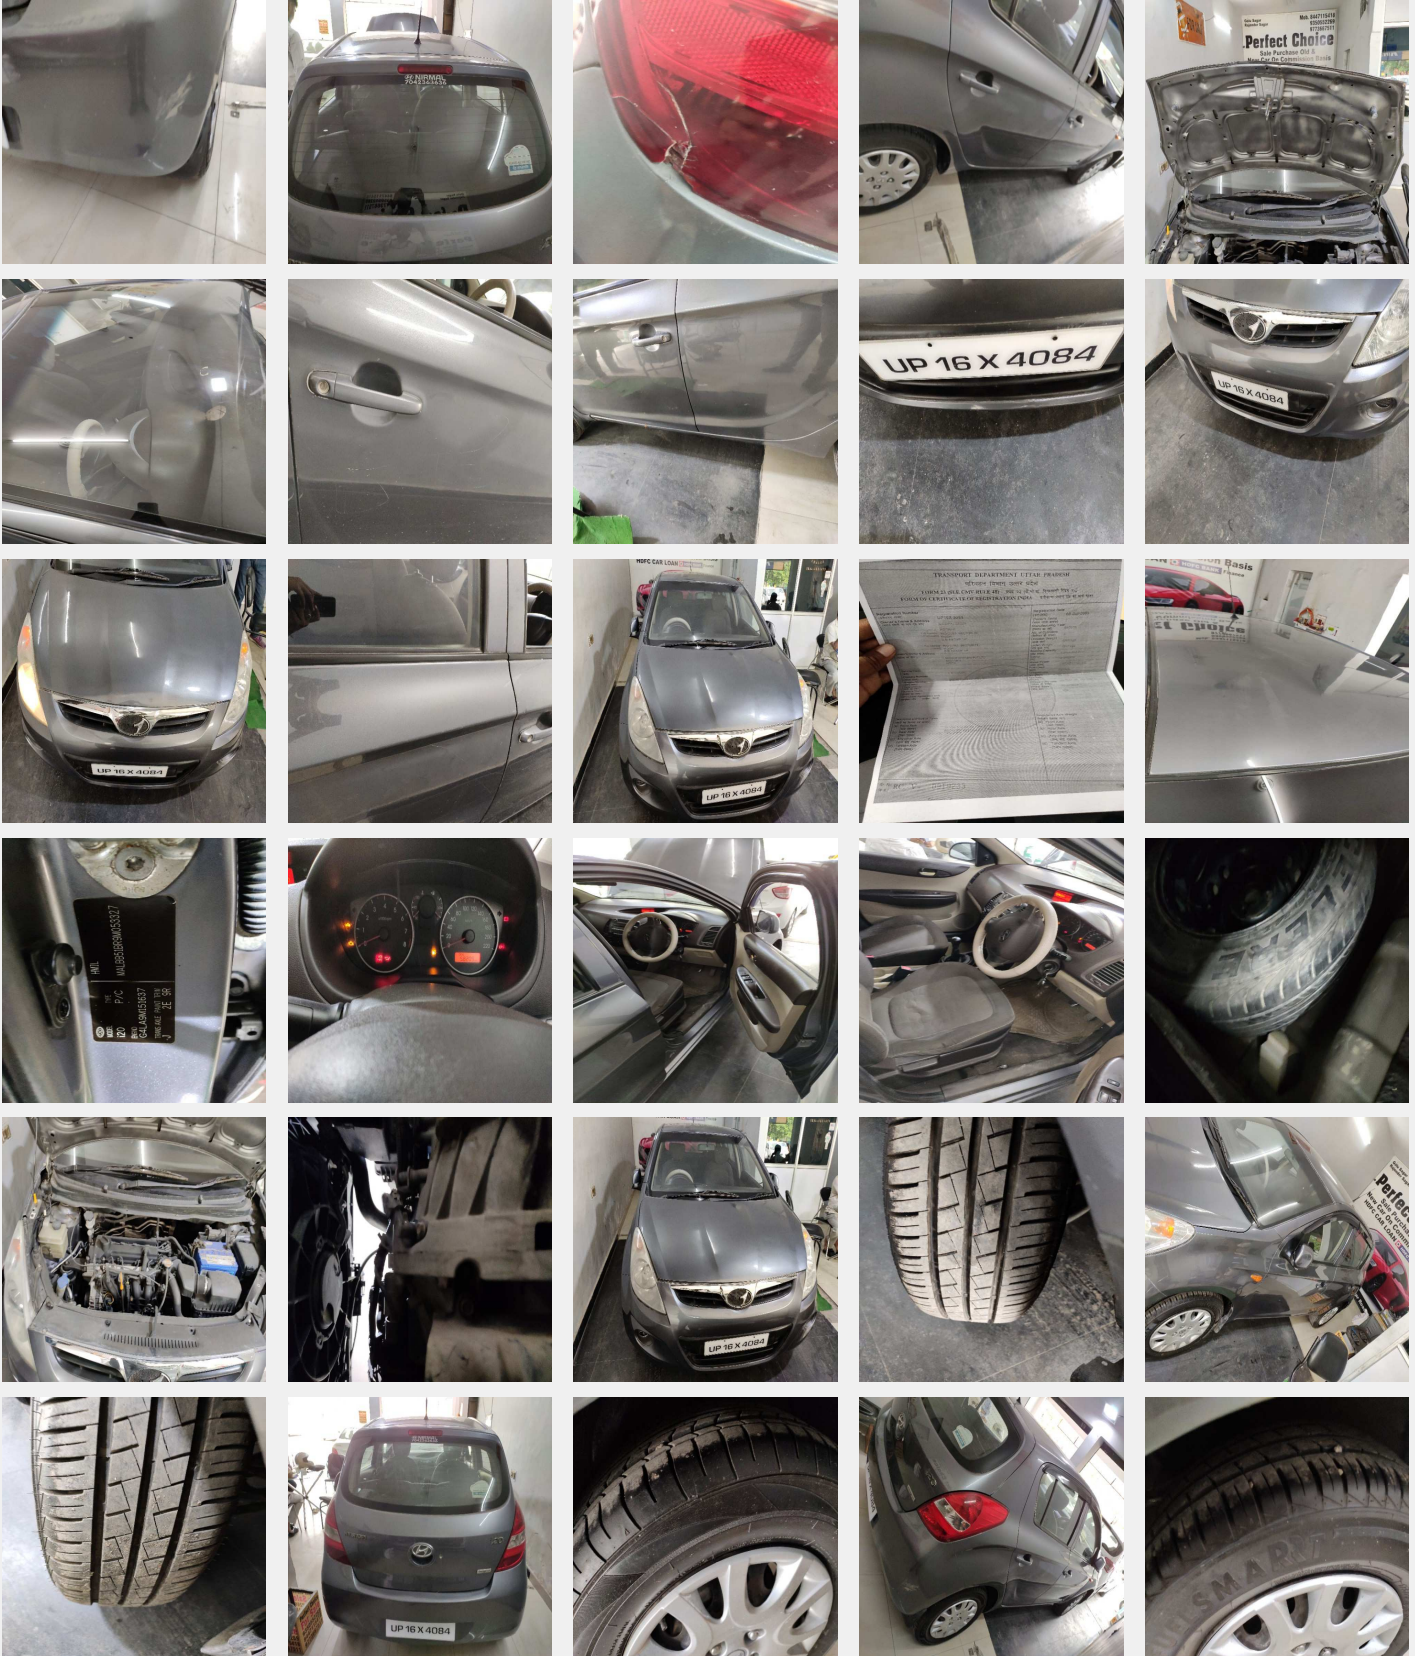
IMAGES

all body minor scratches and clutch hard need to overhall and engine noise need to repair left tail
