ECO INSPECTION CERTIFICATE

121 Points Vehicle Inspection Certificate

Ordered By : Anshul Chawla	Inspection Date : 2019-05-16	Location : GHAZIABAD
--------------------------------------	--	--------------------------------

Toyota Fortuner 3.0 4X2 MT, 2015

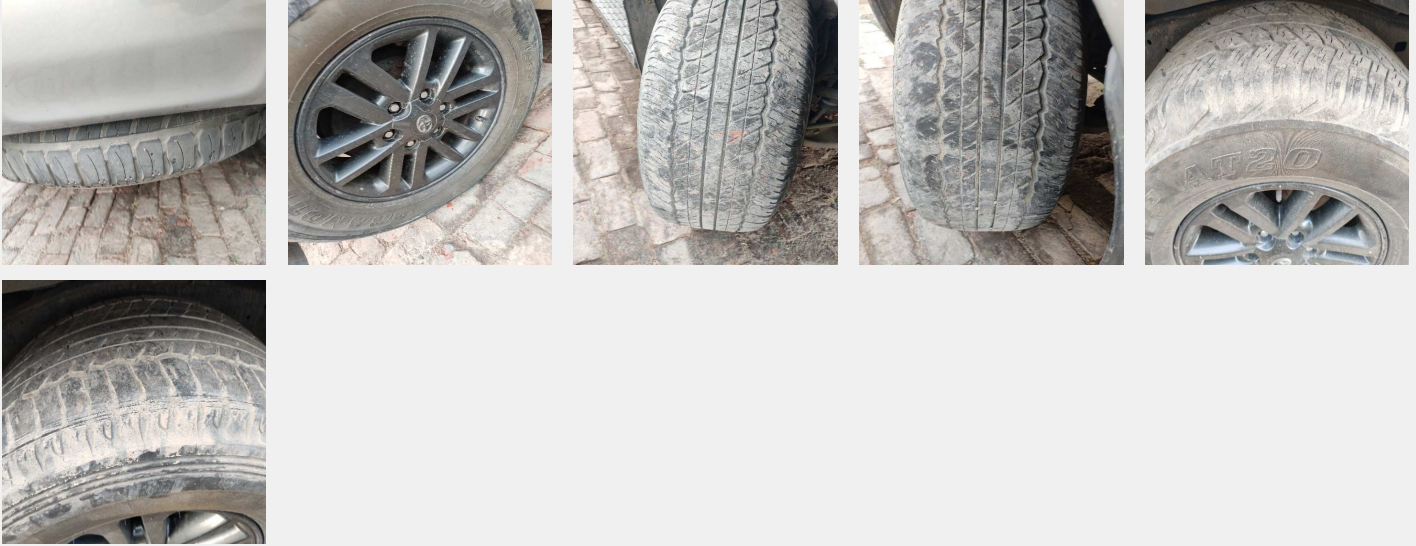
IMAGES

INSPECTION CHECKPOINTS	SCORE(X/10)	REMARKS/COMMENTS	OPTIONAL SPEND EST. (RS)
TYRES	6	AVERAGE CONDITION	0
SPARE TYRE (YES)	8		0
WHEEL ASSEMBLY (ALLOY RIM)	7		0

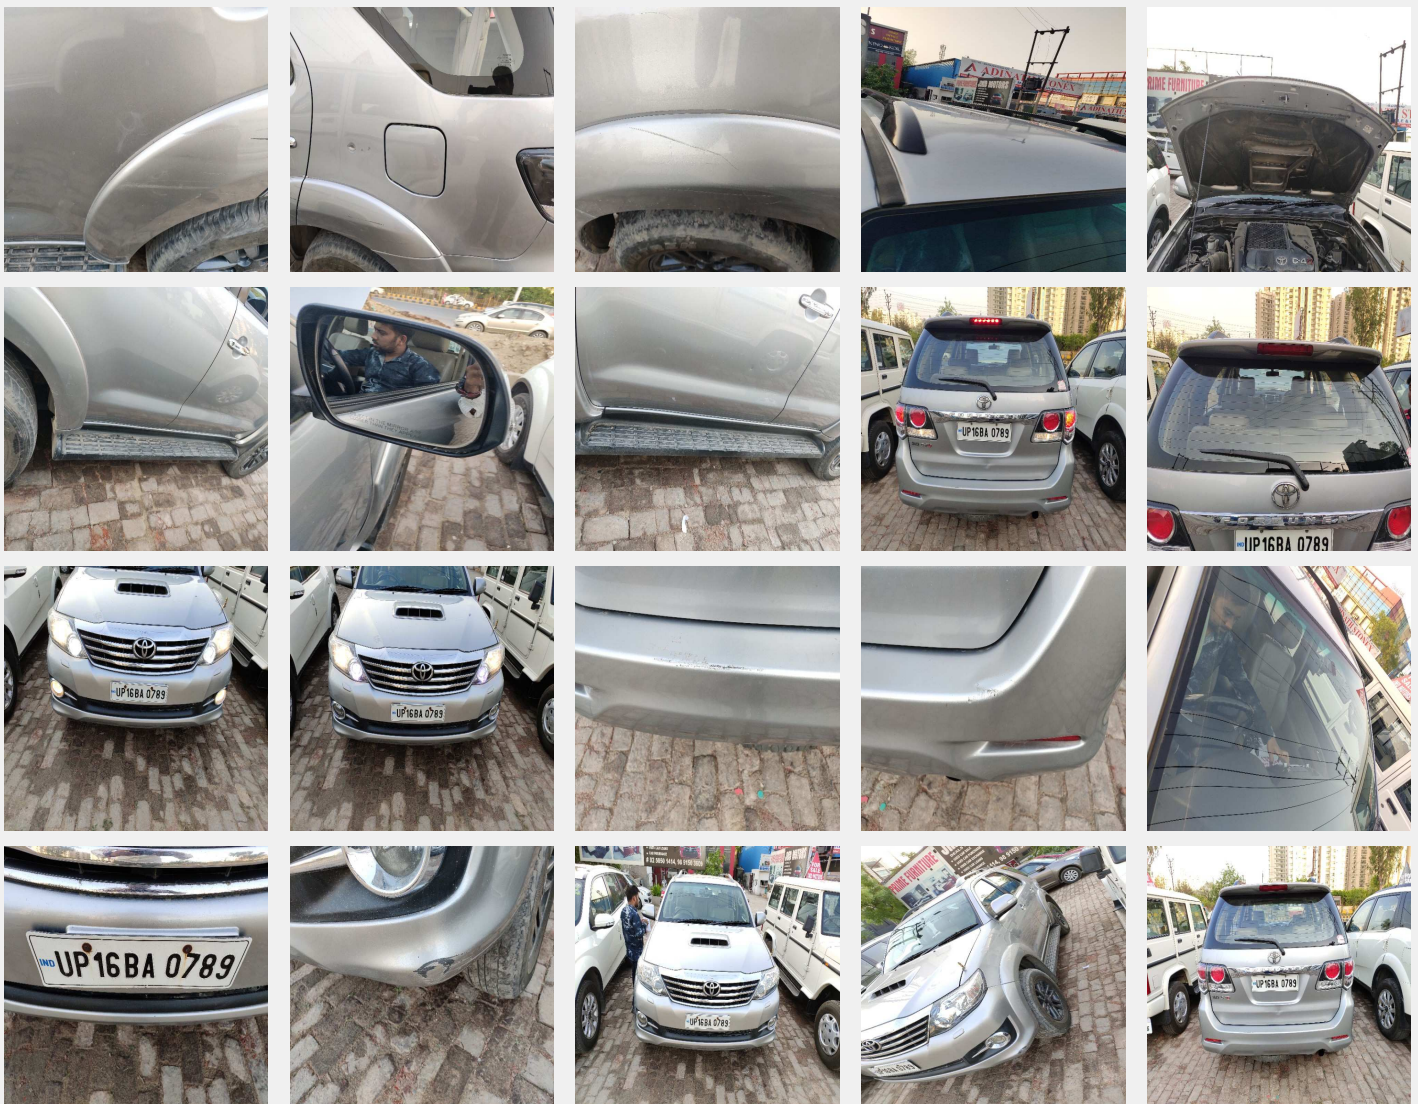
IMAGES

INSPECTION CHECKPOINTS	SCORE(X/10)	REMARKS/COMMENTS	OPTIONAL SPEND EST. (RS)
LICENSE PLATE	7		0
FRONT BUMPER	6	SCRATCHES	250
HEAD LIGHTS	7		0
GRILLE	7		0
TURN SIGNAL	7		0
FOG LAMPS	7		0
HOOD	7		0
PILLAR	7		0
FRONT WINDSHIELD	7		0
SIDE VIEW MIRRORS	7		0
LH FENDER	6	SCRATCHES	100
LH FRONT DOOR	7		0
LH REAR DOOR	6	SCRATCHES	250
LH RUNNING BOARD	7		0
LH QUARTER PANEL	6	MINOR DENT AND SCRATCHES	400
FUEL LID	7		0
REAR WINDSHIELD	7		0
REAR BUMPER	6	SCRATCHES	350
TAIL LIGHT	7		0
TRUNK LID/TAIL GATE	7		0
LUGGAGE COMPARTMENT LIGHT	7		0
RH QUARTER PANEL	7		0
RH RUNNING BOARD	7		0
RH REAR DOOR	7		0

INSPECTION CHECKPOINTS	SCORE(X/10)	REMARKS/COMMENTS	OPTIONAL SPEND EST. (RS)
RH FRONT DOOR	7		0
RH FENDER	7		0
BODY RUST	7		0
ROOF (REGULAR)	7		0
PAINT CONDITION	7		0

all body minor scratches and tyres worn out
