ECO INSPECTION CERTIFICATE

Order ID : 73339

121 Points Vehicle Inspection Certificate

Hyundai Accent EXECUTIVE, 2009

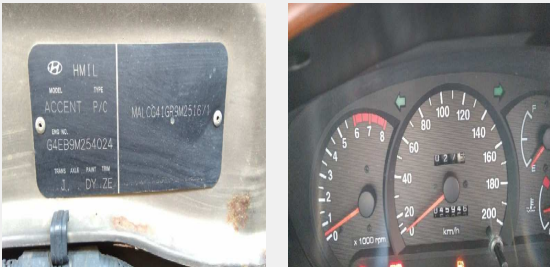
IMAGES

INSPECTION CHECKPOINTS	SCORE(X/10)	REMARKS/COMMENTS	OPTIONAL SPEND EST. (RS)
STEERING PERFORMANCE	7	GOOD	0
BRAKE PERFORMANCE	6	WORKING FINE	0
CLUTCH PERFORMANCE	6	WORKING PROPERLY	0
IGNITION SYSTEM	7	GOOD CONDITION	0
SUSPENSION PERFORMANCE	6	FINE	0
SUSPENSION FRONT SHOCKS	6	NO DAMAGE	0
SUSPENSION REAR SHOCKS	6	NO DAMAGE	0
TRANSMISSION ENGAGE	6	WORKING FINE	0
CRUISE CONTROL (NO)	10		0
REAR PARKING SENSORS (NO)	10		0
REAR VIEW CAMERA (NO)	10		0
ENGINE NOISE	4	AVERAGE NOISE , NEED TO REPAIR FOR GASKET LEAKGE	3000

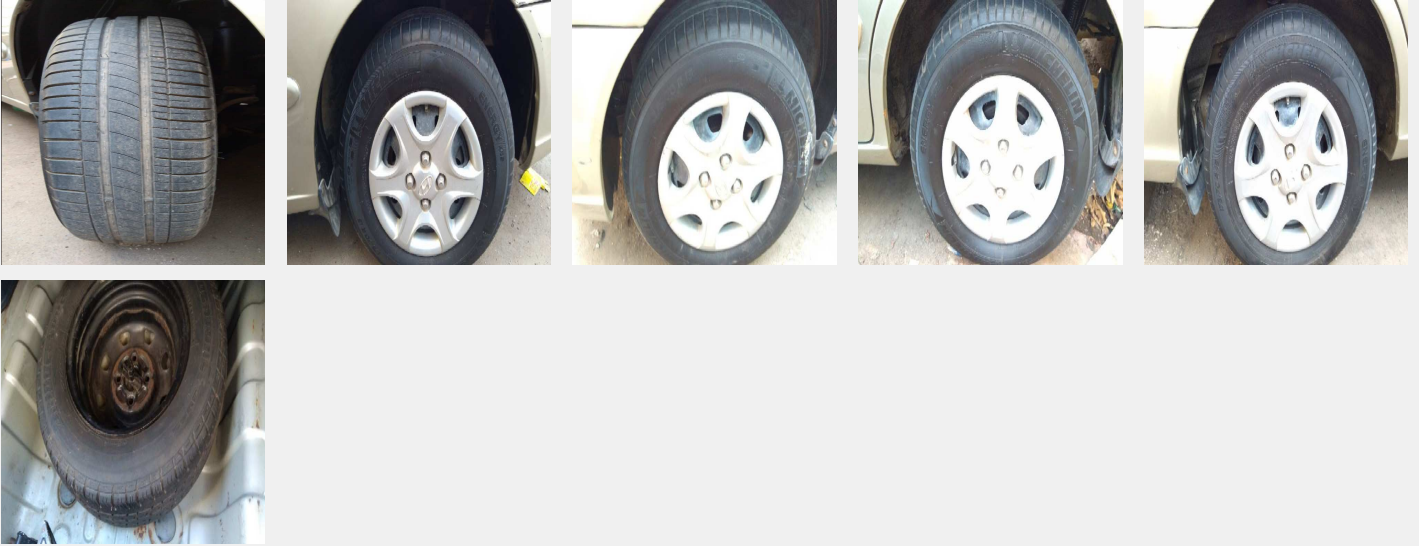
IMAGES

INSPECTION CHECKPOINTS	SCORE(X/10)	REMARKS/COMMENTS	OPTIONAL SPEND EST. (RS)
TYRES	6	AVERAGE CONDITION	0
SPARE TYRE (YES)	6	AVERAGE CONDITION	0
WHEEL ASSEMBLY (STEEL RIM)	6	NO DAMAGE	0

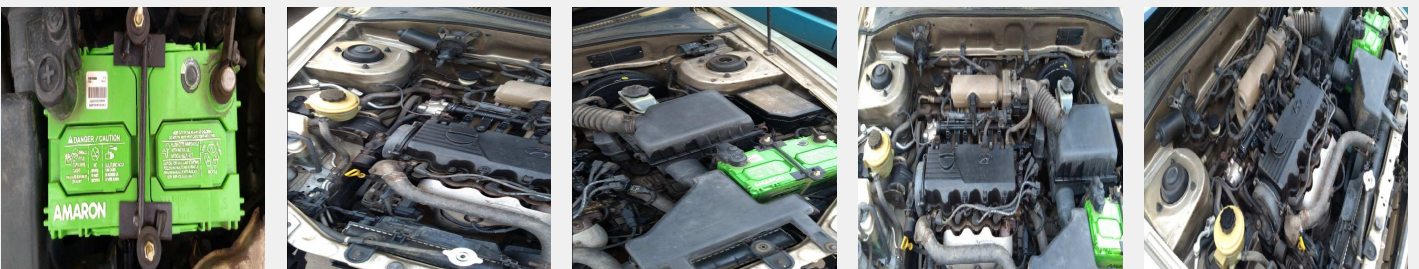
IMAGES

INSPECTION CHECKPOINTS	SCORE(X/10)	REMARKS/COMMENTS	OPTIONAL SPEND EST. (RS)
LH APRON	6	AVERAGE CONDITION	0
RH APRON	6	AVERAGE CONDITION	0
RADIATOR	6	WORKING PROPERLY	0
WIRING	6	NO DAMAGE	0
BATTERY	7	GOOD CONDITION	0
BRAKE FLUID LEVEL	7	MAXIMUM	0
ENGINE OIL	6	ACCEPTABLE	0
COOLANT LEVEL	7	MAXIMUM	0
BRAKE & COOLANT HOSE PIPES	6	AVERAGE CONDITION	0
UNDERCARRIAGE	6	NO DAMAGE	0
EXHAUST SYSTEM	6	WORKING FINE	0

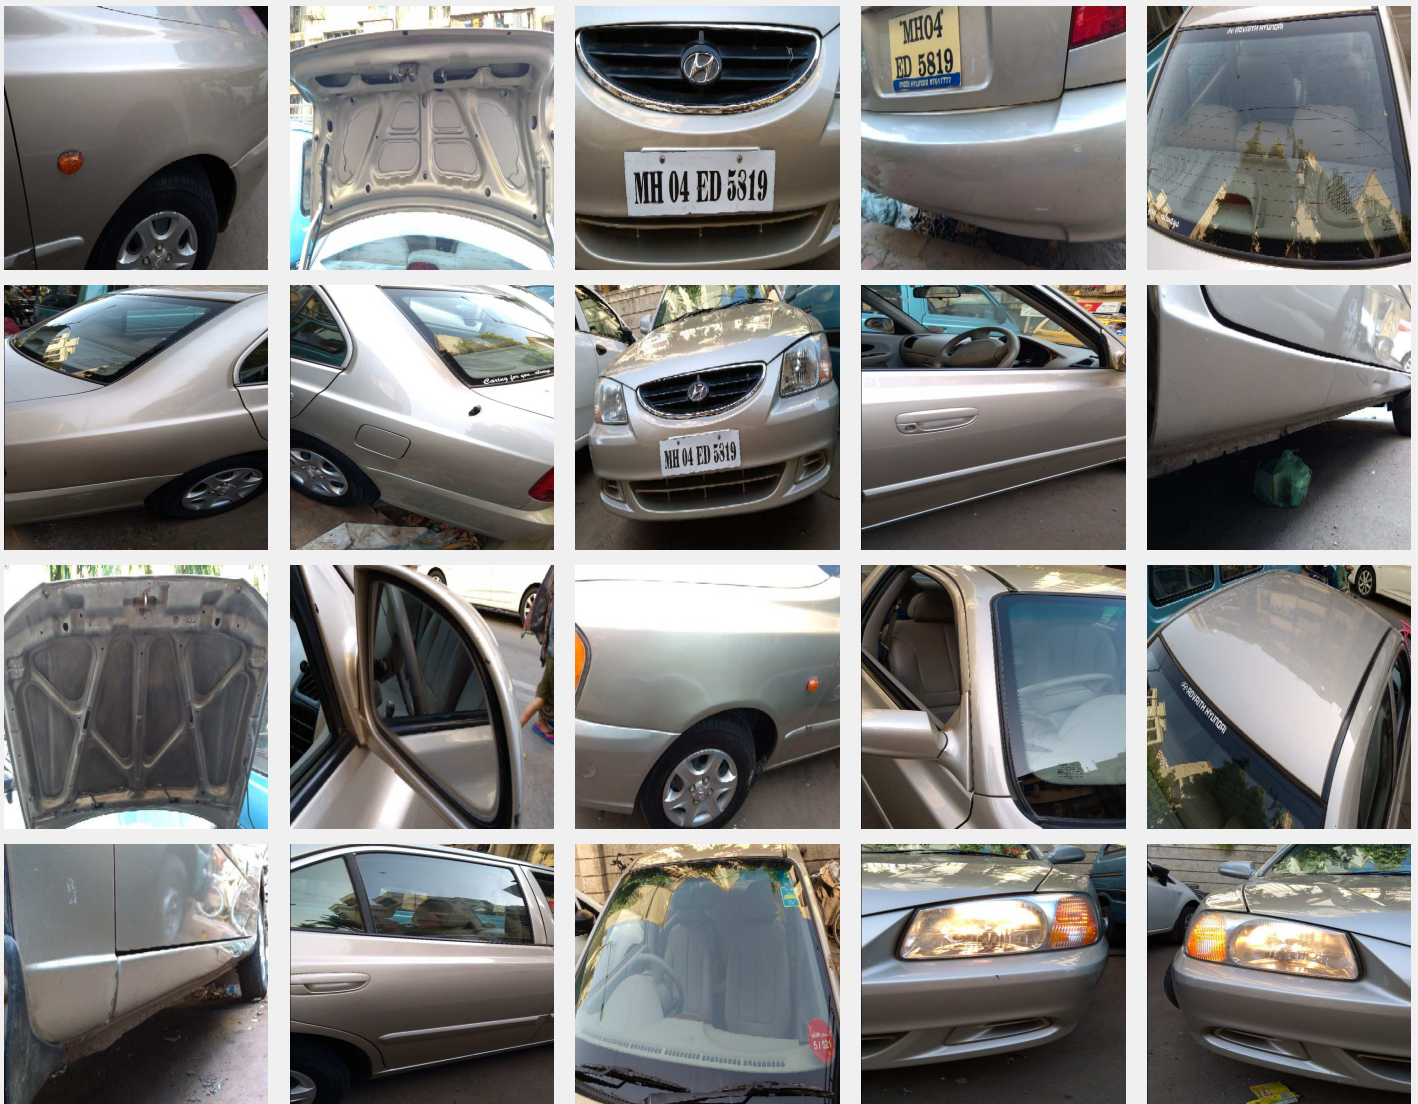
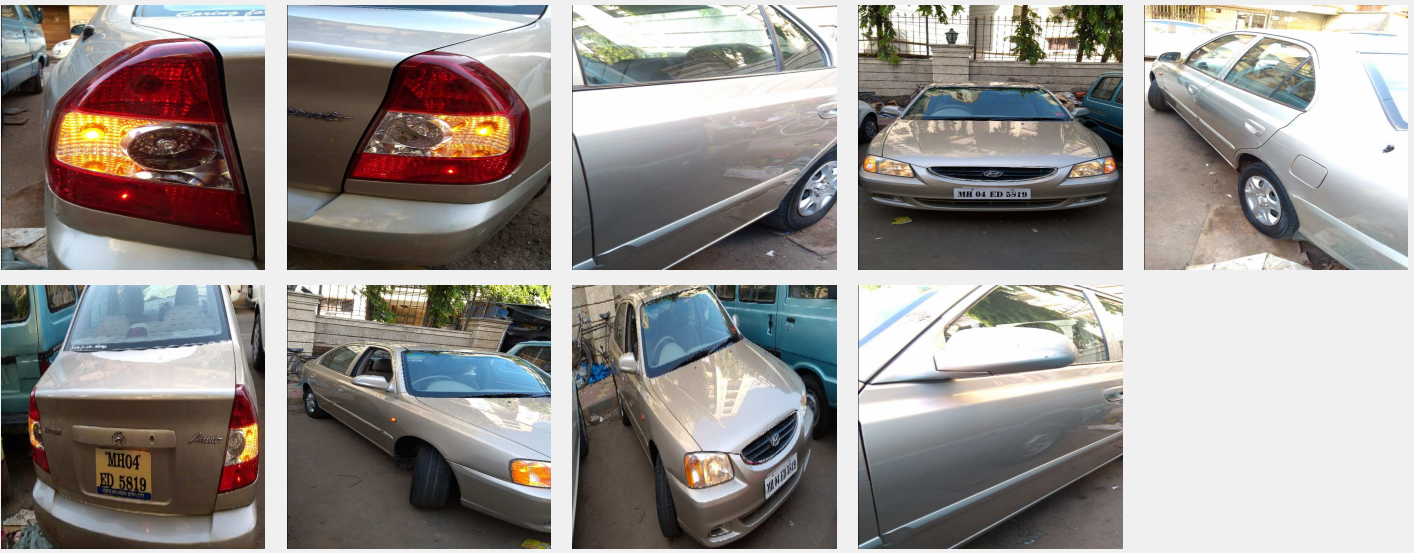
IMAGES

INSPECTION CHECKPOINTS	SCORE(X/10)	REMARKS/COMMENTS	OPTIONAL SPEND EST. (RS)
LICENSE PLATE	7	GOOD CONDITION	0
FRONT BUMPER	7	GOOD CONDITION	0
HEAD LIGHTS	7	GOOD CONDITION	0
GRILLE	7	GOOD CONDITION	0
TURN SIGNAL	7	GOOD CONDITION	0
HOOD	6	AVERAGE CONDITION	0
PILLAR	6	AVERAGE CONDITION	0
FRONT WINDSHIELD	6	AVERAGE CONDITION	0
SIDE VIEW MIRRORS	6	NO DAMAGE	0
LH FENDER	7	GOOD CONDITION	0
LH FRONT DOOR	7	GOOD CONDITION	0
LH REAR DOOR	7	GOOD CONDITION	0
LH RUNNING BOARD	6	AVERAGE CONDITION	0
LH QUARTER PANEL	7	GOOD CONDITION	0
FUEL LID	7	GOOD	0
REAR WINDSHIELD	6	NO DAMAGE	0
REAR BUMPER	7	GOOD CONDITION	0
TAIL LIGHT	7	GOOD CONDITION	0
TRUNK LID/TAIL GATE	7	GOOD CONDITION	0
LUGGAGE COMPARTMENT LIGHT	7	GOOD	0
RH QUARTER PANEL	7	GOOD CONDITION	0
RH RUNNING BOARD	6	ACCEPTABLE CONDITION	0
RH REAR DOOR	7	GOOD CONDITION	0
RH FRONT DOOR	7	GOOD CONDITION	0

INSPECTION CHECKPOINTS	SCORE(X/10)	REMARKS/COMMENTS	OPTIONAL SPEND EST. (RS)
RH FENDER	7	GOOD CONDITION	0
BODY RUST	6	NO RUST	0
ROOF (REGULAR)	7	GOOD CONDITION	0
PAINT CONDITION	7	GOOD	0
FOG LAMPS	0	N/A	0
