ECO INSPECTION CERTIFICATE

Order ID : 72055

121 Points Vehicle Inspection Certificate

Toyota Innova 2.5 V 7 STR, 2008

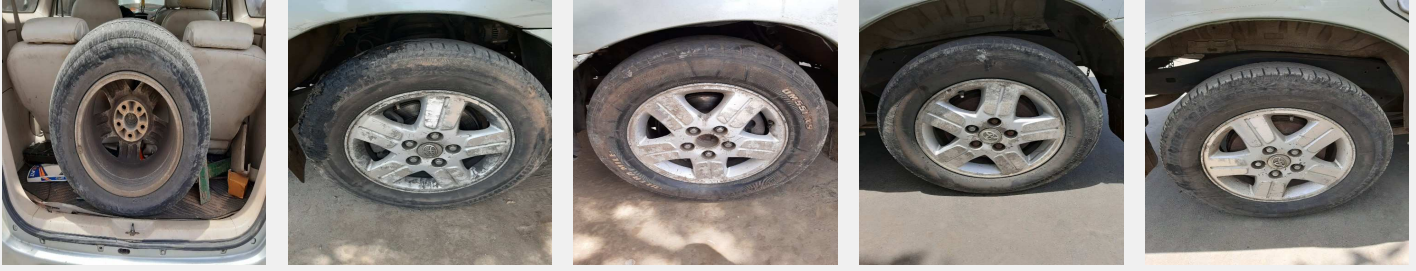
IMAGES

INSPECTION CHECKPOINTS	SCORE(X/10)	REMARKS/COMMENTS	OPTIONAL SPEND EST. (RS)
SPARE TYRE (YES)	6	AVERAGE	0
WHEEL ASSEMBLY (ALLOY RIM)	6	AVERAGE	0
TYRES	5	NEED TO CHANGE ALL TYRE	12000

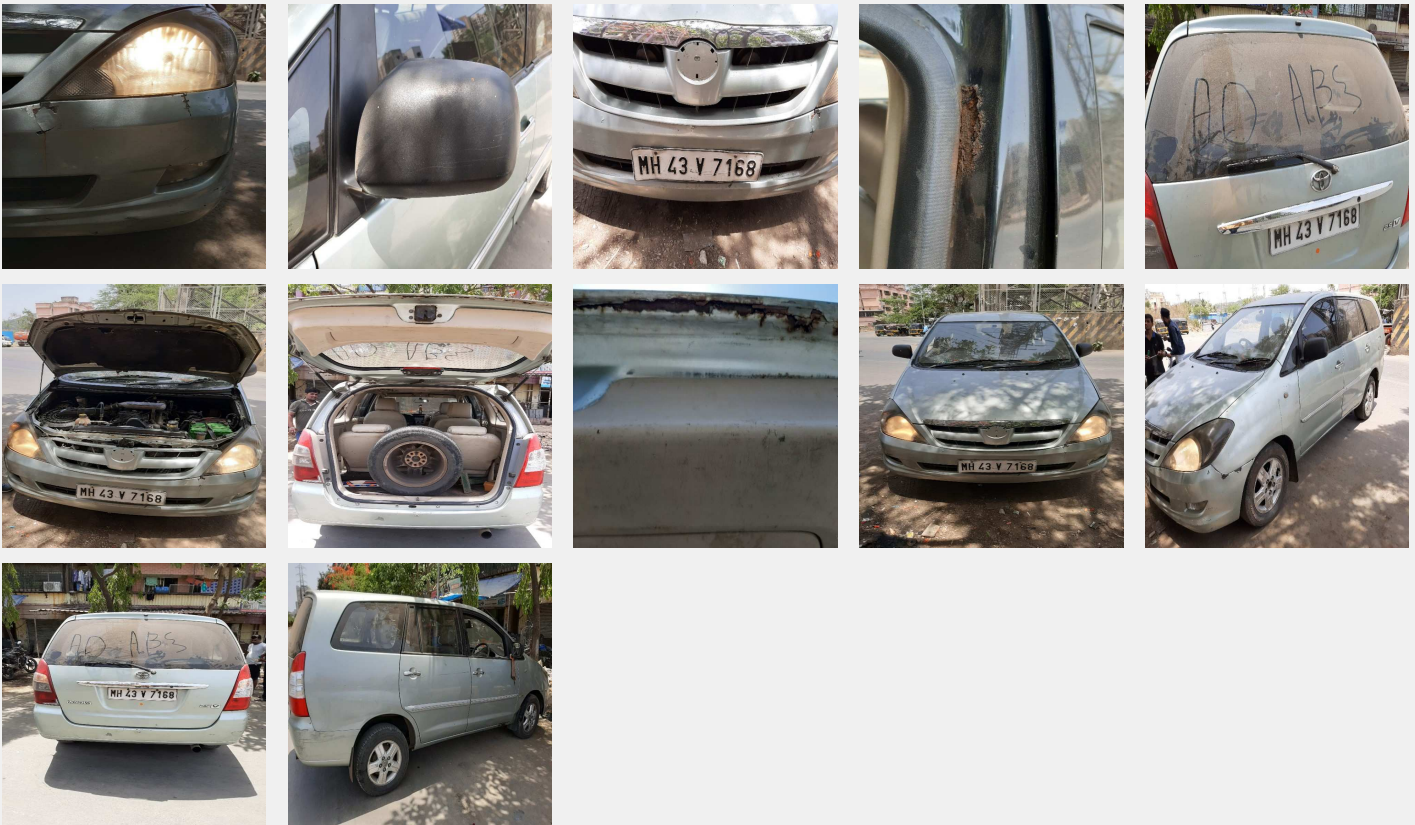
IMAGES

INSPECTION CHECKPOINTS	SCORE(X/10)	REMARKS/COMMENTS	OPTIONAL SPEND EST. (RS)
RH REAR DOOR	5	NEED TO REPAINT	1500
RH FRONT DOOR	4	NEED TO REPAINT & REPAIR	2500
RH FENDER	5	DENTING PAINTING WORK	2000
BODY RUST	5	MANY BODY RUSH	0
ROOF (REGULAR)	5	DENT ON IT	2000

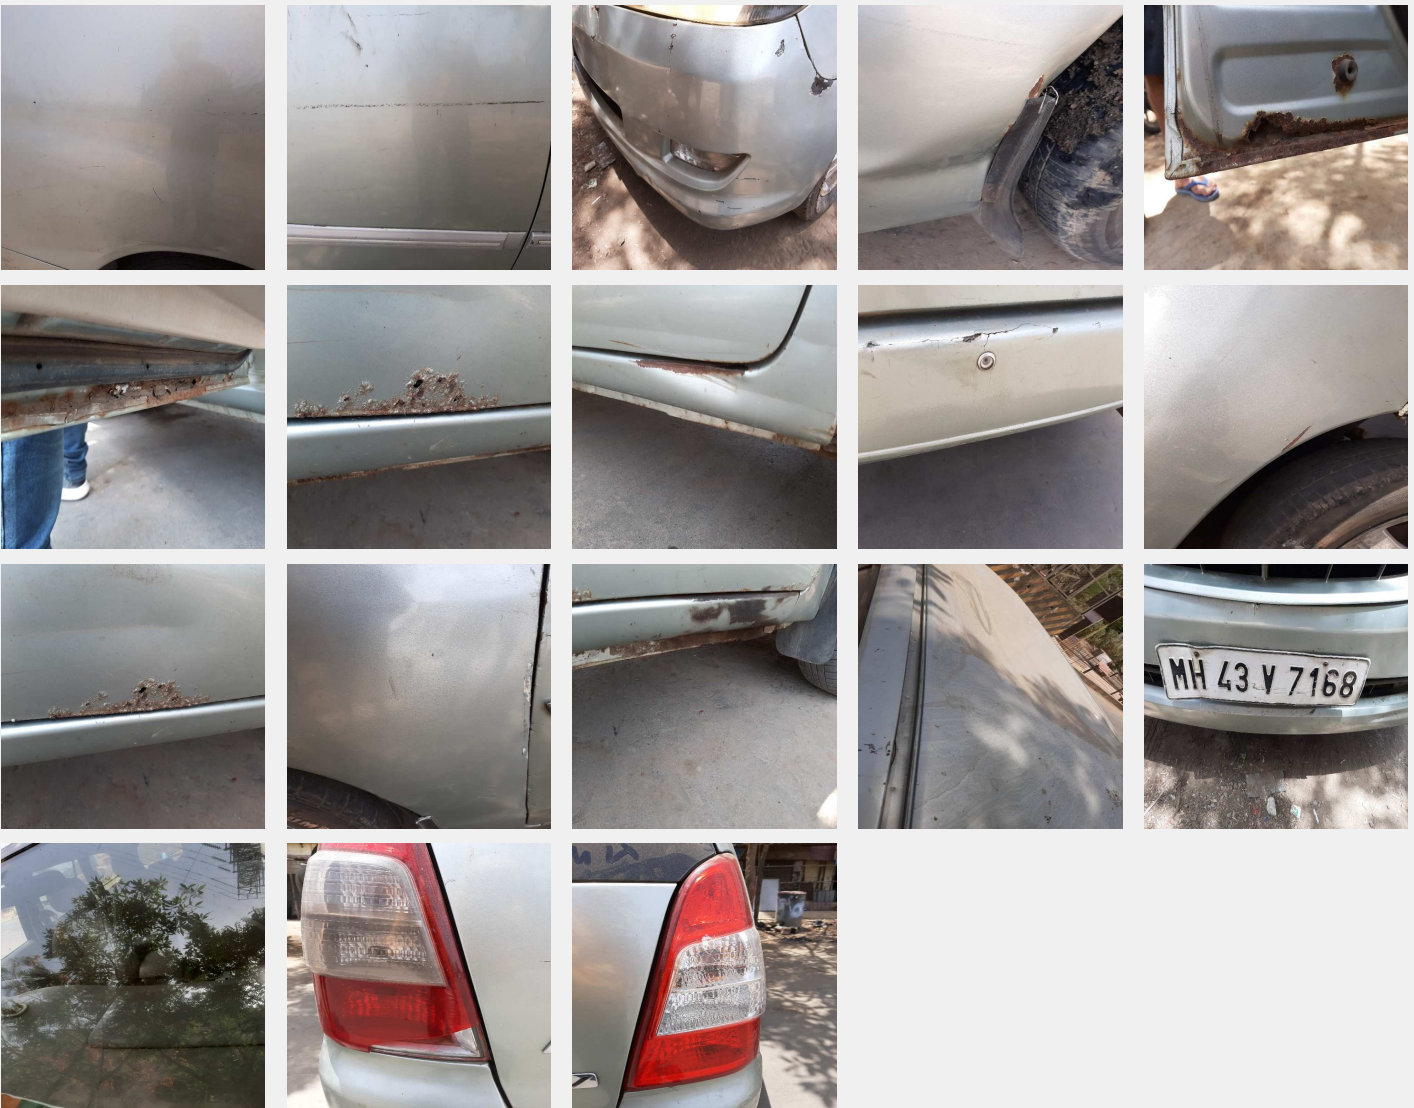
NEED ATTENTION

not good car whole body is damage need to change all 4 tyre
