# ECO INSPECTION CERTIFICATE

121 Points Vehicle Inspection Certificate

## Skoda Fabia CLASSIC 1.2 TDI, 2011

MAKE	SKODA	ENGINE NUMBER	CFW070735
MODEL	FABIA	REGISTRATION NO.	GJ01KJ6888
MFG. DATE	01/2011	VIN/CHASSIS NUMBER	TMBFKM5J8AG01839
TRIM	CLASSIC 1.2 TDI	ODOMETER READING	100412
COLOR	C WHITE	INSURANCE EXPIRY	2019-5-19
BODY TYPE	HATCHBACK	VEHICLE PASSING	PRIVATE
FUEL TYPE	PETROL	ENGINE SOUND LINK	<a href="#">LISTEN ENGINE SOUND</a>

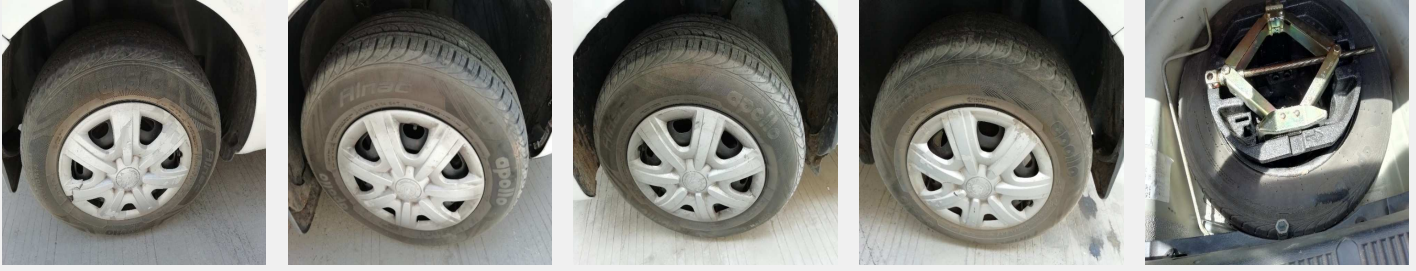
IMAGES

INSPECTION CHECKPOINTS	SCORE(X/10)	REMARKS/COMMENTS	OPTIONAL SPEND EST. (RS)
TYRES	6	NEUTRAL CONDITION	0
SPARE TYRE (YES)	6	NEUTRAL CONDITION	0
WHEEL ASSEMBLY (STEEL RIM)	8	GOOD CONDITION	0

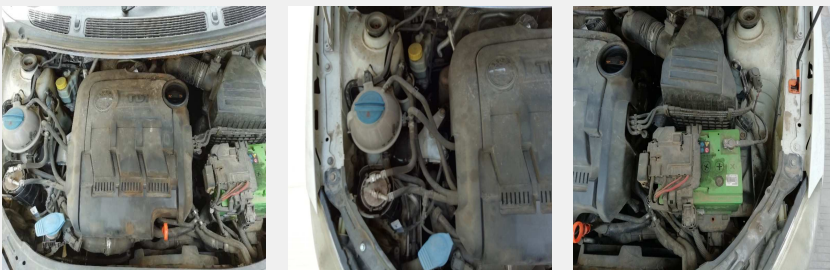
IMAGES

INSPECTION CHECKPOINTS	SCORE(X/10)	REMARKS/COMMENTS	OPTIONAL SPEND EST. (RS)
LH APRON	7	GOOD CONDITION	0
RH APRON	7	GOOD CONDITION	0
RADIATOR	7	GOOD CONDITION	0
WIRING	7	GOOD CONDITION	0
BATTERY	7	GOOD CONDITION	0
BRAKE FLUID LEVEL	7	GOOD CONDITION	0
ENGINE OIL	7	GOOD CONDITION	0
COOLANT LEVEL	7	GOOD CONDITION	0
BRAKE & COOLANT HOSE PIPES	7	GOOD CONDITION	0
UNDERCARRIAGE	7	GOOD CONDITION	0
EXHAUST SYSTEM	7	GOOD CONDITION	0

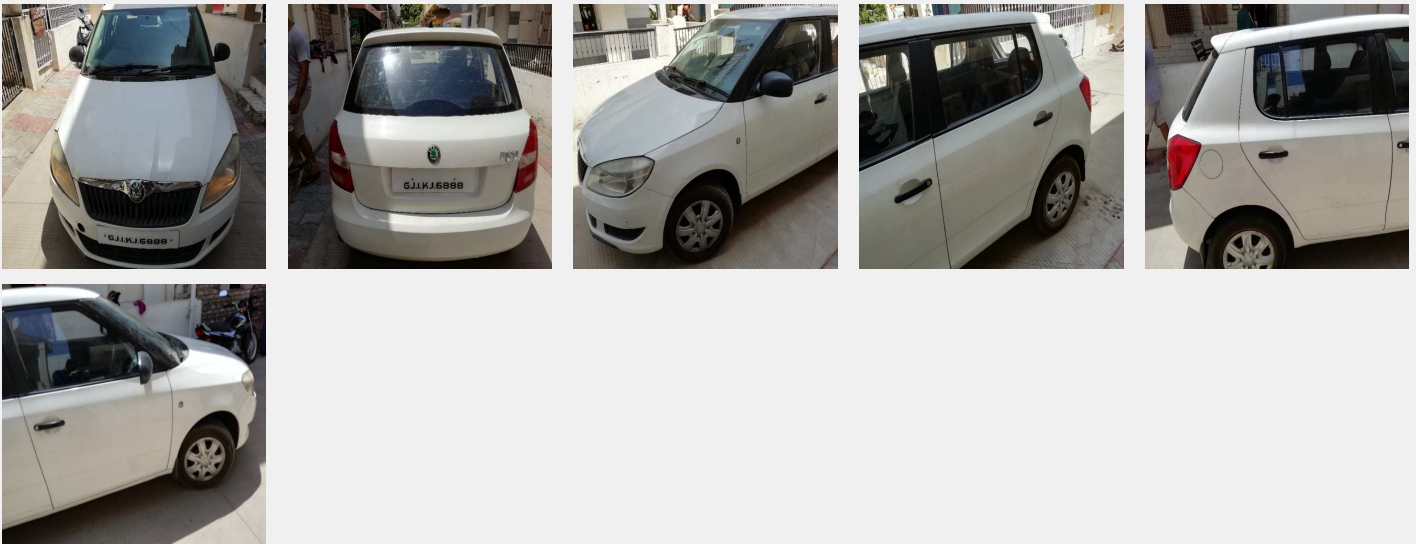
## IMAGES

INSPECTION CHECKPOINTS	SCORE(X/10)	REMARKS/COMMENTS	OPTIONAL SPEND EST. (RS)
RH FRONT DOOR	7	GOOD CONDITION	0
RH FENDER	7	GOOD CONDITION	0
BODY RUST	7	GOOD CONDITION	0
ROOF (REGULAR)	7	GOOD CONDITION	0
PAINT CONDITION	7	GOOD CONDITION	0
