# ECO INSPECTION CERTIFICATE

121 Points Vehicle Inspection Certificate

<b>Ordered By :</b> Deepak Rajpal	<b>Inspection Date :</b> 2019-05-19	<b>Location :</b> LUDHIANA	<b>Inspected By</b>   <b>Verified Technician</b> 321+ vehicle inspected 1+ years experience <b>Pawan Kumar Gupta</b>
--------------------------------------	--	-------------------------------	--

## Honda City 1.5 V At, 2010

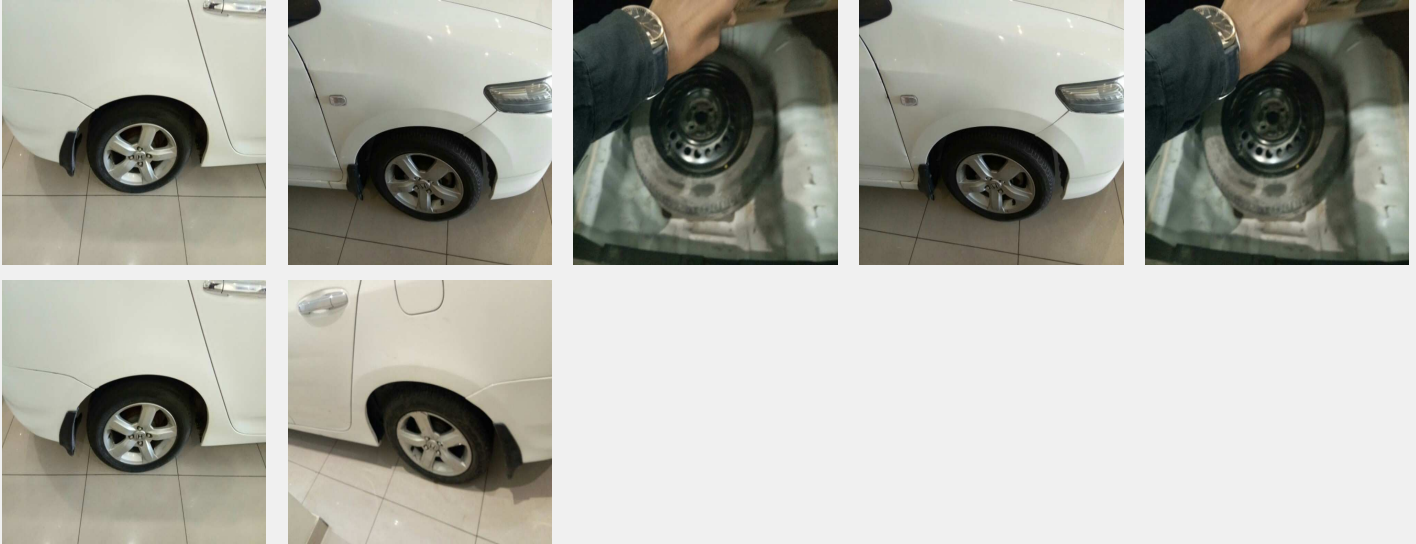
IMAGES

INSPECTION CHECKPOINTS	SCORE(X/10)	REMARKS/COMMENTS	OPTIONAL SPEND EST. (RS)
TYRES	7	OKK	0
SPARE TYRE (YES)	7	OKK	0
WHEEL ASSEMBLY (STEEL RIM)	8	GOOD	0

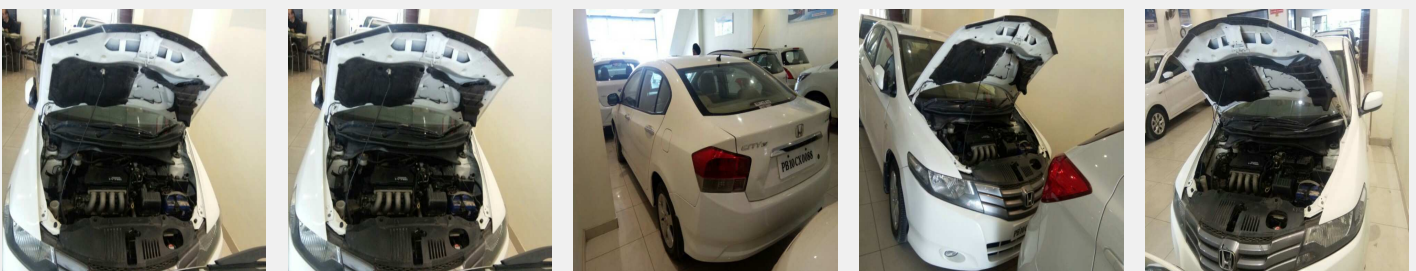
IMAGES

INSPECTION CHECKPOINTS	SCORE(X/10)	REMARKS/COMMENTS	OPTIONAL SPEND EST. (RS)
LH APRON	7	OKK	0
RH APRON	7	GOOD	0
RADIATOR	7	OKK	0
WIRING	7	WORKING	0
BATTERY	7	OKK	0
BRAKE FLUID LEVEL	7	ABOVE AVRAGE	0
ENGINE OIL	7	OKK	0
COOLANT LEVEL	7	OKK	0
BRAKE & COOLANT HOSE PIPES	7	GOOD	0
UNDERCARRIAGE	7	OKK	0
EXHAUST SYSTEM	7	GOOD	0

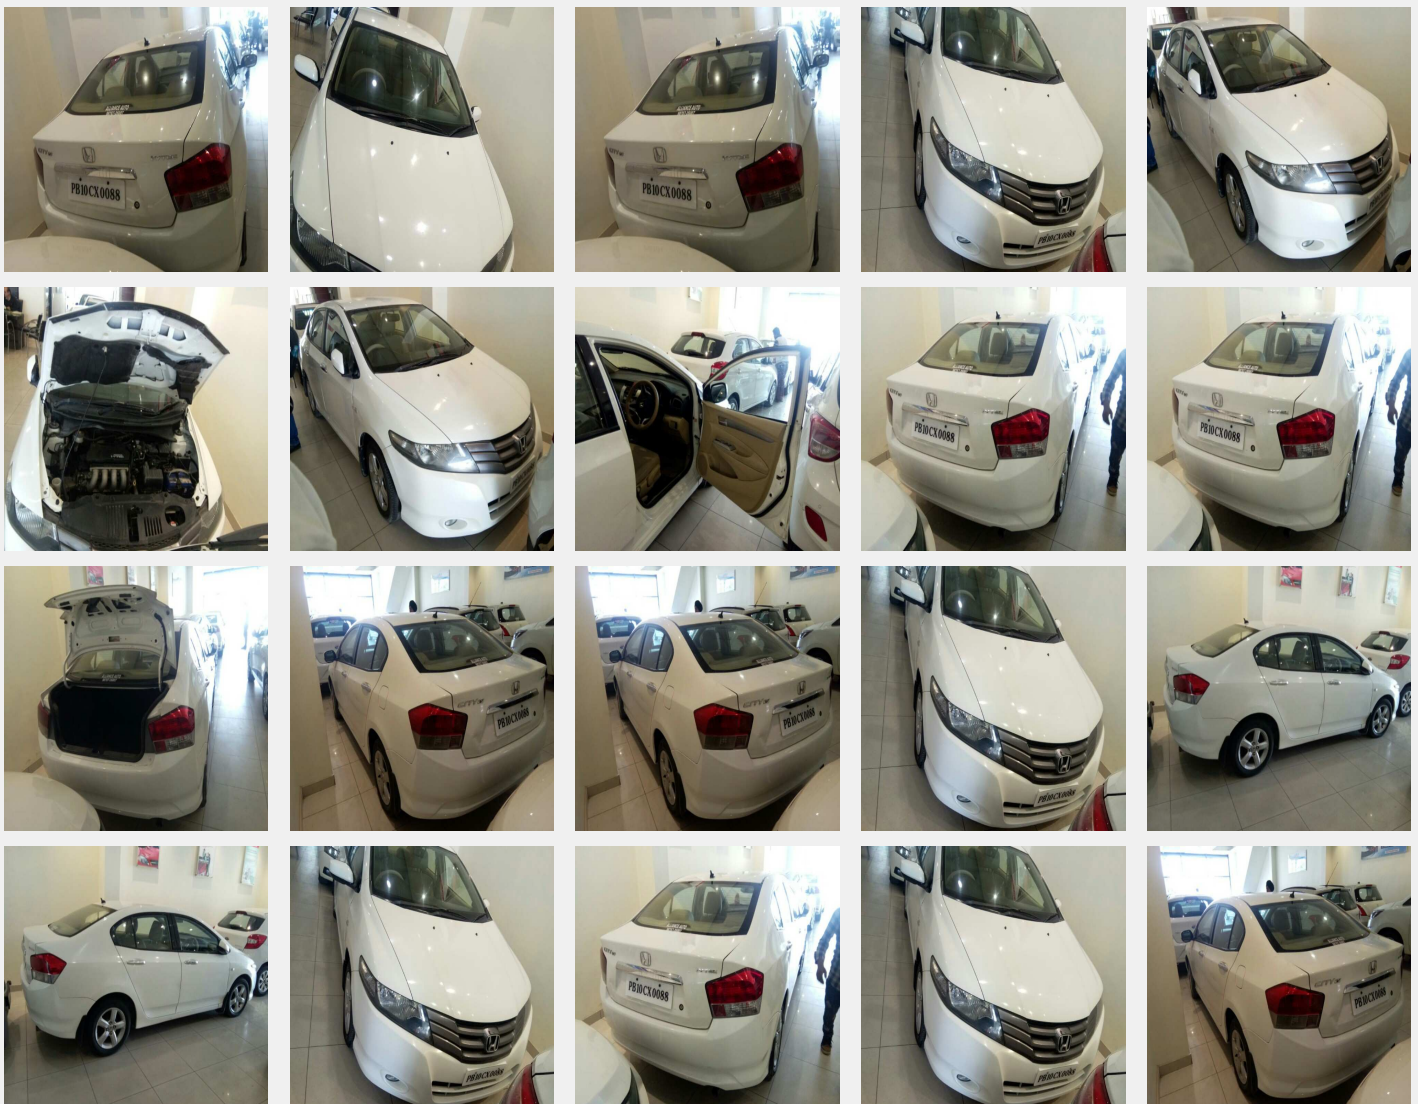
**IMAGES**

INSPECTION CHECKPOINTS	SCORE(X/10)	REMARKS/COMMENTS	OPTIONAL SPEND EST. (RS)
RH FRONT DOOR	8	SAFE	0
RH FENDER	7	GOOD	0
BODY RUST	7	NO RUST	0
ROOF (REGULAR)	7	OKK	0
PAINT CONDITION	8	GOOD	0
