ECO INSPECTION CERTIFICATE

121 Points Vehicle Inspection Certificate

Ordered By : Mohan Mr	Inspection Date : 2019-05-19	Location : HYDERABAD	Inspected By

Hyundai I20 SPORTZ 1.4 CRDI, 2011

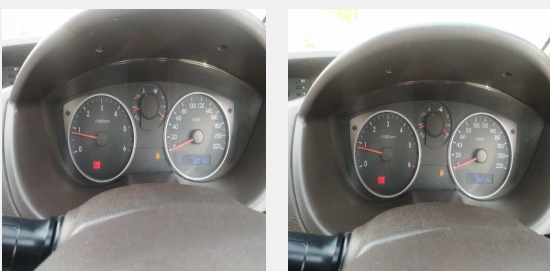
TEST DRIVE

INSPECTION CHECKPOINTS	SCORE(X/10)	REMARKS/COMMENTS	OPTIONAL SPEND EST. (RS)
STEERING PERFORMANCE	8		0
BRAKE PERFORMANCE	9		0
CLUTCH PERFORMANCE	8		0
ENGINE NOISE	8		0
IGNITION SYSTEM	7		0
SUSPENSION PERFORMANCE	8		0
SUSPENSION FRONT SHOCKS	8		0
SUSPENSION REAR SHOCKS	8		0
TRANSMISSION ENGAGE	7		0
CRUISE CONTROL (YES)	8		0
REAR PARKING SENSORS (YES)	8		0
REAR VIEW CAMERA (NO)	10		0

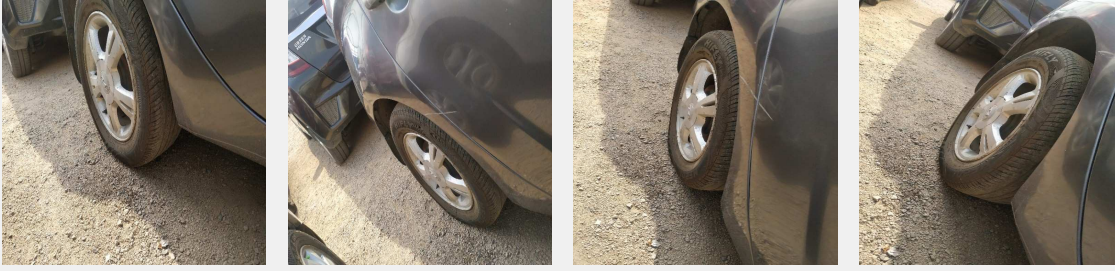
INSPECTION CHECKPOINTS	SCORE(X/10)	REMARKS/COMMENTS	OPTIONAL SPEND EST. (RS)
TYRES	9		0
SPARE TYRE (YES)	8		0
WHEEL ASSEMBLY (STEEL RIM)	8		0

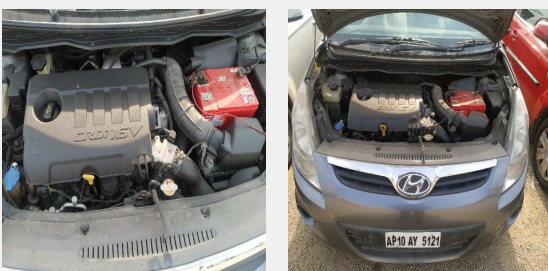
HOOD

INSPECTION CHECKPOINTS	SCORE(X/10)	REMARKS/COMMENTS	OPTIONAL SPEND EST. (RS)
LH APRON	8		0
RH APRON	8		0
RADIATOR	9		0
WIRING	8		0
BATTERY	8		0
BRAKE FLUID LEVEL	9		0
ENGINE OIL	8		0
COOLANT LEVEL	9		0
BRAKE & COOLANT HOSE PIPES	9		0
UNDERCARRIAGE	9		0
EXHAUST SYSTEM	9		0
