ECO INSPECTION CERTIFICATE

121 Points Vehicle Inspection Certificate

Ordered By : Tarun	Inspection Date : 2019-05-18	Location : PHASE 3
-----------------------	---------------------------------	-----------------------

Maruti Suzuki Swift Dzire VDI, 2011

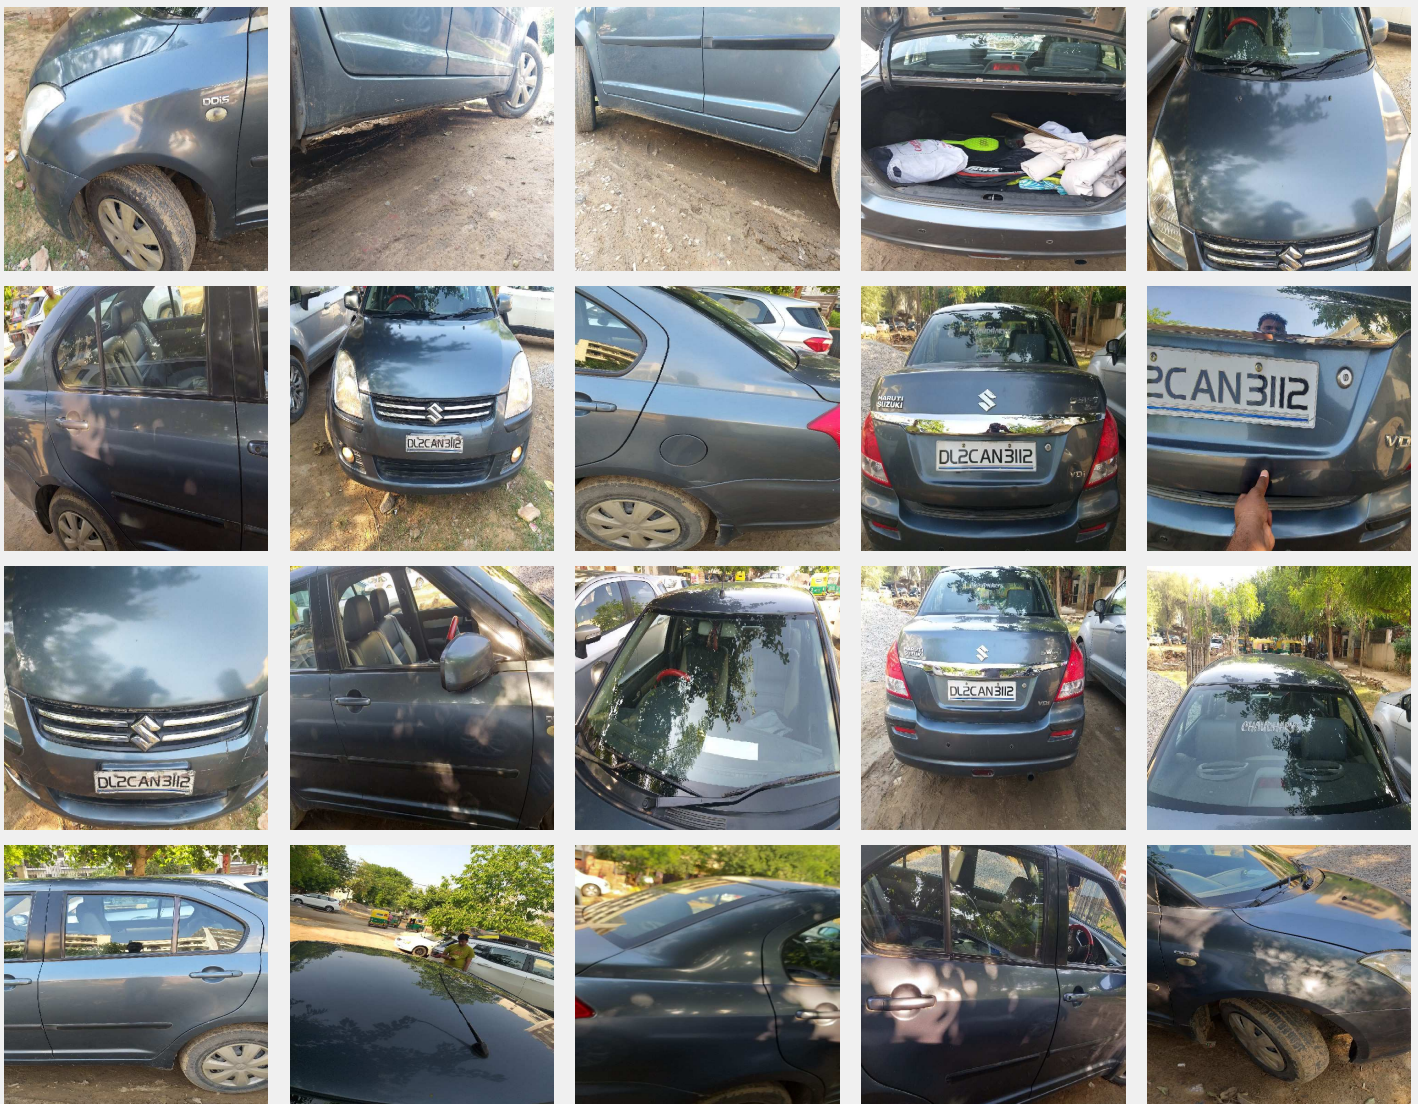
INSPECTION CHECKPOINTS	SCORE(X/10)	REMARKS/COMMENTS	OPTIONAL SPEND EST. (RS)
ROOF (REGULAR)	7	GOOD	0
PAINT CONDITION	7	GOOD	0
FRONT BUMPER	4	NEED TO BE CHANG	5000
LH FRONT DOOR	5	MINOR DENT NEED TO BE REAPING	500
REAR BUMPER	5	NEED TO BE REAPING	2000

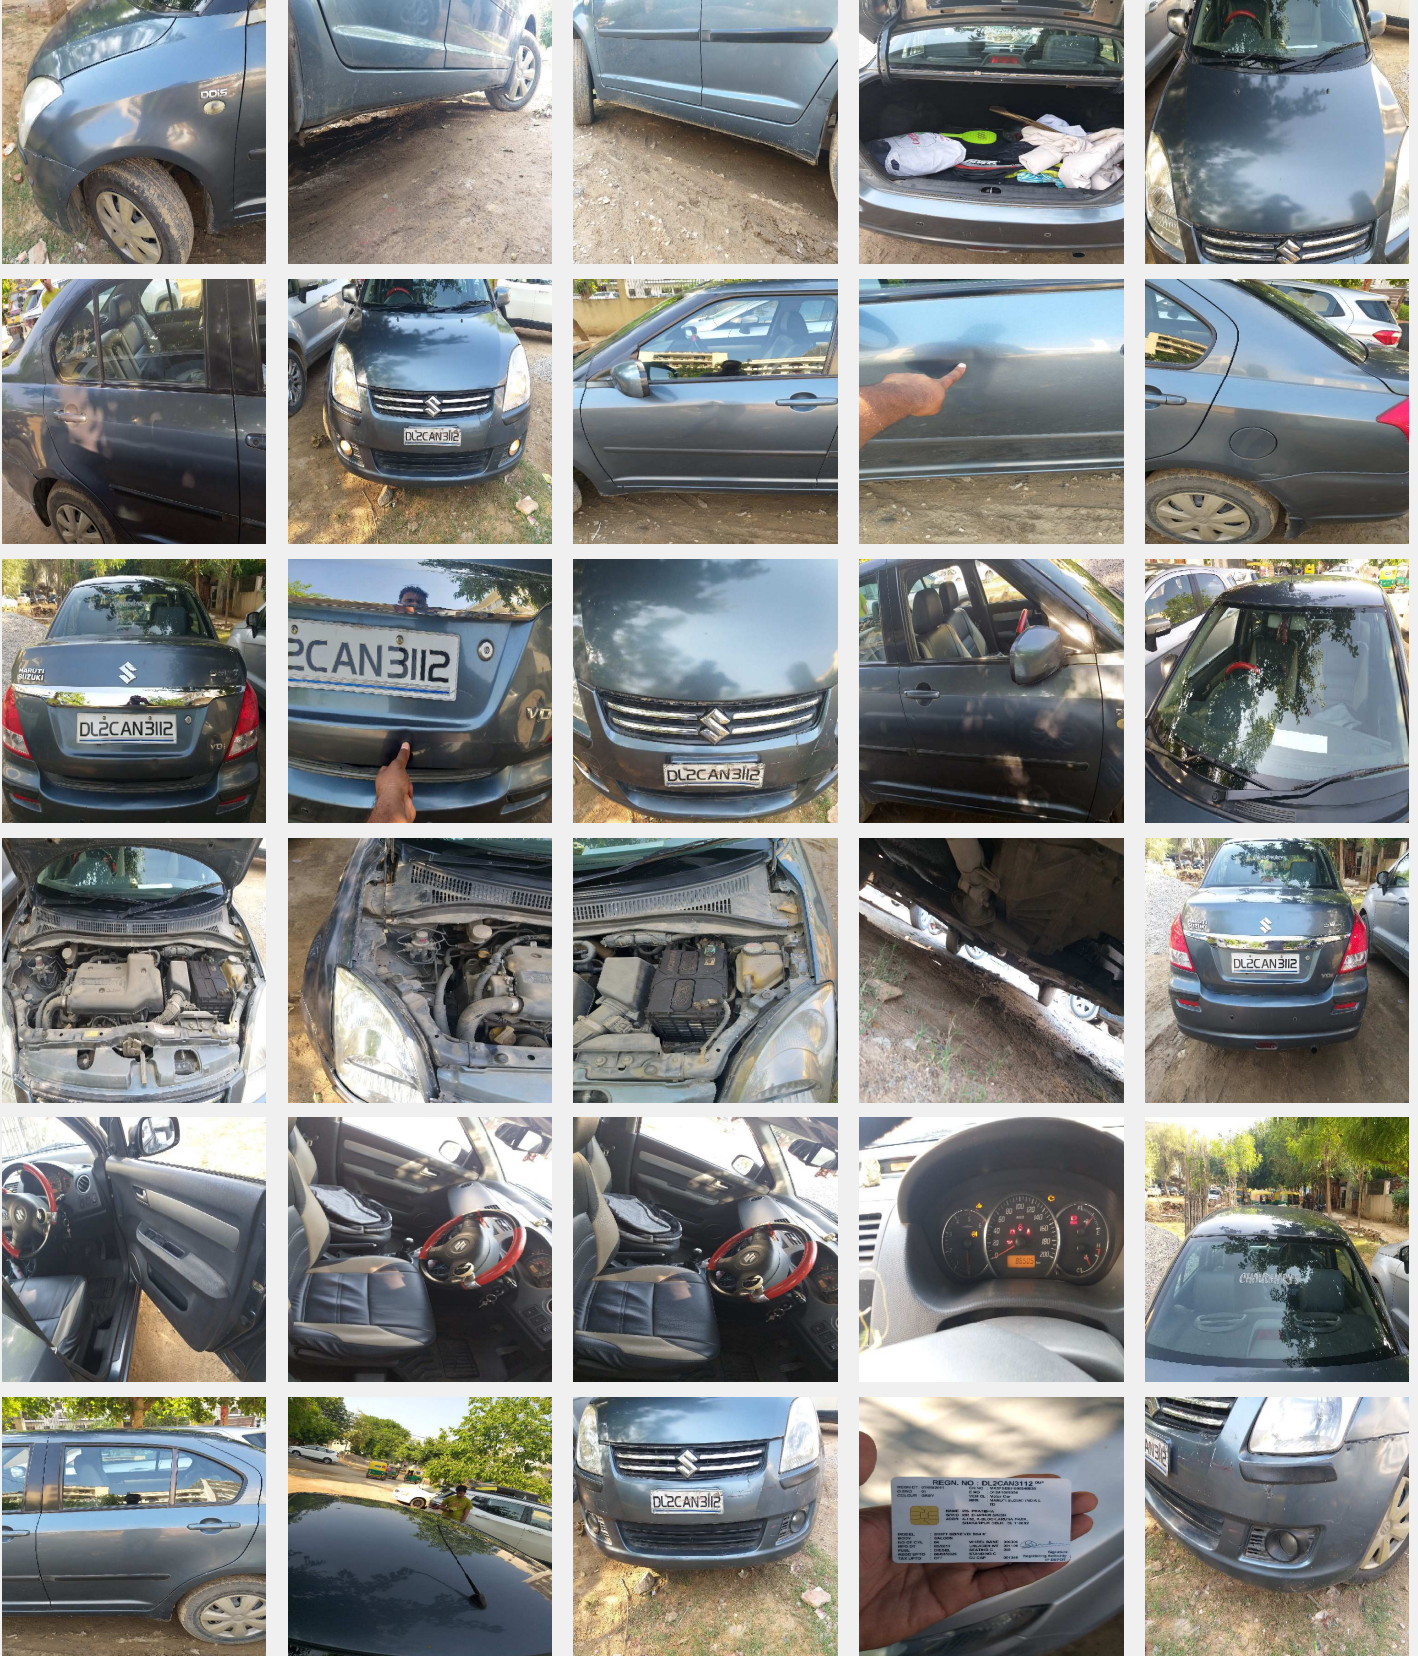
minor scratches and dent front bumper need to be chang
