ECO INSPECTION CERTIFICATE

121 Points Vehicle Inspection Certificate

| Ordered By : Aman Gajwani | Inspection Date : 2019-05-22 | Location : GHAZIABAD | Inspected By Kishan Kumar |

Maruti Suzuki Alto 800 Lxi, 2016

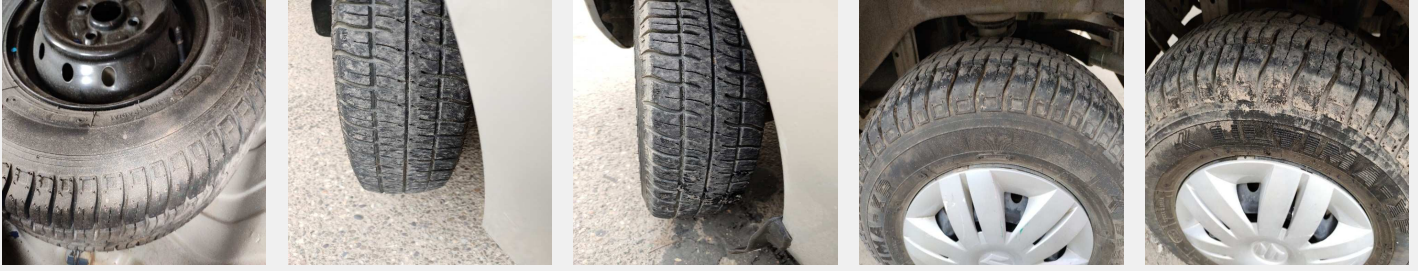
IMAGES

| INSPECTION CHECKPOINTS | SCORE(X/10) | REMARKS/COMMENTS | OPTIONAL SPEND EST. (RS) |
|---|---|---|---|
| SPARE TYRE (YES) | 9 | BRAND NEW | 0 |

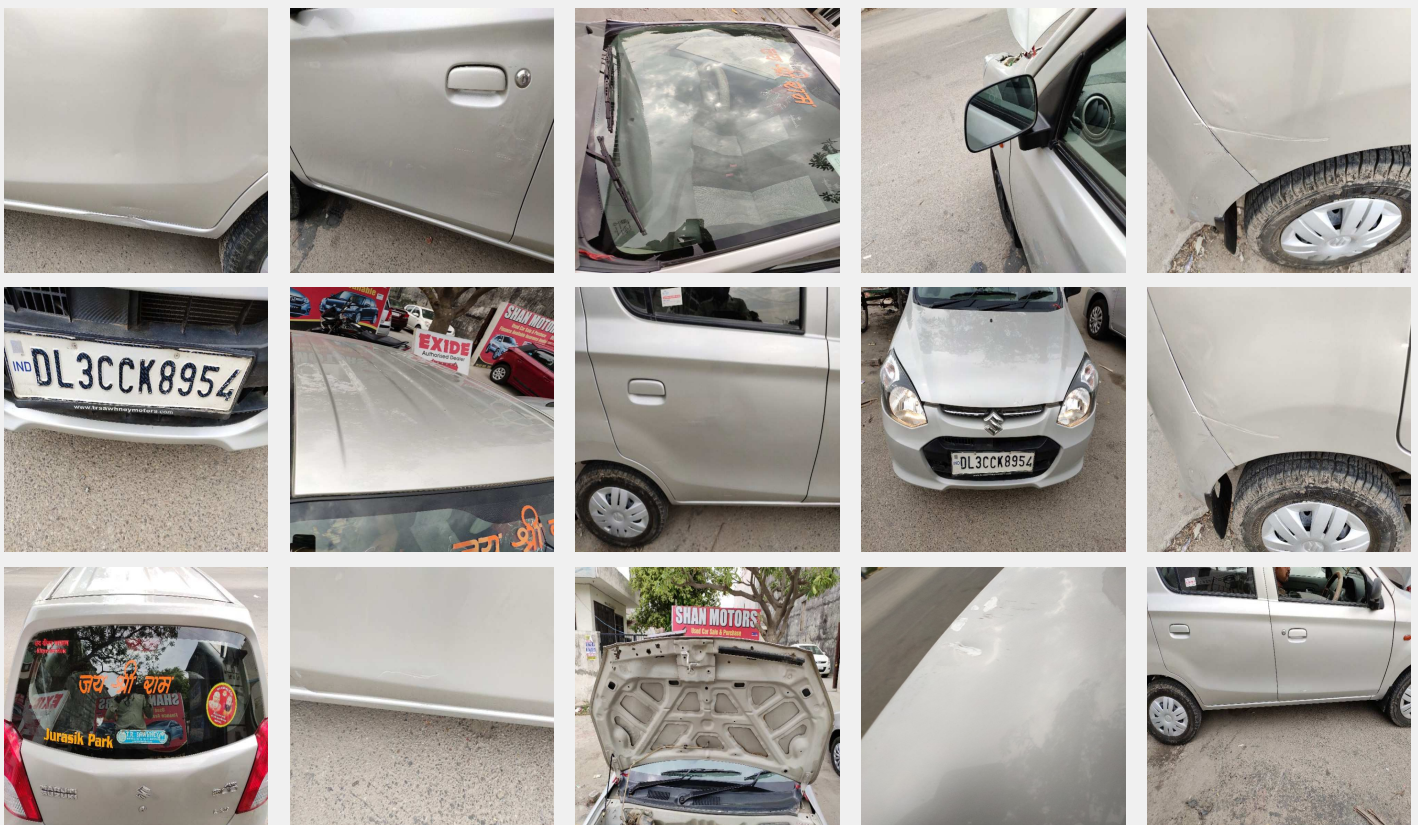
IMAGES

| INSPECTION CHECKPOINTS | SCORE(X/10) | REMARKS/COMMENTS | OPTIONAL SPEND EST. (RS) |
|---|---|--|---|
| LH RUNNING BOARD | 5 | DENT AND SCRATCHES NEED TO BE REPAIR | 600 |
| TAIL LIGHT | 5 | RIGHT TAIL LIGHT BROKEN NEED TO CHANGE | 1000 |

all body scratches and dent need to be repair and right side tail light broken need to change
