ECO INSPECTION CERTIFICATE

121 Points Vehicle Inspection Certificate

Ordered By : Nayeem .	Inspection Date : 2019-05-21	Location : HYDERABAD

Maruti Suzuki Alto K10 LXI, 2010

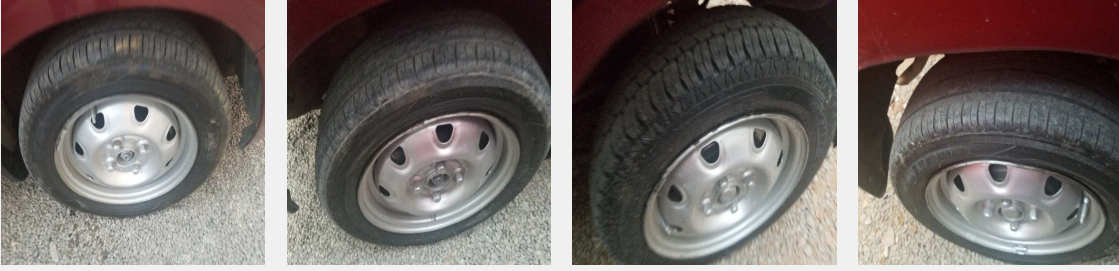
IMAGES

INSPECTION CHECKPOINTS	SCORE(X/10)	REMARKS/COMMENTS	OPTIONAL SPEND EST. (RS)
TYRES	9		0
SPARE TYRE (YES)	9		0
WHEEL ASSEMBLY (STEEL RIM)	9		0

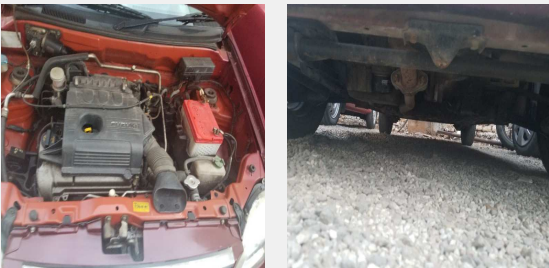
IMAGES

INSPECTION CHECKPOINTS	SCORE(X/10)	REMARKS/COMMENTS	OPTIONAL SPEND EST. (RS)
LH APRON	10		0
RH APRON	10		0
RADIATOR	10		0
WIRING	10		0
BATTERY	9		0
BRAKE FLUID LEVEL	10		0
ENGINE OIL	10		0
COOLANT LEVEL	10		0
BRAKE & COOLANT HOSE PIPES	10		0
UNDERCARRIAGE	10		0
EXHAUST SYSTEM	10		0
