# ECO INSPECTION CERTIFICATE

121 Points Vehicle Inspection Certificate

Ordered By : Jitesh Prajapati	Inspection Date : 2019-05-15	Location : MALAD W	Inspected By Sameer Harmale Verified Technician 1+ vehicle inspected 1+ years experience
----------------------------------	---------------------------------	-----------------------	--

## UM Renegade Commando 280cc, 2018

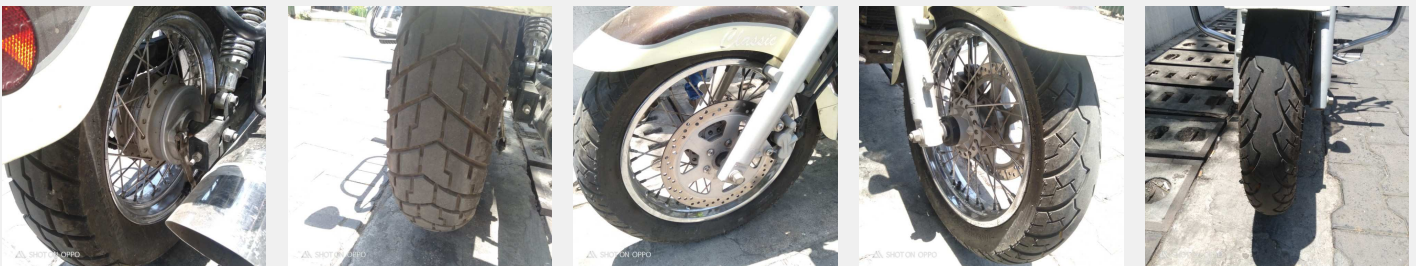
## TYRE

INSPECTION CHECKPOINTS	SCORE(X/10)	REMARKS/COMMENTS	OPTIONAL SPEND EST. (RS)
FRONT TYRE CONDITION & AIR PRESSURE	7		0
REAR TYRE CONDITION & AIR PRESSURE	7		0
WHEEL SPOKES FRONT	7		0
WHEEL SPOKES REAR	7		0
WHEEL RIM FRONT	7		0
WHEEL RIM REAR	7		0
WHEEL BEARINGS FRONT	7		0
WHEEL BEARINGS REAR	7		0
WHEEL SEALS FRONT	7		0
WHEEL SEALS REAR	7		0
BRAKE FUNCTION FRONT	7		0
BRAKE FUNCTION REAR	7		0
BRAKES CONDITION FRONT	6		0
BRAKES CONDITION REAR	7		0

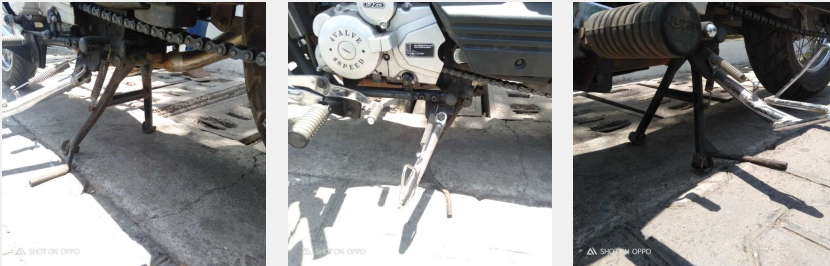
## STAND

INSPECTION CHECKPOINTS	SCORE(X/10)	REMARKS/COMMENTS	OPTIONAL SPEND EST. (RS)
CENTRE STAND CONDITION	7		0
CENTRE STAND RETENTION	7		0
SIDE STAND CONDITION	7		0
SIDE STAND RETENTION	6		0

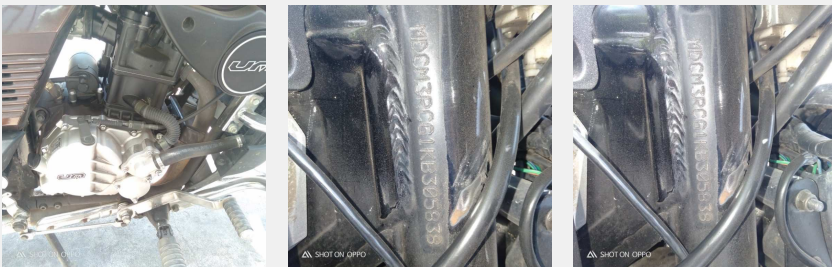
## CHASSIS

INSPECTION CHECKPOINTS	SCORE(X/10)	REMARKS/COMMENTS	OPTIONAL SPEND EST. (RS)
FRAME CONDITION	10	6	0
FRAME STEERING-HEAD BEARINGS	7		0
FRAME SWINGARM BUSHINGS	7		0
SUSPENSION FRONT FORKS LEFT	7		0
SUSPENSION FRONT FORKS RIGHT	7		0
SUSPENSION REAR SHOCKS LEFT	7		0
SUSPENSION REAR SHOCKS RIGHT	7		0
CHAIN/BELT TENSION	7		0
CHAIN/BELT LUBRICATION	7		0
CHAIN/BELT SPROCKETS	7		0
FASTENERS THREADED	7		0
FASTENERS CLIPS & COTTER PINS	7		0
ENGINE	7		0
TRANSMISSION	7		0
