ECO INSPECTION CERTIFICATE

121 Points Vehicle Inspection Certificate

Ordered By : Mahesh Choudshetty	Inspection Date : 2019-05-20	Location : BANGALORE	Inspected By

Tvs Wego 110CC, 2010

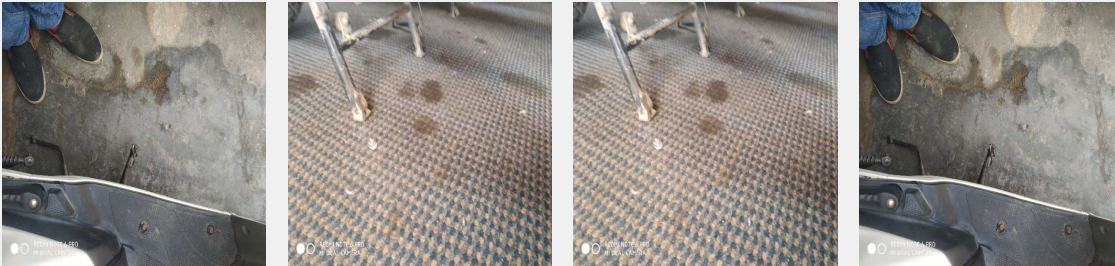
INSPECTION CHECKPOINTS	SCORE(X/10)	REMARKS/COMMENTS	OPTIONAL SPEND EST. (RS)
CENTRE STAND CONDITION	6		0
CENTRE STAND RETENTION	6		0
SIDE STAND CONDITION	6		0
SIDE STAND RETENTION	6		0
