ECO INSPECTION CERTIFICATE

Order ID : 75316

121 Points Vehicle Inspection Certificate

Bajaj Platina ALLOY ES-100CC, 2017

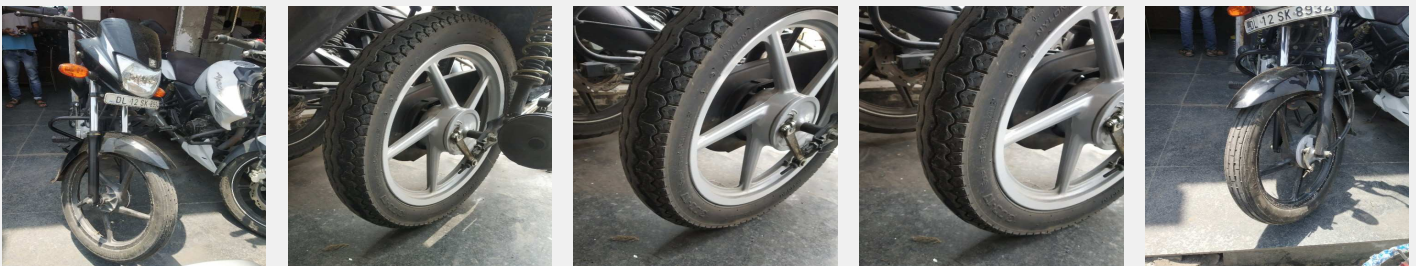
IMAGES

TYRE

INSPECTION CHECKPOINTS	SCORE(X/10)	REMARKS/COMMENTS	OPTIONAL SPEND EST. (RS)
FRONT TYRE CONDITION & AIR PRESSURE	7		0
REAR TYRE CONDITION & AIR PRESSURE	7		0
WHEEL SPOKES FRONT	7		0
WHEEL SPOKES REAR	7		0
WHEEL RIM FRONT	7		0
WHEEL RIM REAR	7		0
WHEEL BEARINGS FRONT	7		0
WHEEL BEARINGS REAR	7		0
WHEEL SEALS FRONT	7		0
WHEEL SEALS REAR	7		0
BRAKE FUNCTION FRONT	7		0
BRAKE FUNCTION REAR	7		0
BRAKES CONDITION FRONT	7		0
BRAKES CONDITION REAR	7		0

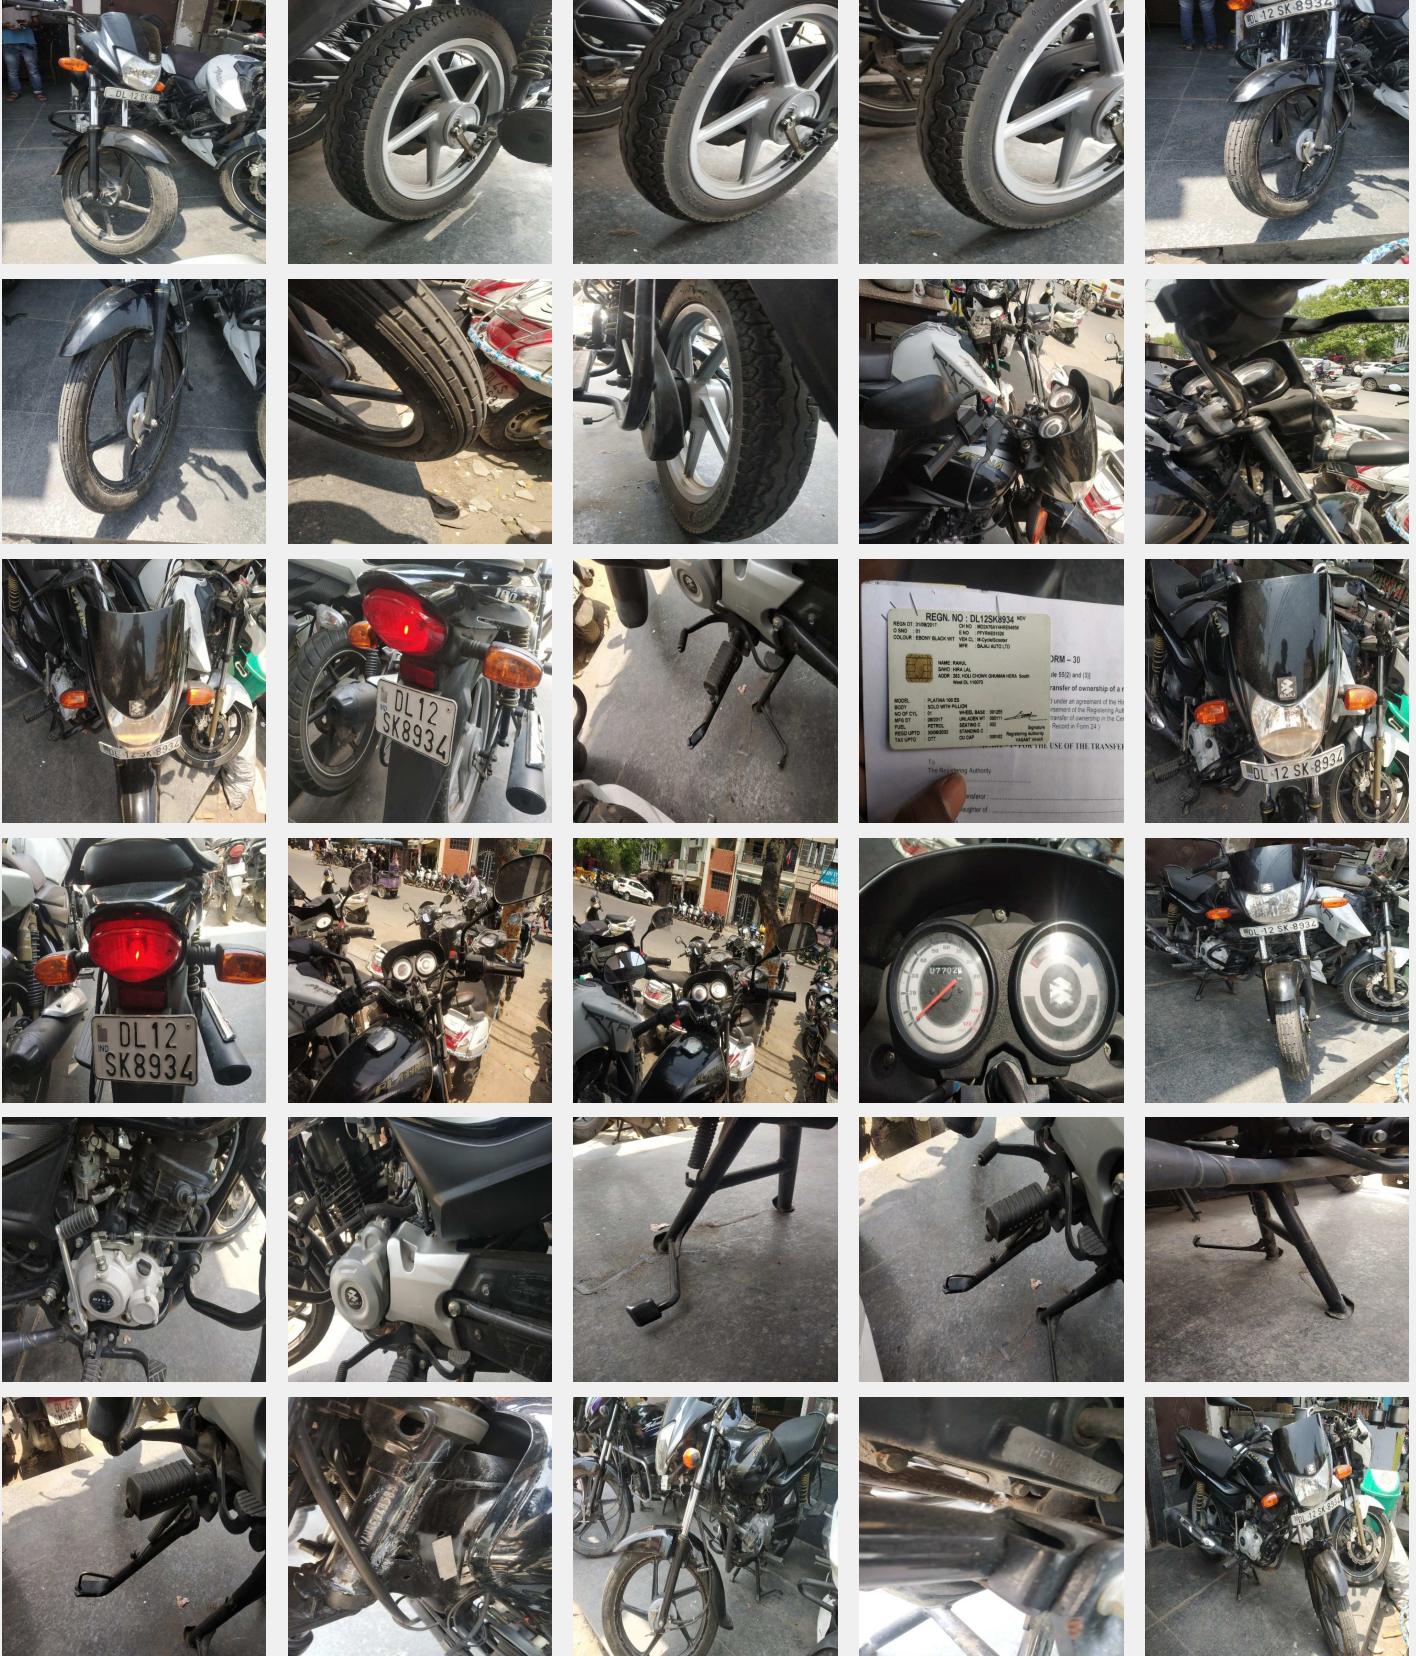
IMAGES

service due and insurance not available
