ECO INSPECTION CERTIFICATE

Order ID : 71594

121 Points Vehicle Inspection Certificate

Maruti Suzuki Alto LXI, 2009

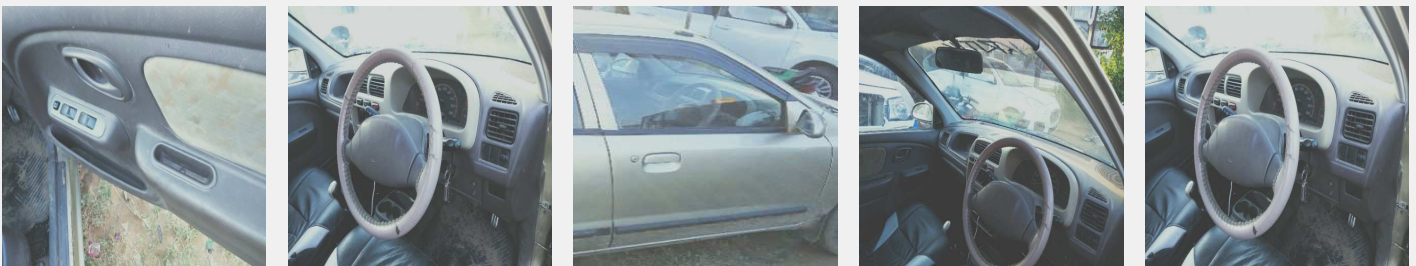
IMAGES

| INSPECTION CHECKPOINTS | SCORE(X/10) | REMARKS/COMMENTS | OPTIONAL SPEND EST. (RS) |
|---|---|---|---|
| CENTRAL LOCK | 0 | NOT FITTING | 0 |

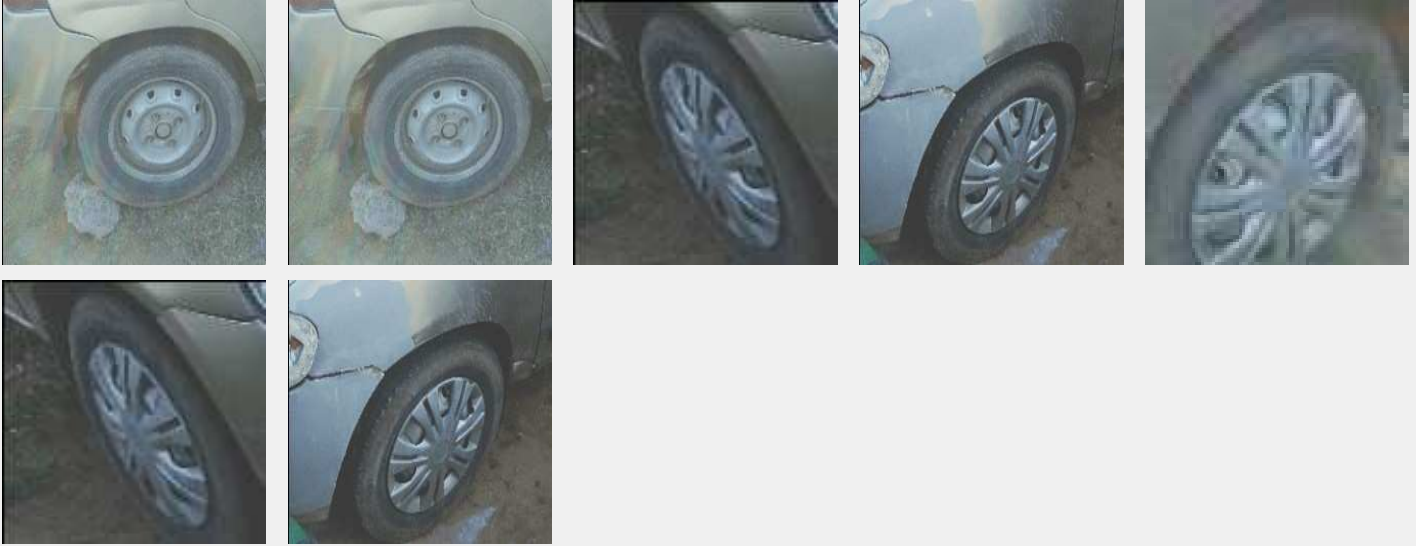
IMAGES

| INSPECTION CHECKPOINTS | SCORE(X/10) | REMARKS/COMMENTS | OPTIONAL SPEND EST. (RS) |
|---|---|---|---|
| TYRES | 7 | | 0 |

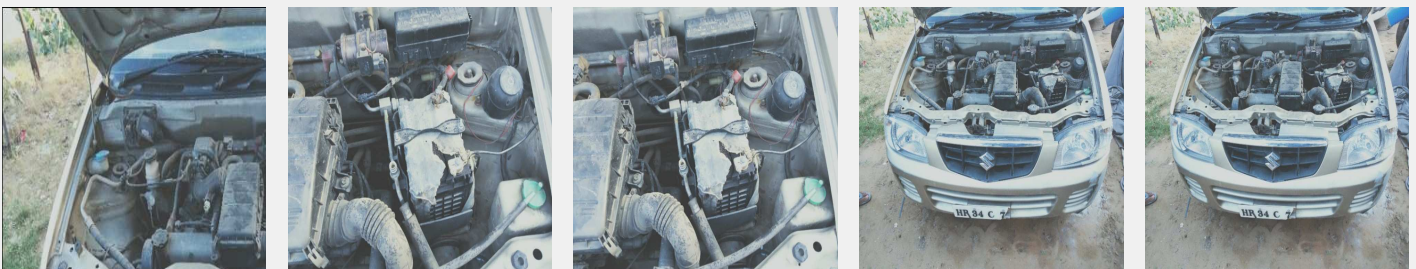
IMAGES

| INSPECTION CHECKPOINTS | SCORE(X/10) | REMARKS/COMMENTS | OPTIONAL SPEND EST. (RS) |
|---|---|---|---|
| LH APRON | 7 | | 0 |
| WIRING | 7 | | 0 |
| BATTERY | 7 | | 0 |
| ENGINE OIL | 7 | | 0 |

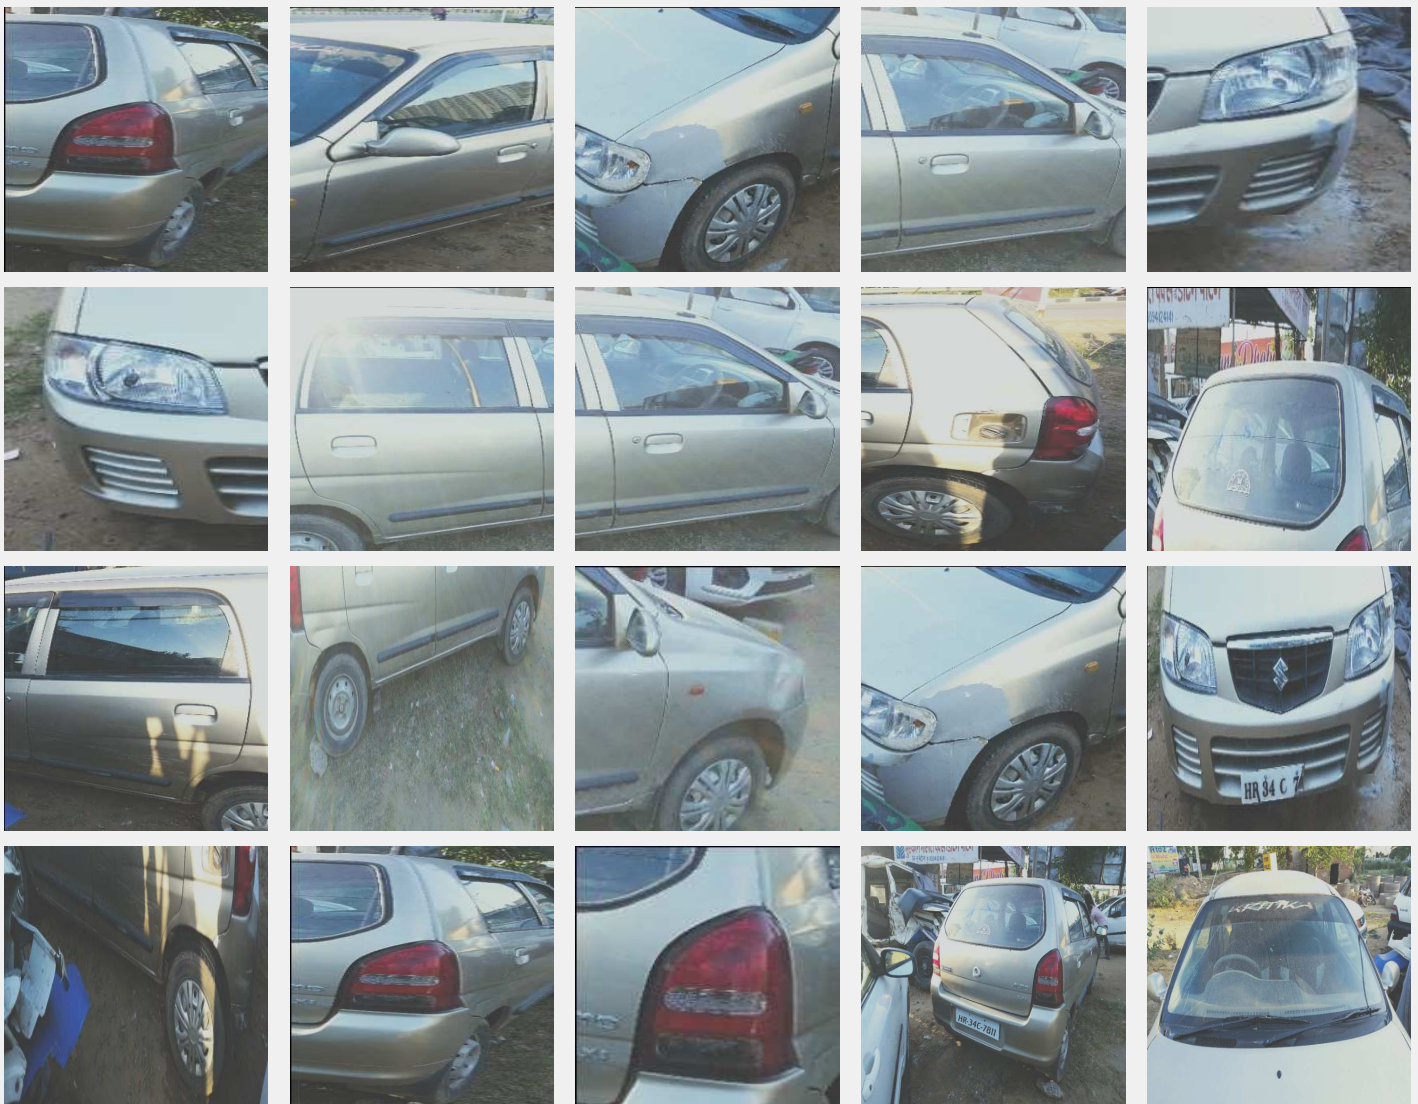
IMAGES

| INSPECTION CHECKPOINTS | SCORE(X/10) | REMARKS/COMMENTS | OPTIONAL SPEND EST. (RS) |
|---|---|---|---|
| LICENSE PLATE | 1 | BROKEN | 1000 |
| FUEL LID | 2 | DOOR MISSING | 4000 |
| RH FENDER | 4 | DENT | 6000 |
| PAINT CONDITION | 4 | FAIR | 10000 |
