ECO INSPECTION CERTIFICATE

121 Points Vehicle Inspection Certificate

Ordered By : SAIREDDY NARESH	Inspection Date : 2019-05-23	Location : HYDERABAD	Inspected By

Maruti Suzuki Swift Dzire VDI BS-IV, 2013

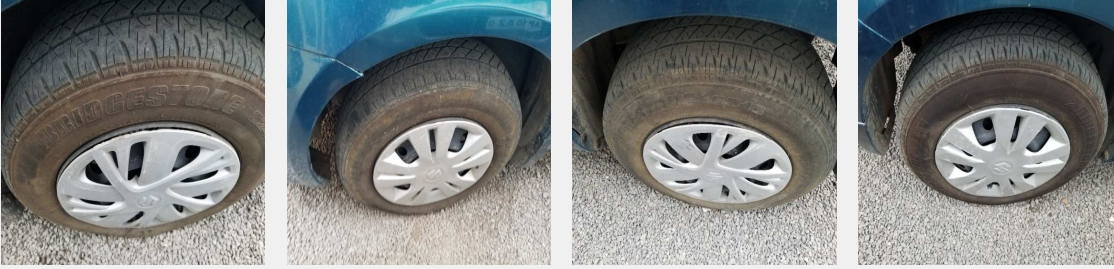
IMAGES

INSPECTION CHECKPOINTS	SCORE(X/10)	REMARKS/COMMENTS	OPTIONAL SPEND EST. (RS)
TYRES	9		0
SPARE TYRE (YES)	10		0
WHEEL ASSEMBLY (STEEL RIM)	9		0

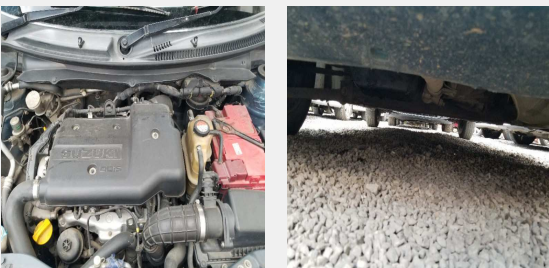
IMAGES

INSPECTION CHECKPOINTS	SCORE(X/10)	REMARKS/COMMENTS	OPTIONAL SPEND EST. (RS)
LH APRON	10		0
RH APRON	9		0
RADIATOR	10		0
WIRING	10		0
BATTERY	10		0
BRAKE FLUID LEVEL	10		0
ENGINE OIL	10		0
COOLANT LEVEL	10		0
BRAKE & COOLANT HOSE PIPES	10		0
UNDERCARRIAGE	10		0
EXHAUST SYSTEM	9		0
