# ECO INSPECTION CERTIFICATE

Order ID : 72618

121 Points Vehicle Inspection Certificate

## Maruti Suzuki Eeco 5 STR, 2013

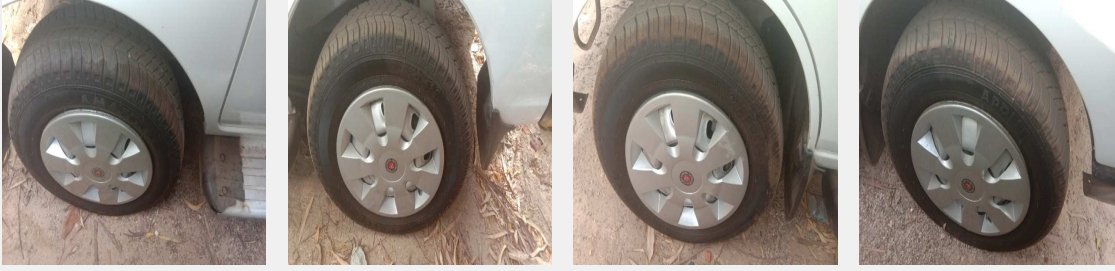
INSPECTION CHECKPOINTS	SCORE(X/10)	REMARKS/COMMENTS	OPTIONAL SPEND EST. (RS)
TYRES	6	AVERAGE	0
SPARE TYRE (YES)	7		0
WHEEL ASSEMBLY (STEEL RIM)	7		0

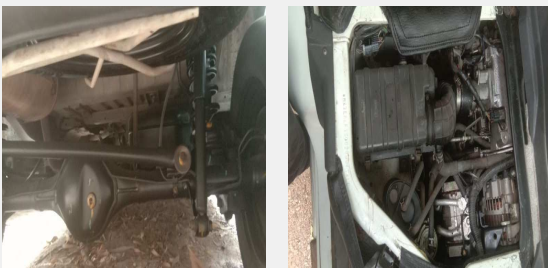
INSPECTION CHECKPOINTS	SCORE(X/10)	REMARKS/COMMENTS	OPTIONAL SPEND EST. (RS)
LH APRON	7		0
RH APRON	7		0
RADIATOR	7		0
WIRING	7		0
BATTERY	7		0
BRAKE FLUID LEVEL	7		0
ENGINE OIL	7		0
COOLANT LEVEL	7		0
BRAKE & COOLANT HOSE PIPES	7		0
UNDERCARRIAGE	7		0
EXHAUST SYSTEM	7		0

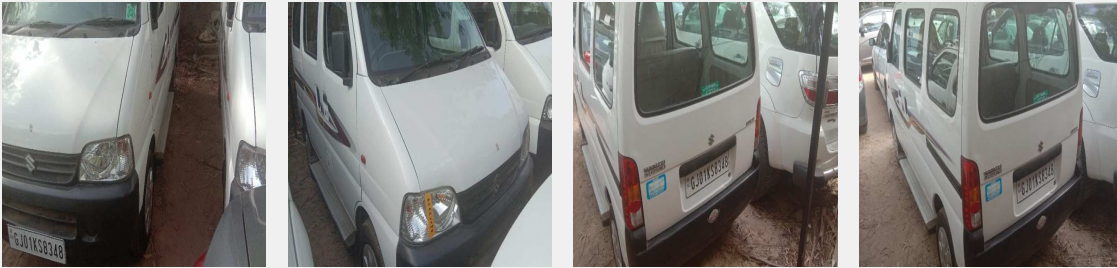
INSPECTION CHECKPOINTS	SCORE(X/10)	REMARKS/COMMENTS	OPTIONAL SPEND EST. (RS)
LICENSE PLATE	7		0
FRONT BUMPER	6	AVERAGE	0
HEAD LIGHTS	6	AVERAGE	0
GRILLE	6	AVERAGE	0
TURN SIGNAL	6	AVERAGE	0
FOG LAMPS	6	AVERAGE	0
HOOD	6	AVERAGE	0
PILLAR	6	AVERAGE	0
FRONT WINDSHIELD	7		0
SIDE VIEW MIRRORS	7		0
LH FENDER	7		0
LH FRONT DOOR	7		0
LH REAR DOOR	7		0
LH RUNNING BOARD	7		0
LH QUARTER PANEL	7		0
FUEL LID	7		0
REAR WINDSHIELD	7		0
REAR BUMPER	7		0
TAIL LIGHT	7		0
TRUNK LID/TAIL GATE	7		0
LUGGAGE COMPARTMENT LIGHT	7		0
RH QUARTER PANEL	7		0
RH RUNNING BOARD	7		0
RH REAR DOOR	7		0

INSPECTION CHECKPOINTS	SCORE(X/10)	REMARKS/COMMENTS	OPTIONAL SPEND EST. (RS)
RH FRONT DOOR	7		0
RH FENDER	7		0
BODY RUST	7		0
ROOF (REGULAR)	7		0
PAINT CONDITION	7		0

average condition
