# ECO INSPECTION CERTIFICATE

Order ID : 76302

121 Points Vehicle Inspection Certificate

## Honda Wr-V VX DIESEL, 2018

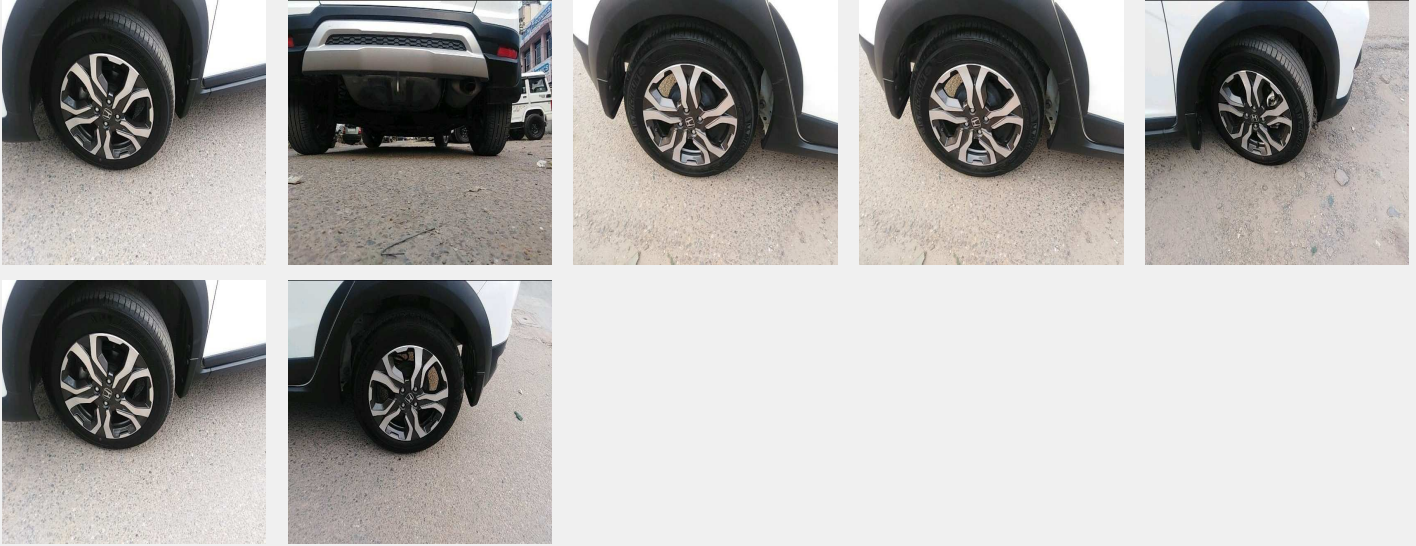
IMAGES

INSPECTION CHECKPOINTS	SCORE(X/10)	REMARKS/COMMENTS	OPTIONAL SPEND EST. (RS)
TYRES	8	EXCELENT GOOD	0
SPARE TYRE (YES)	7	GOOD	0
WHEEL ASSEMBLY (STEEL RIM)	8	EXCELENT GOOD	0

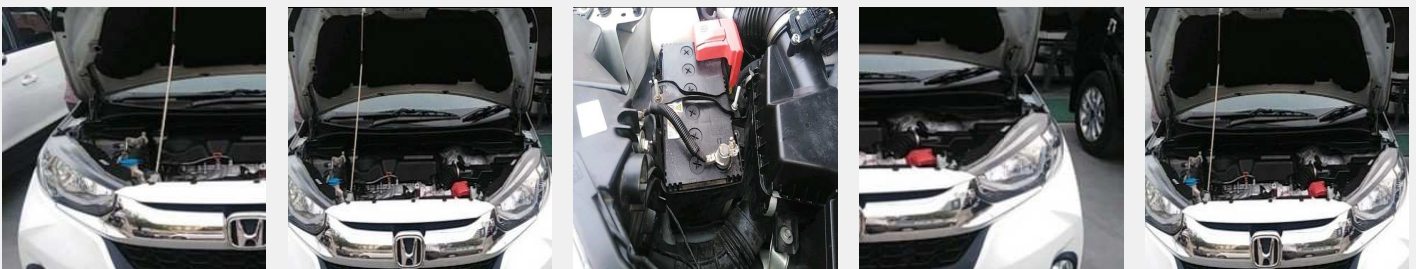
IMAGES

INSPECTION CHECKPOINTS	SCORE(X/10)	REMARKS/COMMENTS	OPTIONAL SPEND EST. (RS)
LH APRON	8	EXCELENT GOOD	0
RH APRON	7	GOOD	0
RADIATOR	8	EXCELENT GOOD	0
WIRING	7	GOOD	0
BATTERY	8	EXCELENT GOOD	0
BRAKE FLUID LEVEL	7	GOOD	0
ENGINE OIL	8	EXCELENT GOOD	0
COOLANT LEVEL	7	GOOD	0
BRAKE & COOLANT HOSE PIPES	8	EXCELENT GOOD	0
UNDERCARRIAGE	7	GOOD	0
EXHAUST SYSTEM	8	EXCELENT GOOD	0

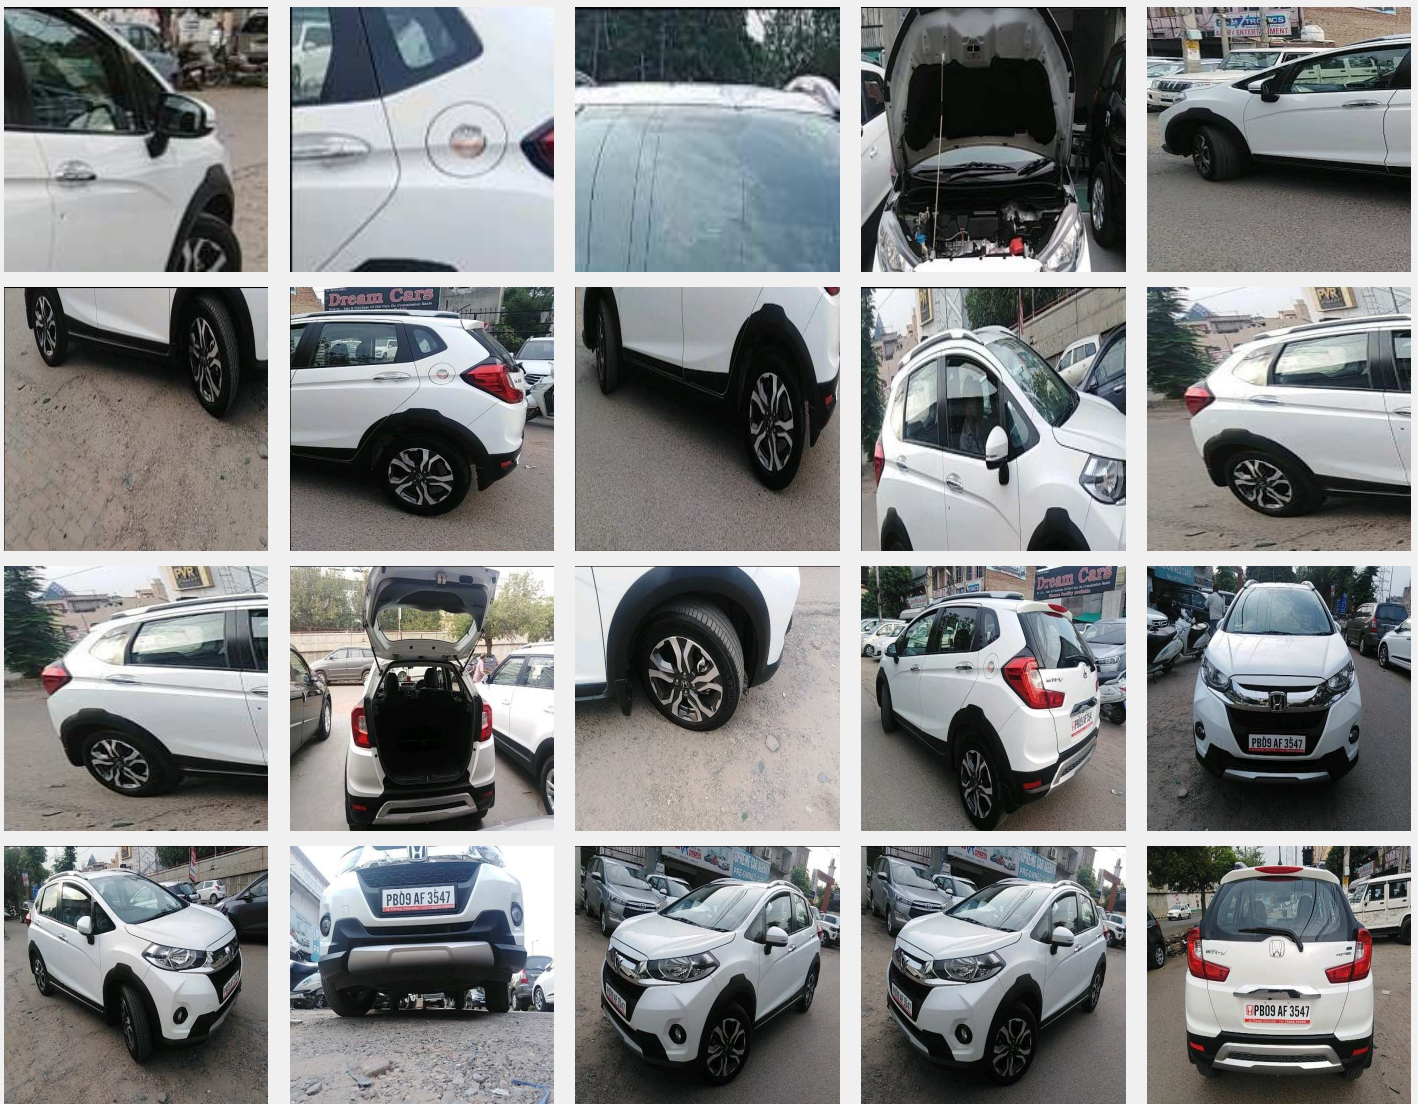
**IMAGES**

INSPECTION CHECKPOINTS	SCORE(X/10)	REMARKS/COMMENTS	OPTIONAL SPEND EST. (RS)
RH FRONT DOOR	8	EXCELENT GOOD	0
RH FENDER	7	GOOD	0
BODY RUST	8	EXCELENT GOOD	0
ROOF (REGULAR)	7	GOOD	0
PAINT CONDITION	8	EXCELENT GOOD	0
