ECO INSPECTION CERTIFICATE

Order ID : 76952

121 Points Vehicle Inspection Certificate

Toyota Innova Crysta 2.8 ZX AT 7 STR, 2018

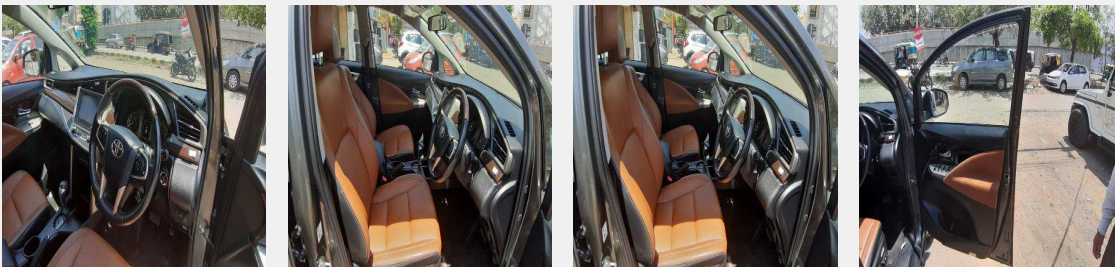
IMAGES

INSPECTION CHECKPOINTS	SCORE(X/10)	REMARKS/COMMENTS	OPTIONAL SPEND EST. (RS)
DOOR PANEL	7	GOOD	0
DOOR HINGES	8	EXCELENT GOOD	0
CARPET & FLOOR MAT	7	GOOD	0
SEAT & SEAT BELT	8	EXCELENT GOOD	0
DASHBOARD & INSTRUMENT PANEL	7	GOOD	0
HORN	7	GOOD	0
SPEAKERS & MUSIC SYSTEM	8	EXCELENT GOOD	0
HANDBRAKE	7	GOOD	0
STEERING-MOUNTED CONTROLS	8	EXCELENT GOOD	0
PEDALS	7	GOOD	0
CENTRAL LOCK	8	EXCELENT GOOD	0
A/C VENTS & HEATER	7	GOOD	0
CUP HOLDERS	8	EXCELENT GOOD	0
NAVIGATION (YES)	7	GOOD	0
ODOMETER	8	EXCELENT GOOD	0
POWER WINDOWS (YES)	7	GOOD	0
HAZARD LIGHT	8	EXCELENT GOOD	0

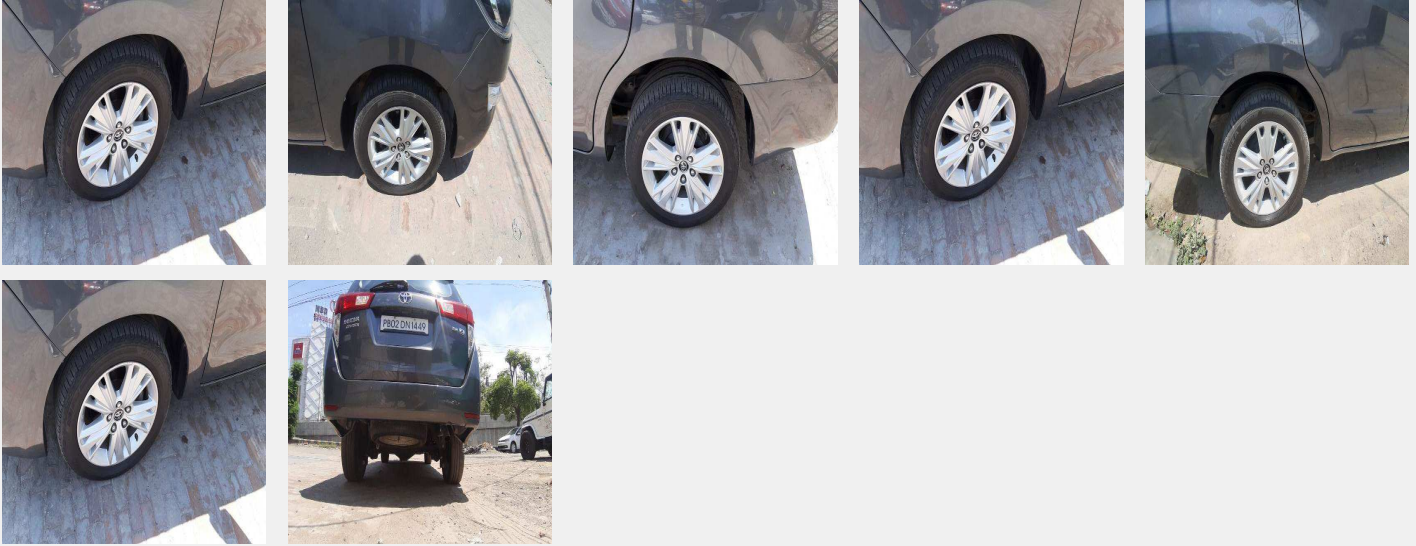
IMAGES

INSPECTION CHECKPOINTS	SCORE(X/10)	REMARKS/COMMENTS	OPTIONAL SPEND EST. (RS)
TYRES	7	GOOD	0
SPARE TYRE (YES)	8	EXCELENT GOOD	0
WHEEL ASSEMBLY (STEEL RIM)	7		0

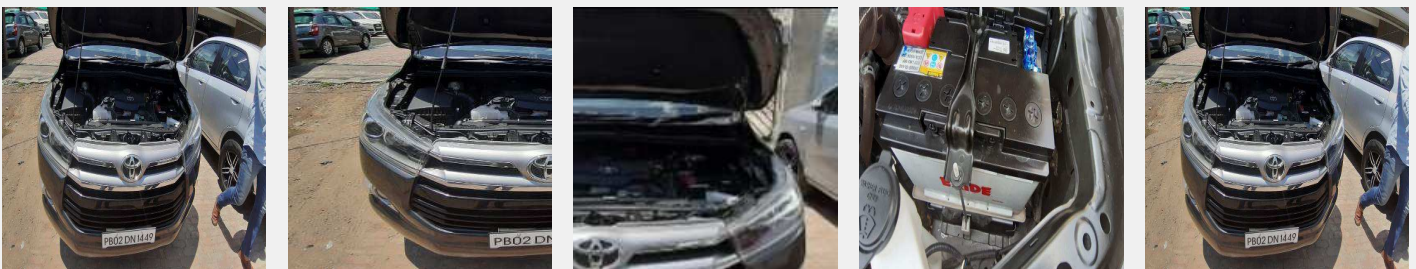
IMAGES

INSPECTION CHECKPOINTS	SCORE(X/10)	REMARKS/COMMENTS	OPTIONAL SPEND EST. (RS)
LH APRON	8	EXCELENT GOOD	0
RH APRON	7	GOOD	0
RADIATOR	8	EXCELENT GOOD	0
WIRING	8	EXCELENT GOOD	0
BATTERY	8	EXCELENT GOOD	0
BRAKE FLUID LEVEL	8	EXCELENT GOOD	0
ENGINE OIL	8	EXCELENT GOOD	0
COOLANT LEVEL	8	EXCELENT GOOD	0
BRAKE & COOLANT HOSE PIPES	8	EXCELENT GOOD	0
UNDERCARRIAGE	8	EXCELENT GOOD	0
EXHAUST SYSTEM	8	EXCELENT GOOD	0

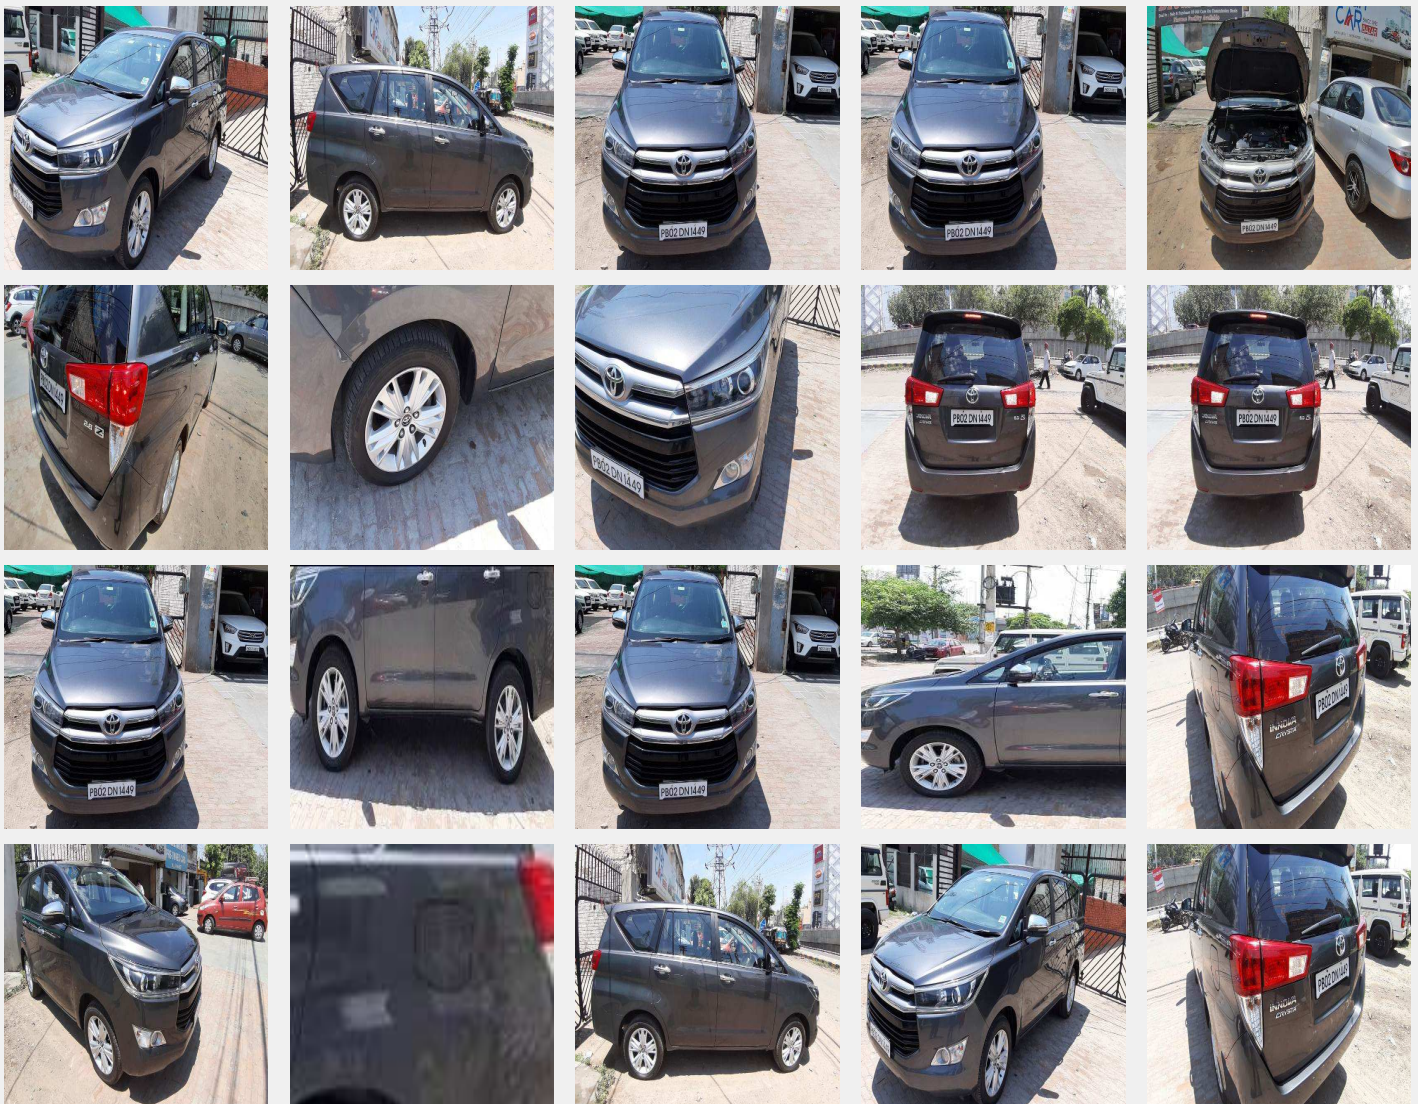
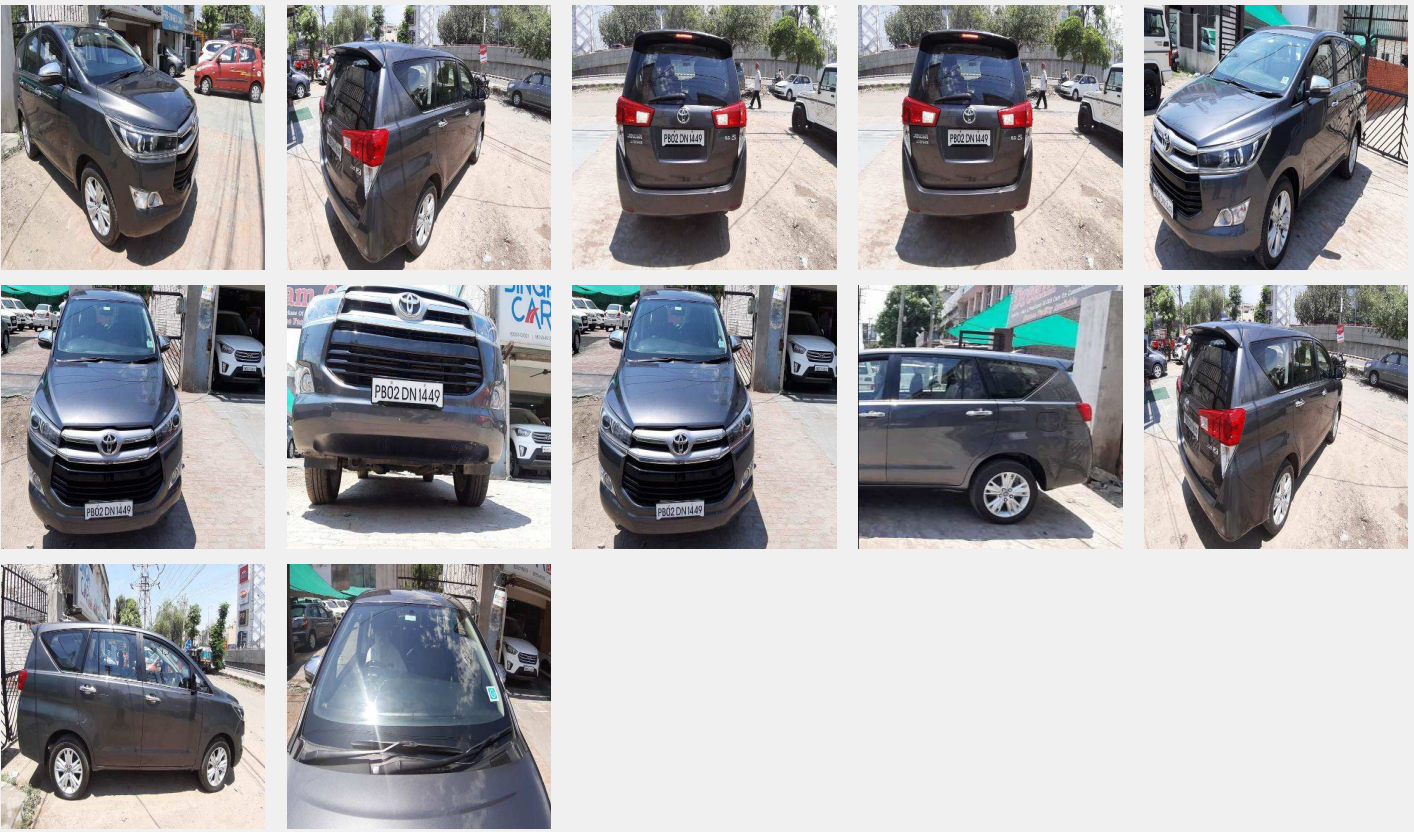
IMAGES

INSPECTION CHECKPOINTS	SCORE(X/10)	REMARKS/COMMENTS	OPTIONAL SPEND EST. (RS)
RH FENDER	8	EXCELENT GOOD	0
BODY RUST	7	GOOD	0
ROOF (REGULAR)	8	EXCELENT GOOD	0
PAINT CONDITION	8	EXCELENT GOOD	0
LUGGAGE COMPARTMENT LIGHT	5	NEUTRAL	0
