ECO INSPECTION CERTIFICATE

121 Points Vehicle Inspection Certificate

Ordered By : Caravan Car	Inspection Date : 2019-05-25	Location : GOREGAON WEST	Inspected By

Hyundai Elite I20 SPORTZ 1.2, 2017

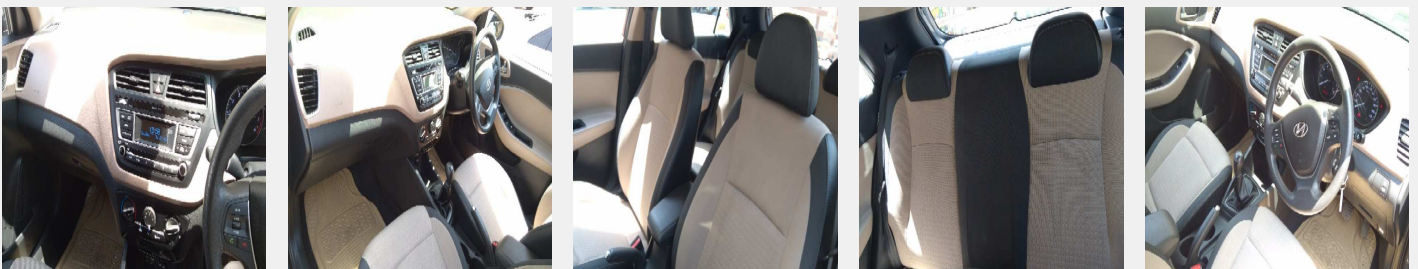
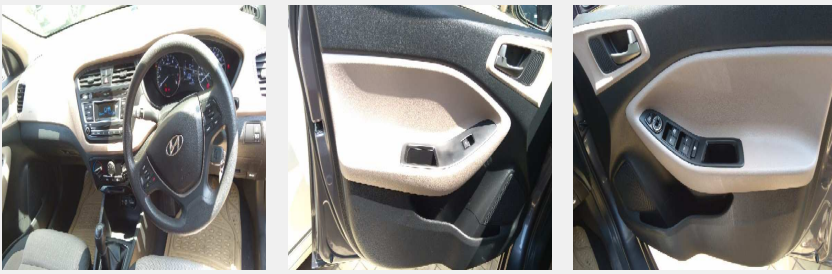
IMAGES

INSPECTION CHECKPOINTS	SCORE(X/10)	REMARKS/COMMENTS	OPTIONAL SPEND EST. (RS)
DOOR PANEL	7	GOOD CONDITION	0
DOOR HINGES	7	GOOD CONDITION	0
CARPET & FLOOR MAT	7	GOOD CONDITION	0
SEAT & SEAT BELT	8	GOOD CONDITION	0
DASHBOARD & INSTRUMENT PANEL	8	GOOD CONDITION	0
HORN	8	GOOD SOUND	0
SPEAKERS & MUSIC SYSTEM	8	GOOD CONDITION	0
HANDBRAKE	8	GOOD CONDITION	0
STEERING-MOUNTED CONTROLS	8	GOOD CONDITION	0
PEDALS	8	GOOD WORKING	0
CENTRAL LOCK	8	GOOD	0
A/C VENTS & HEATER	8	GOOD COOLING	0
CUP HOLDERS	8	GOOD CONDITION	0
NAVIGATION (NO)	10		0
ODOMETER	8	GOOD CONDITION	0
POWER WINDOWS (YES)	8	ALL WORKING GOOD	0
HAZARD LIGHT	8	GOOD CONDITION	0

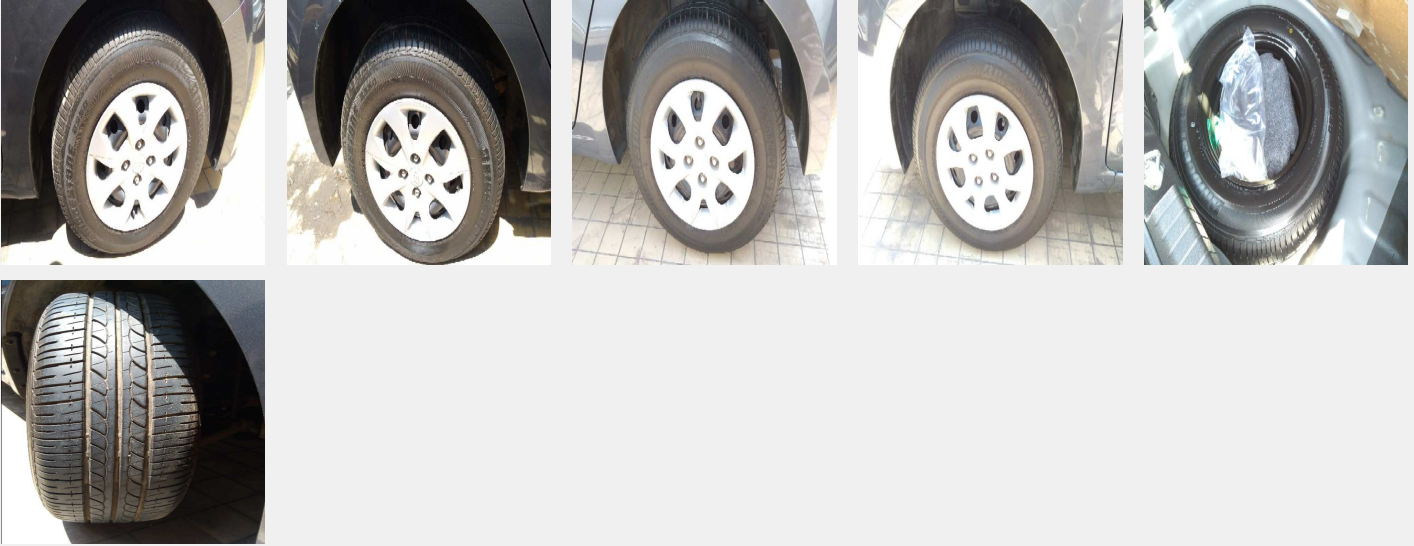
IMAGES

INSPECTION CHECKPOINTS	SCORE(X/10)	REMARKS/COMMENTS	OPTIONAL SPEND EST. (RS)
TYRES	7	GOOD CONDITION	0
SPARE TYRE (YES)	8	GOOD CONDITION	0
WHEEL ASSEMBLY (STEEL RIM)	7	GOOD CONDITION	0

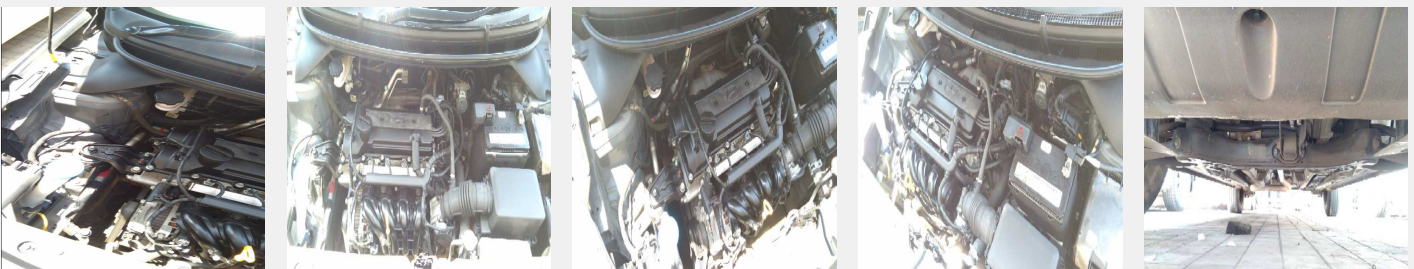
IMAGES

INSPECTION CHECKPOINTS	SCORE(X/10)	REMARKS/COMMENTS	OPTIONAL SPEND EST. (RS)
LH APRON	7	GOOD CONDITION	0
RH APRON	7	GOOD CONDITION	0
RADIATOR	7	GOOD WORKING	0
WIRING	7	GOOD CONDITION	0
BATTERY	7	GOOD CONDITION	0
BRAKE FLUID LEVEL	6	MORE THAN AVERAGE	0
ENGINE OIL	6	GOOD CONDITION	0
COOLANT LEVEL	6	AVERAGE LEVEL	0
BRAKE & COOLANT HOSE PIPES	7	GOOD CONDITION	0
UNDERCARRIAGE	7	GOOD CONDITION	0
EXHAUST SYSTEM	7	GOOD WORKING	0

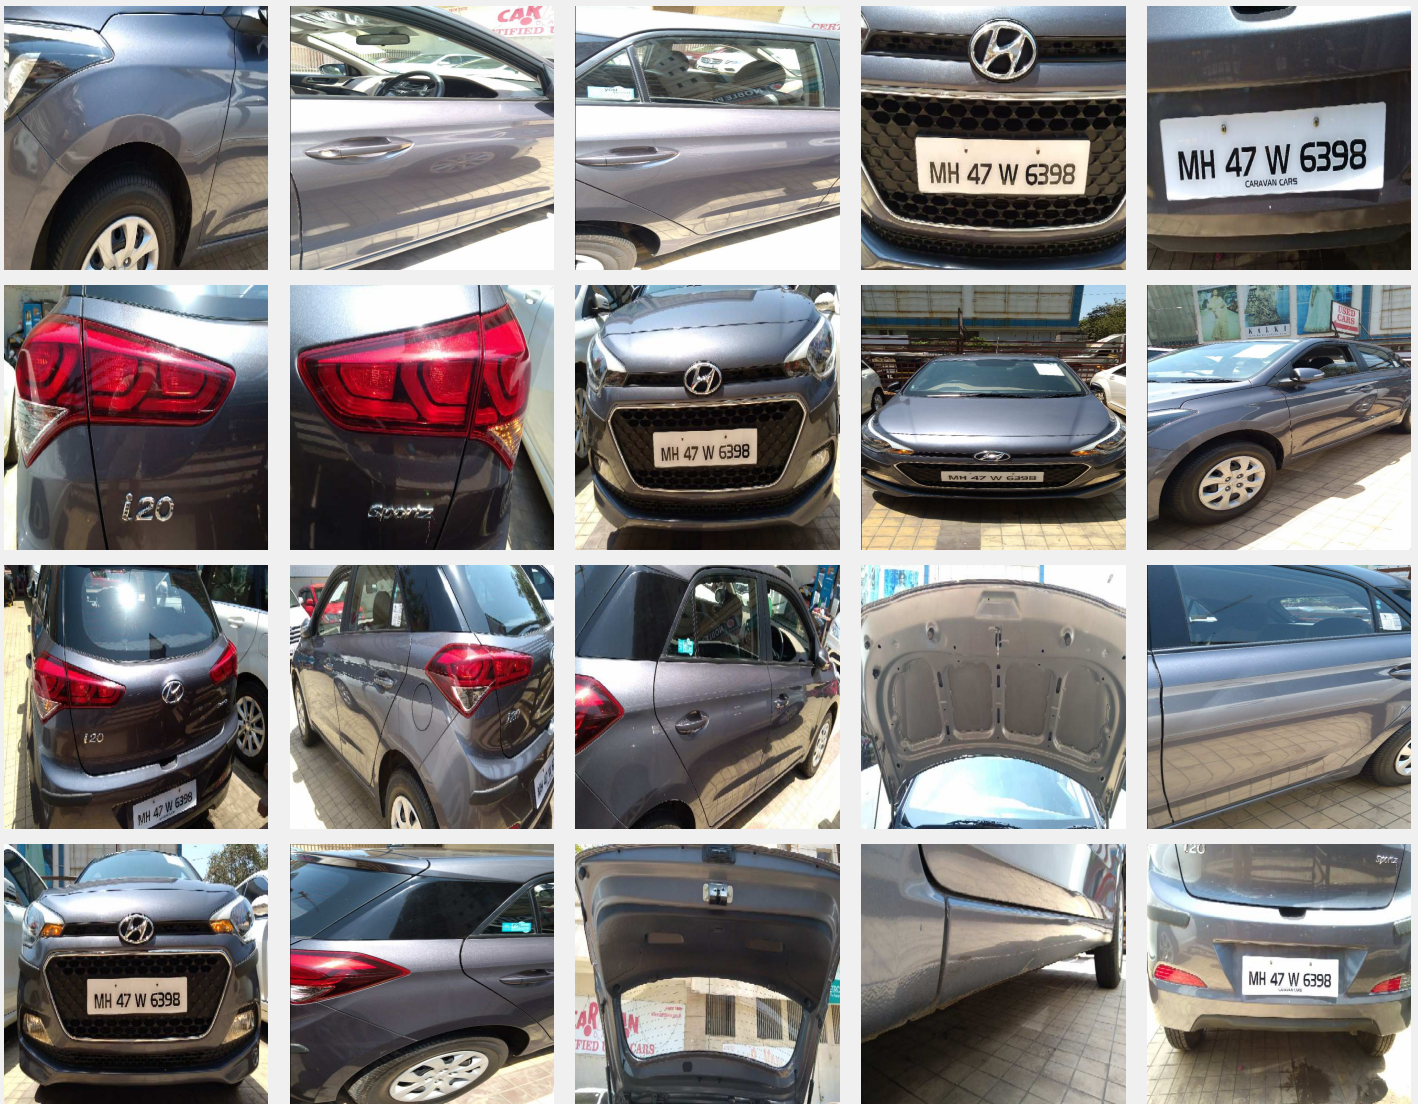
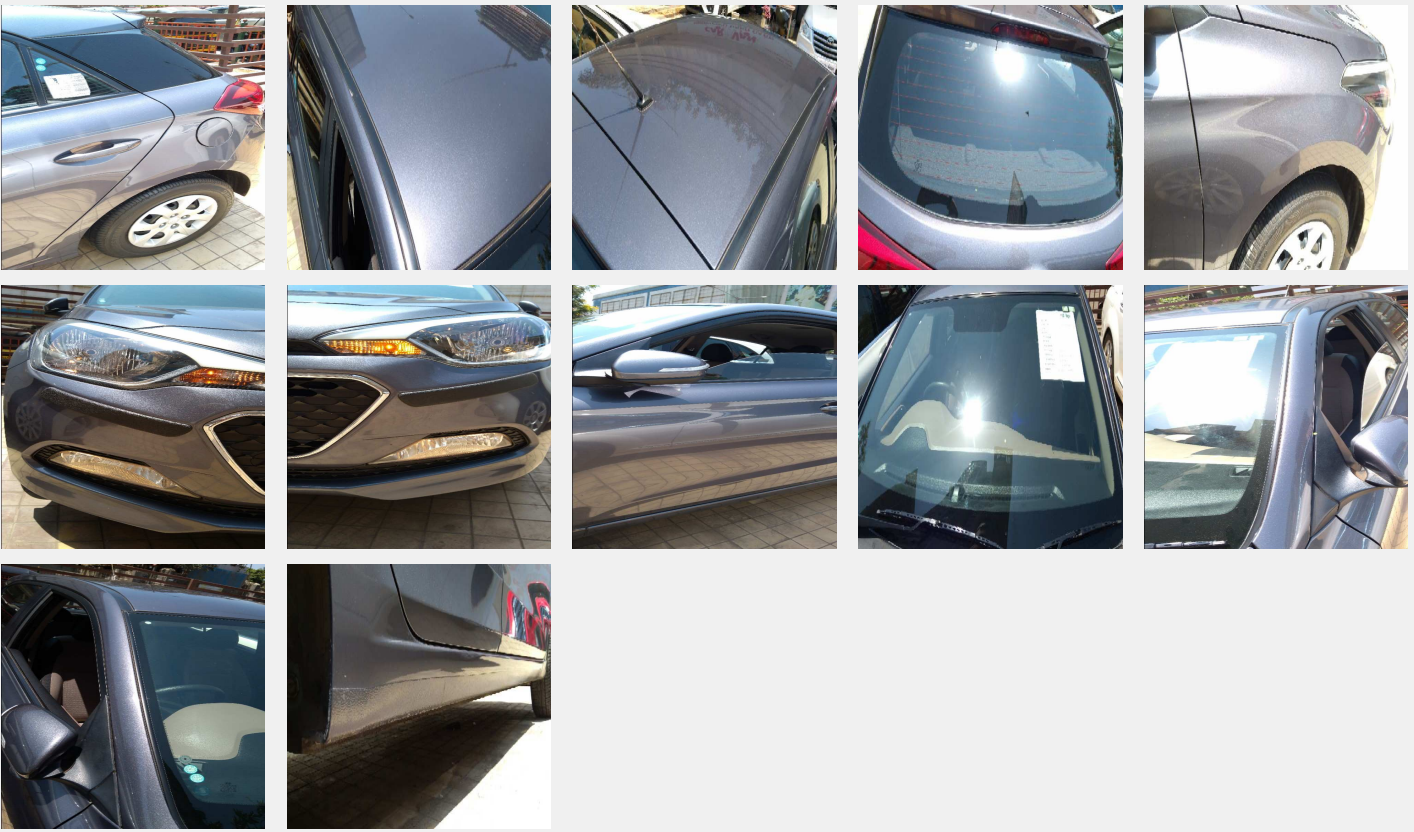
IMAGES

INSPECTION CHECKPOINTS	SCORE(X/10)	REMARKS/COMMENTS	OPTIONAL SPEND EST. (RS)
LICENSE PLATE	8	BOTH GOOD CONDITION	0
FRONT BUMPER	8	GOOD CONDITION	0
HEAD LIGHTS	8	GOOD CONDITION	0
GRILLE	8	GOOD CONDITION	0
TURN SIGNAL	8	GOOD CONDITION	0
FOG LAMPS	8	GOOD WORKING	0
HOOD	8	GOOD CONDITION	0
PILLAR	8	GOOD CONDITION	0
FRONT WINDSHIELD	7	GOOD CONDITION	0
SIDE VIEW MIRRORS	7	GOOD CONDITION	0
LH FENDER	8	GOOD CONDITION	0
LH FRONT DOOR	8	GOOD CONDITION	0
LH REAR DOOR	8	GOOD CONDITION	0
LH RUNNING BOARD	7	GOOD CONDITION	0
LH QUARTER PANEL	8	GOOD CONDITION	0
FUEL LID	8	GOOD CONDITION	0
REAR WINDSHIELD	7	GOOD CONDITION	0
REAR BUMPER	8	GOOD CONDITION	0
TAIL LIGHT	7	GOOD CONDITION	0
TRUNK LID/TAIL GATE	7	GOOD CONDITION	0
RH QUARTER PANEL	8	GOOD CONDITION	0
RH RUNNING BOARD	7	GOOD CONDITION	0
RH REAR DOOR	7	GOOD CONDITION	0
RH FRONT DOOR	8	GOOD CONDITION	0

INSPECTION CHECKPOINTS	SCORE(X/10)	REMARKS/COMMENTS	OPTIONAL SPEND EST. (RS)
RH FENDER	8	GOOD CONDITION	0
BODY RUST	7	NO RUST	0
ROOF (REGULAR)	7	GOOD CONDITION	0
PAINT CONDITION	8	GOOD	0
LUGGAGE COMPARTMENT LIGHT	0	N/A	0
