ECO INSPECTION CERTIFICATE

Order ID : 73299

121 Points Vehicle Inspection Certificate

Volkswagen Vento 1.6 MPI HIGHLINE PLUS, 2016

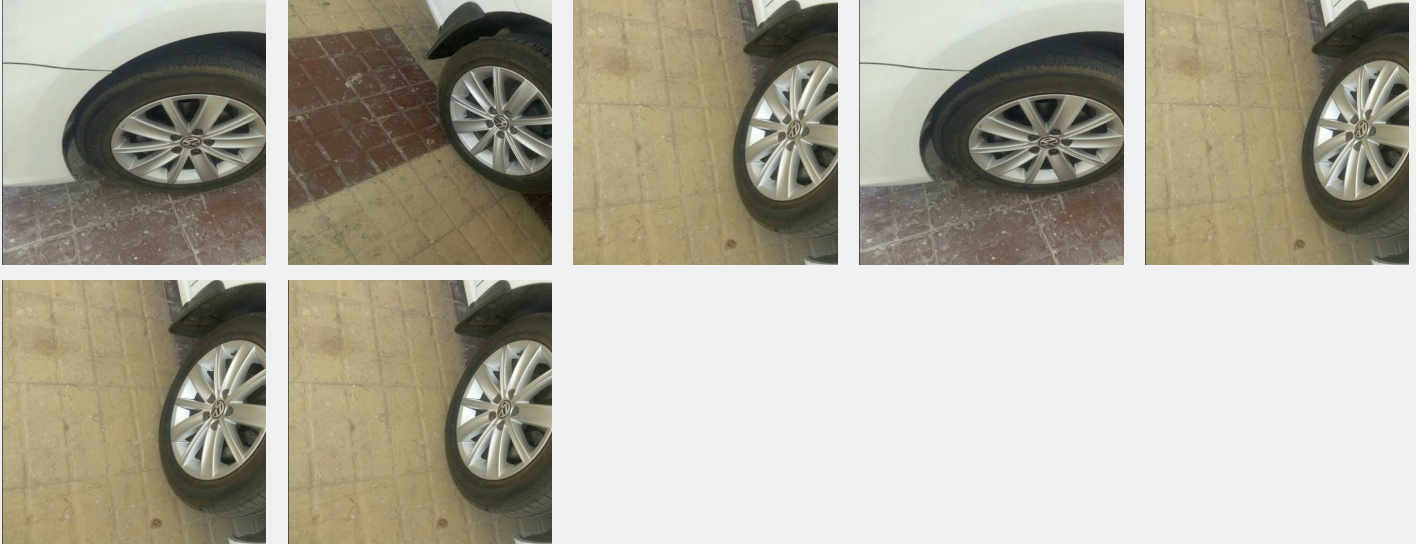
IMAGES

INSPECTION CHECKPOINTS	SCORE(X/10)	REMARKS/COMMENTS	OPTIONAL SPEND EST. (RS)
TYRES	8		0
SPARE TYRE (YES)	8		0
WHEEL ASSEMBLY (ALLOY RIM)	9		0

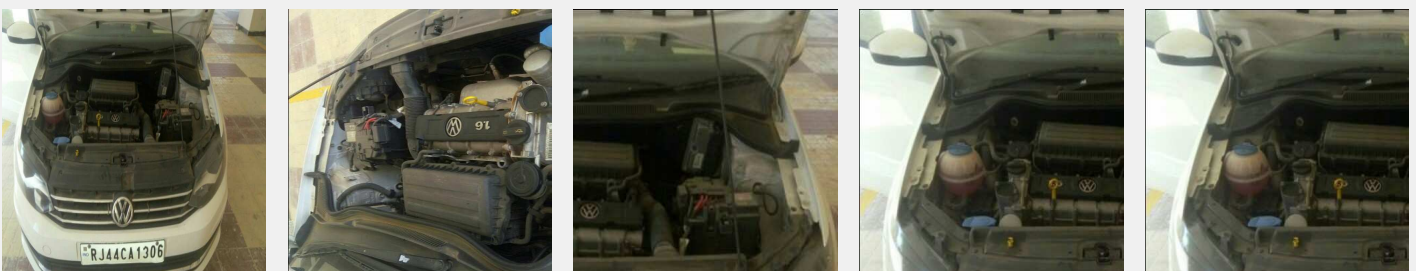
IMAGES

INSPECTION CHECKPOINTS	SCORE(X/10)	REMARKS/COMMENTS	OPTIONAL SPEND EST. (RS)
LH APRON	8		0
RH APRON	9		0
RADIATOR	8		0
WIRING	9		0
BATTERY	8		0
BRAKE FLUID LEVEL	9		0
ENGINE OIL	8		0
COOLANT LEVEL	8		0
BRAKE & COOLANT HOSE PIPES	7		0
UNDERCARRIAGE	9		0
EXHAUST SYSTEM	8		0

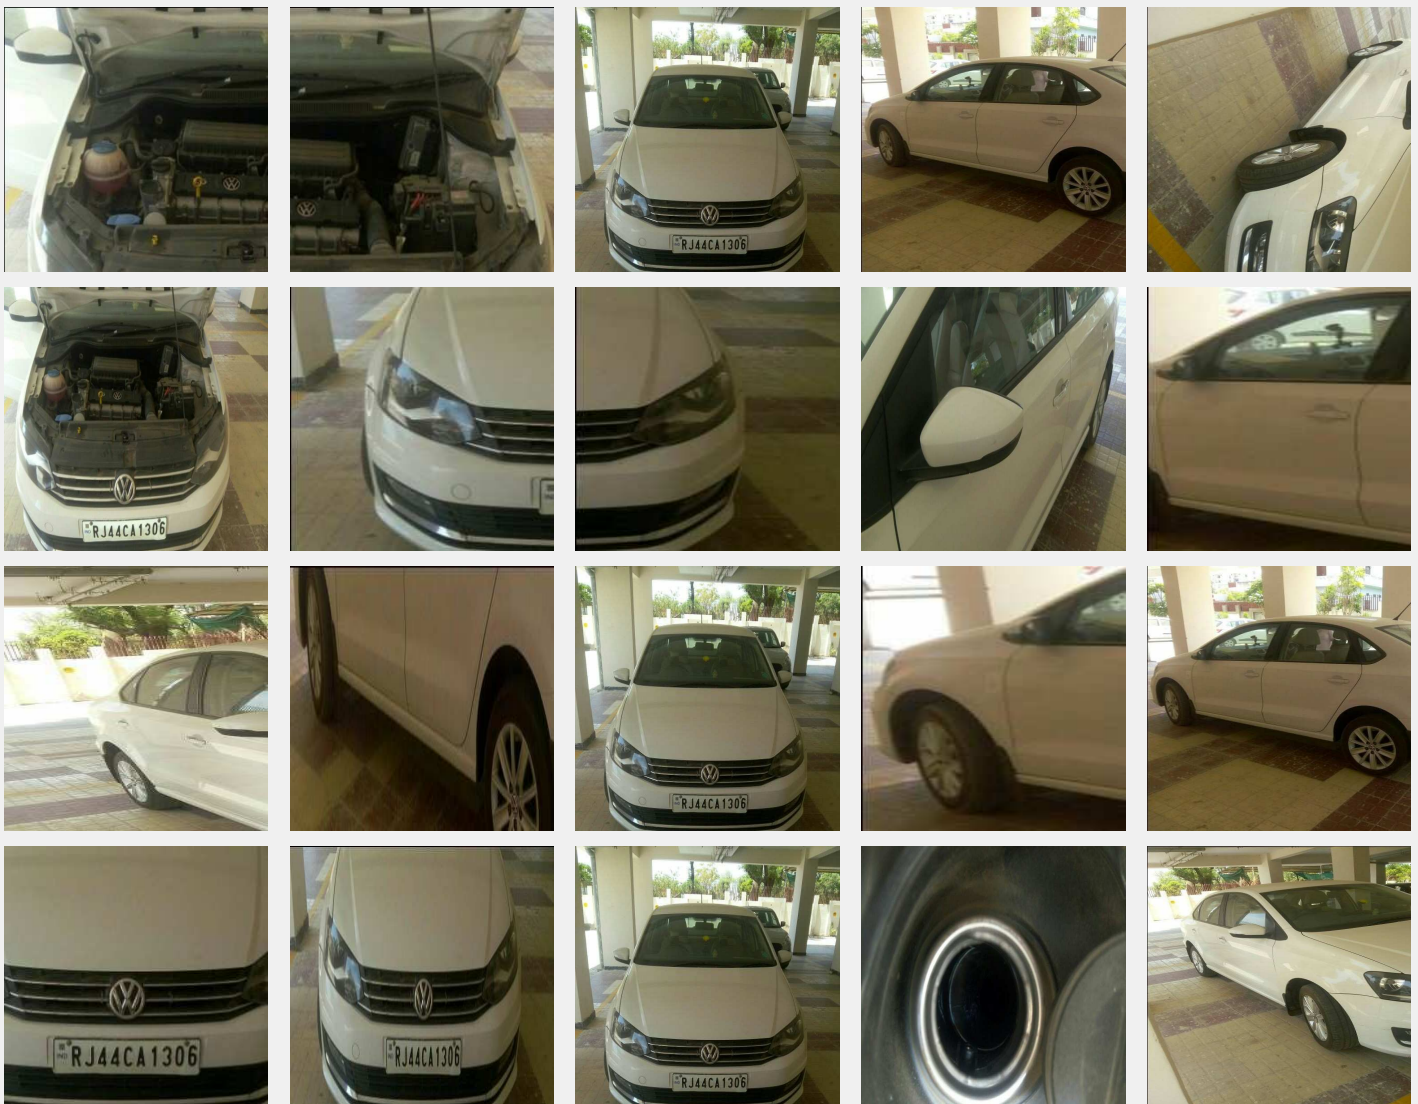
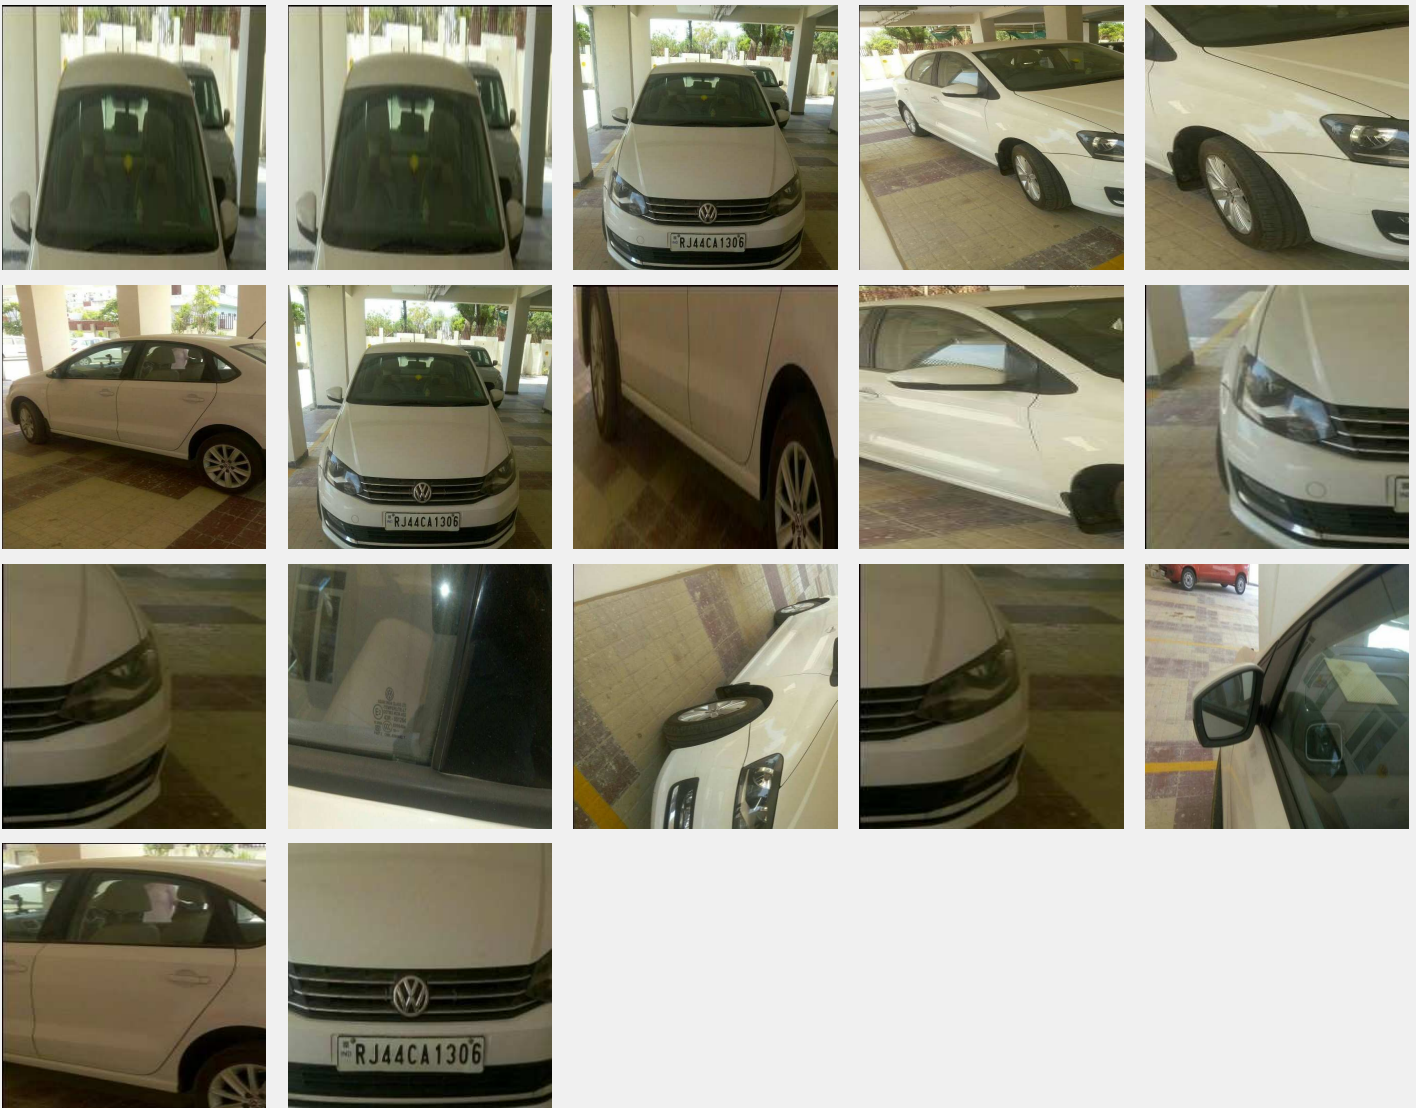
IMAGES

INSPECTION CHECKPOINTS	SCORE(X/10)	REMARKS/COMMENTS	OPTIONAL SPEND EST. (RS)
LICENSE PLATE	9		0
FRONT BUMPER	8		0
HEAD LIGHTS	8		0
GRILLE	9		0
TURN SIGNAL	8		0
FOG LAMPS	8		0
HOOD	8		0
PILLAR	9		0
FRONT WINDSHIELD	8		0
SIDE VIEW MIRRORS	8		0
LH FENDER	9		0
LH FRONT DOOR	8		0
LH REAR DOOR	8		0
LH RUNNING BOARD	9		0
LH QUARTER PANEL	8		0
FUEL LID	9		0
REAR WINDSHIELD	8		0
REAR BUMPER	8	REFUSED	0
TAIL LIGHT	8	REFUSED	0
TRUNK LID/TAIL GATE	9	REFUSED	0
LUGGAGE COMPARTMENT LIGHT	8	REFUSED	0
RH QUARTER PANEL	9		0
RH RUNNING BOARD	9		0
RH REAR DOOR	8		0

INSPECTION CHECKPOINTS	SCORE(X/10)	REMARKS/COMMENTS	OPTIONAL SPEND EST. (RS)
RH FRONT DOOR	8		0
RH FENDER	9		0
BODY RUST	9		0
ROOF (REGULAR)	8		0
PAINT CONDITION	9		0
