ECO INSPECTION CERTIFICATE

Order ID : 76916

121 Points Vehicle Inspection Certificate

Volkswagen Polo HIGHLINE 1.5L (D), 2016

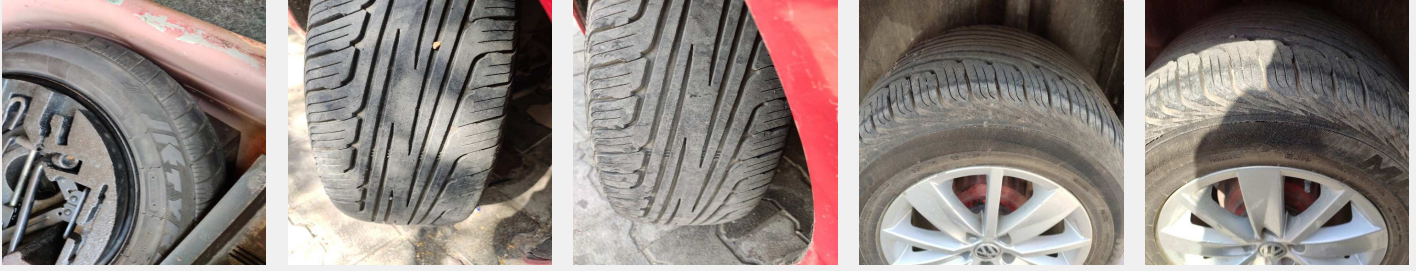
INSPECTION CHECKPOINTS	SCORE(X/10)	REMARKS/COMMENTS	OPTIONAL SPEND EST. (RS)
TYRES	7		0
SPARE TYRE (YES)	8		0
WHEEL ASSEMBLY (ALLOY RIM)	7		0

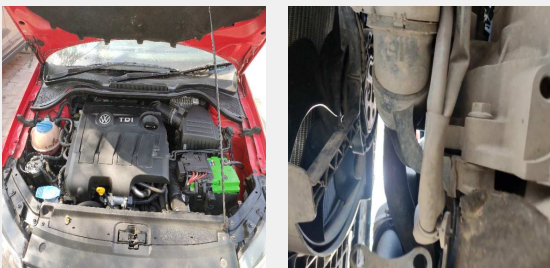
INSPECTION CHECKPOINTS	SCORE(X/10)	REMARKS/COMMENTS	OPTIONAL SPEND EST. (RS)
LH APRON	7		0
RH APRON	7		0
RADIATOR	7		0
WIRING	7		0
BATTERY	7		0
BRAKE FLUID LEVEL	7		0
ENGINE OIL	7		0
COOLANT LEVEL	7		0
BRAKE & COOLANT HOSE PIPES	7		0
UNDERCARRIAGE	7		0
EXHAUST SYSTEM	7		0

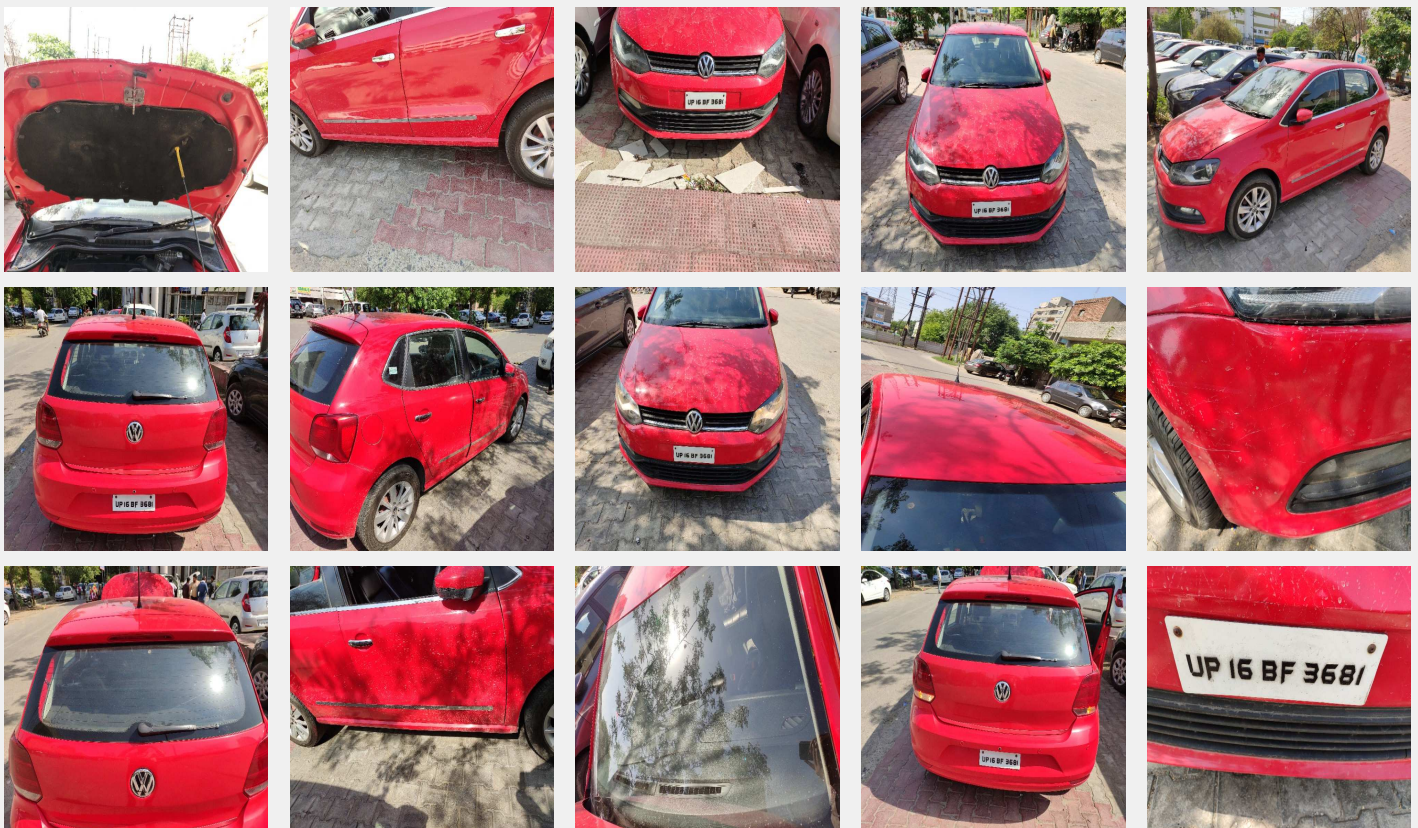
INSPECTION CHECKPOINTS	SCORE(X/10)	REMARKS/COMMENTS	OPTIONAL SPEND EST. (RS)
RH FRONT DOOR	7		0
RH FENDER	7		0
BODY RUST	7		0
ROOF (REGULAR)	7		0
PAINT CONDITION	7		0

all body scratches
