ECO INSPECTION CERTIFICATE

121 Points Vehicle Inspection Certificate

Inspection Date :
2019-05-25

Maruti Suzuki Wagon R VXI, 2016

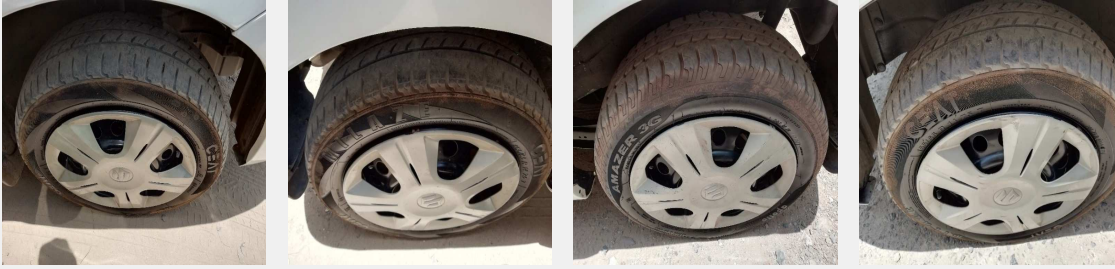
IMAGES

INSPECTION CHECKPOINTS	SCORE(X/10)	REMARKS/COMMENTS	OPTIONAL SPEND EST. (RS)
TYRES	7	GOOD CONDITION	0
SPARE TYRE (YES)	8	GOOD CONDITION	0
WHEEL ASSEMBLY (STEEL RIM)	8	GOOD CONDITION	0

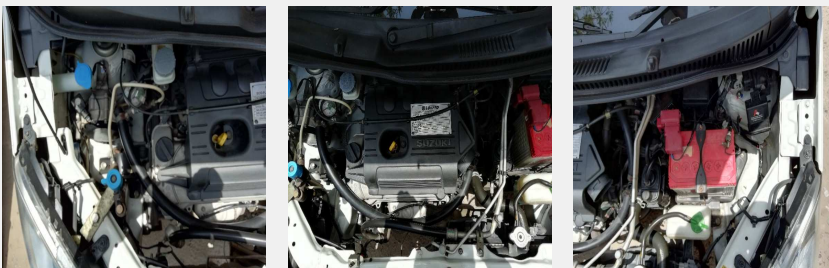
IMAGES

INSPECTION CHECKPOINTS	SCORE(X/10)	REMARKS/COMMENTS	OPTIONAL SPEND EST. (RS)
LH APRON	8	GOOD CONDITION	0
RH APRON	8	GOOD CONDITION	0
RADIATOR	8	GOOD CONDITION	0
WIRING	8	GOOD CONDITION	0
BATTERY	8	GOOD CONDITION	0
BRAKE FLUID LEVEL	8	GOOD CONDITION	0
ENGINE OIL	8	GOOD CONDITION	0
COOLANT LEVEL	8	GOOD CONDITION	0
BRAKE & COOLANT HOSE PIPES	8	GOOD CONDITION	0
UNDERCARRIAGE	8	GOOD CONDITION	0
EXHAUST SYSTEM	8	GOOD CONDITION	0
