# ECO INSPECTION CERTIFICATE

121 Points Vehicle Inspection Certificate

Ordered By : Anshul Chawla	Inspection Date : 2019-05-24	Location : GHAZIABAD	Inspected By  Kishan Kumar
-------------------------------	---------------------------------	-------------------------	----------------------------------

## Toyota Innova Crysta 2.8 Z 7 STR AT, 2017

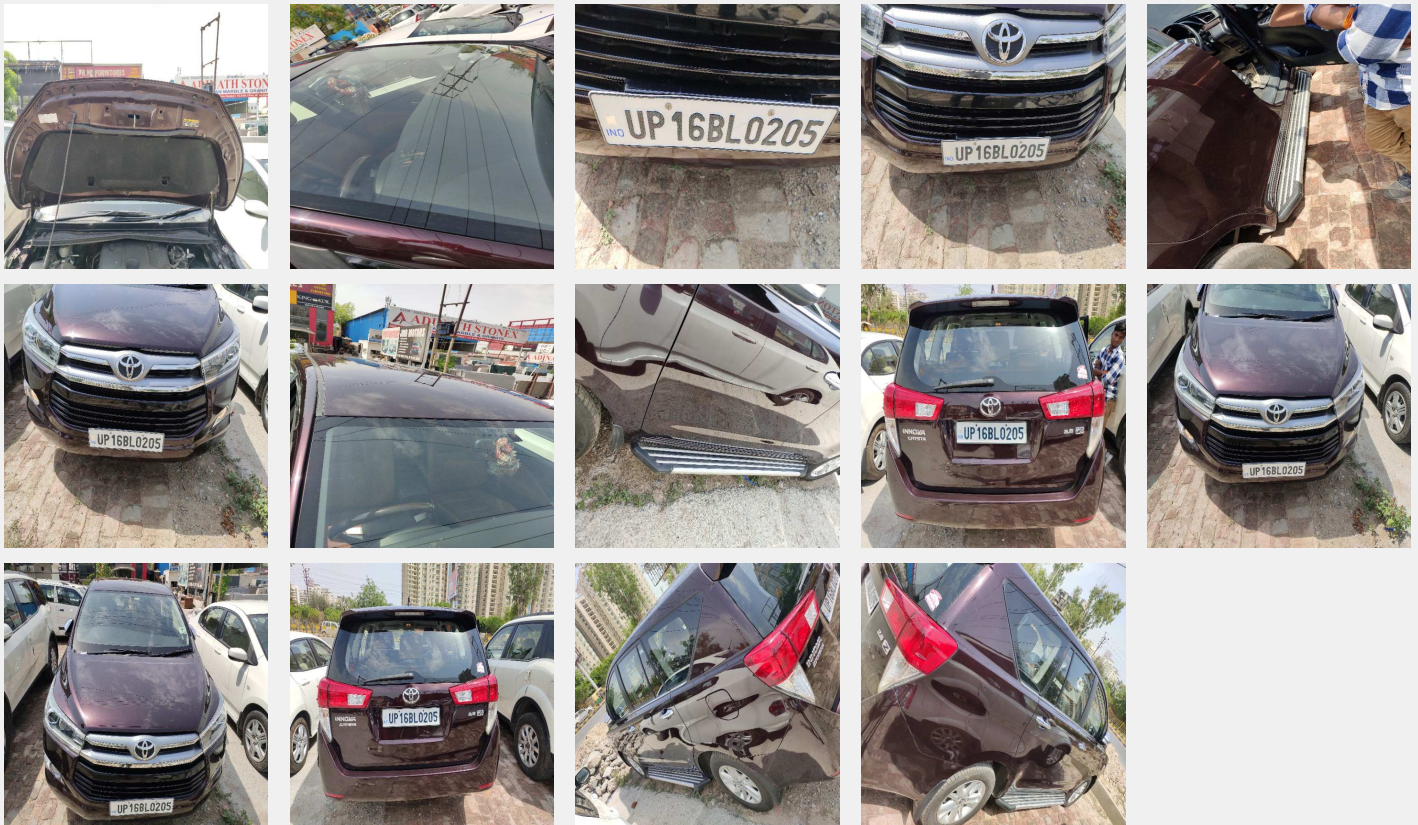
all body minor scratches
