ECO INSPECTION CERTIFICATE

Order ID : 75828

121 Points Vehicle Inspection Certificate

Tata Indigo LX, 2006

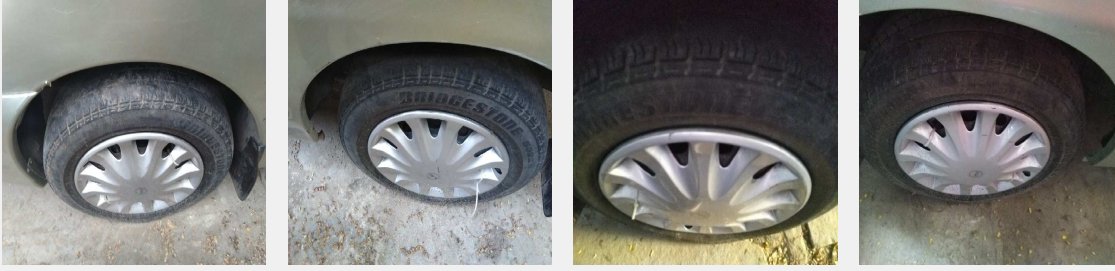
INSPECTION CHECKPOINTS	SCORE(X/10)	REMARKS/COMMENTS	OPTIONAL SPEND EST. (RS)
TYRES	8	NEED TO BE CHANGED	3500
SPARE TYRE (YES)	8		0
WHEEL ASSEMBLY (STEEL RIM)	8		0

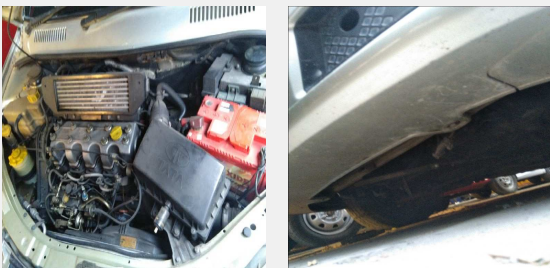
HOOD

INSPECTION CHECKPOINTS	SCORE(X/10)	REMARKS/COMMENTS	OPTIONAL SPEND EST. (RS)
LH APRON	10		0
RH APRON	10		0
RADIATOR	10		0
WIRING	10		0
BATTERY	10		0
BRAKE FLUID LEVEL	10		0
ENGINE OIL	10		0
COOLANT LEVEL	10		0
BRAKE & COOLANT HOSE PIPES	10		0
UNDERCARRIAGE	10		0
EXHAUST SYSTEM	10		0

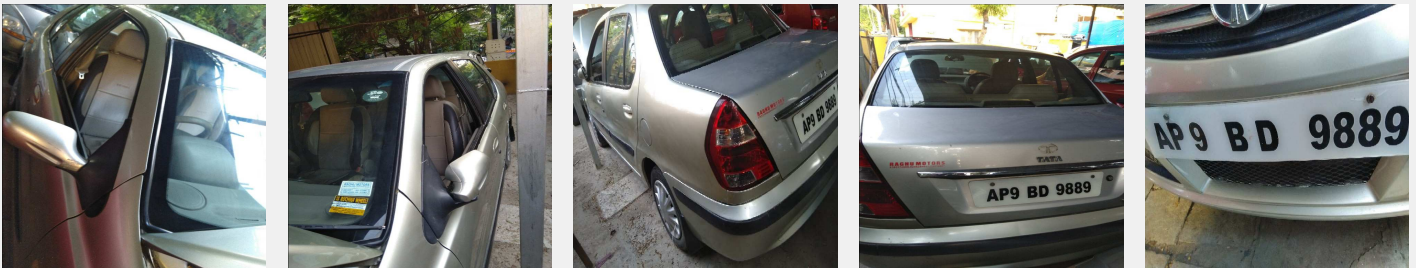
EXTERIOR (CONTINUED)

INSPECTION CHECKPOINTS	SCORE(X/10)	REMARKS/COMMENTS	OPTIONAL SPEND EST. (RS)
RH FRONT DOOR	8		0
RH FENDER	8		0
BODY RUST	8		0
ROOF (REGULAR)	10		0
PAINT CONDITION	10		0

good
