ECO INSPECTION CERTIFICATE

121 Points Vehicle Inspection Certificate

Ordered By : Amit Malhotra	Inspection Date : 2019-05-23	Location : DELHI	Inspected By

Skoda Laura ELEGANCE 2.0 TDI CR MT, 2011

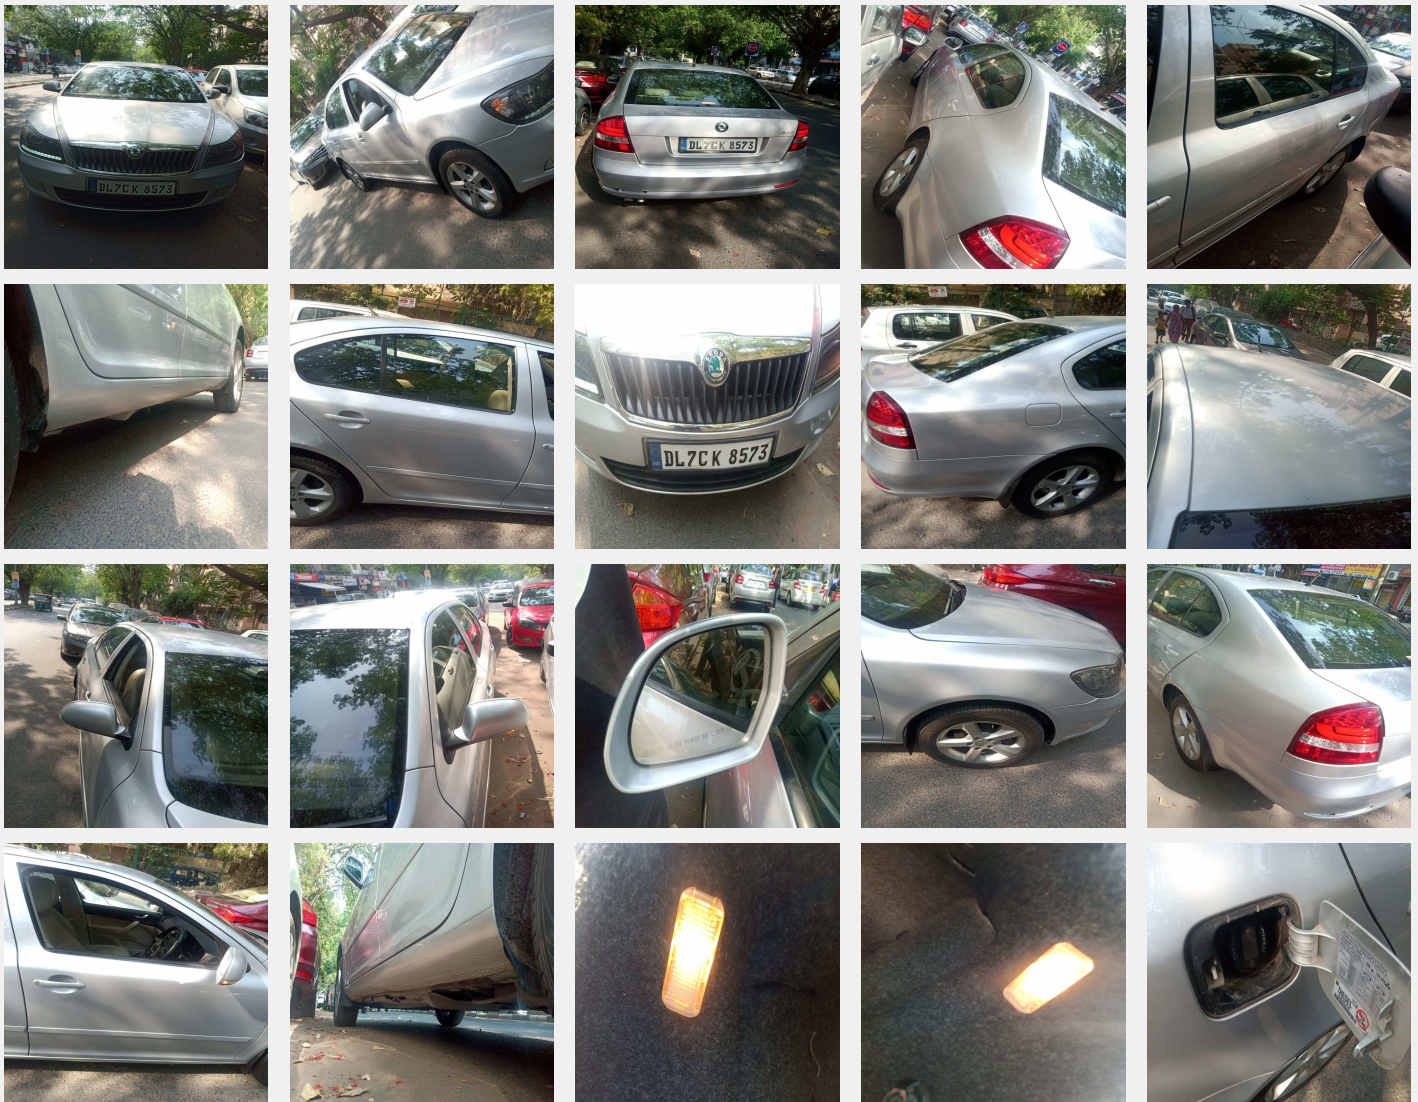
INSPECTION CHECKPOINTS	SCORE(X/10)	REMARKS/COMMENTS	OPTIONAL SPEND EST. (RS)
BODY RUST	7	NO	0
ROOF (REGULAR)	8	GOOD	0
PAINT CONDITION	8	GOOD	0
HEAD LIGHTS	3	ONE SIDE NOT WORKING	2500
REAR BUMPER	5	BUMPER COVER NEED TO REPLACE	350
