# ECO INSPECTION CERTIFICATE

Order ID : 76950

121 Points Vehicle Inspection Certificate

## Volkswagen Polo Trendline 1.2L (P), 2011

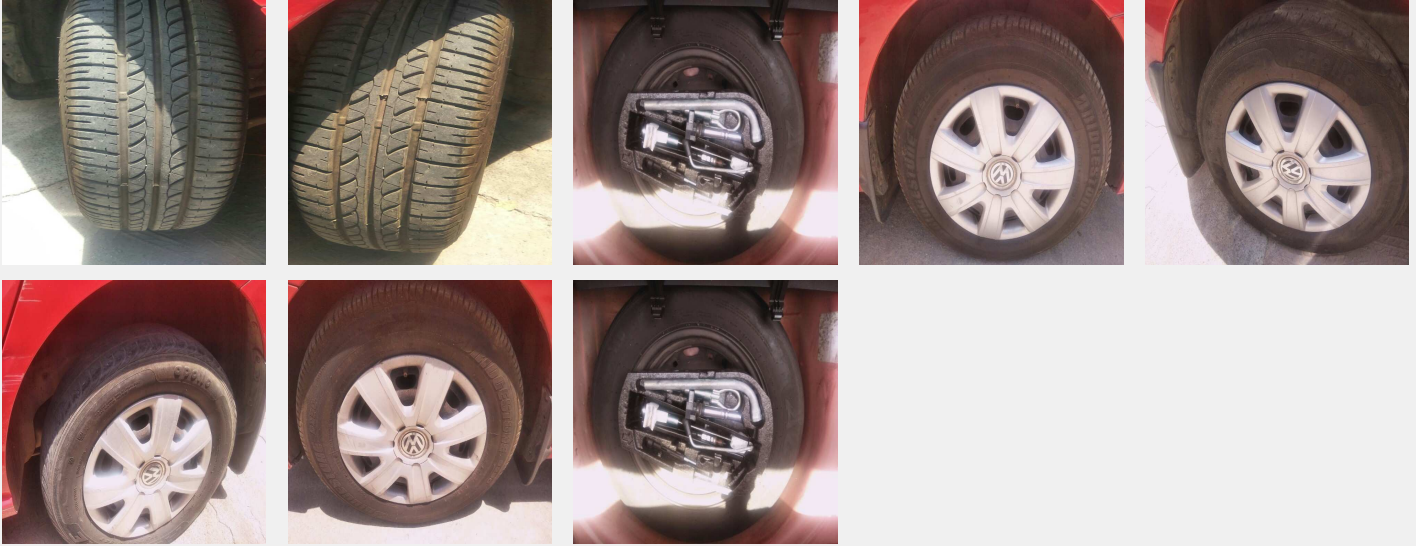
IMAGES

INSPECTION CHECKPOINTS	SCORE(X/10)	REMARKS/COMMENTS	OPTIONAL SPEND EST. (RS)
TYRES	8		0
SPARE TYRE (YES)	6		0
WHEEL ASSEMBLY (STEEL RIM)	8		0

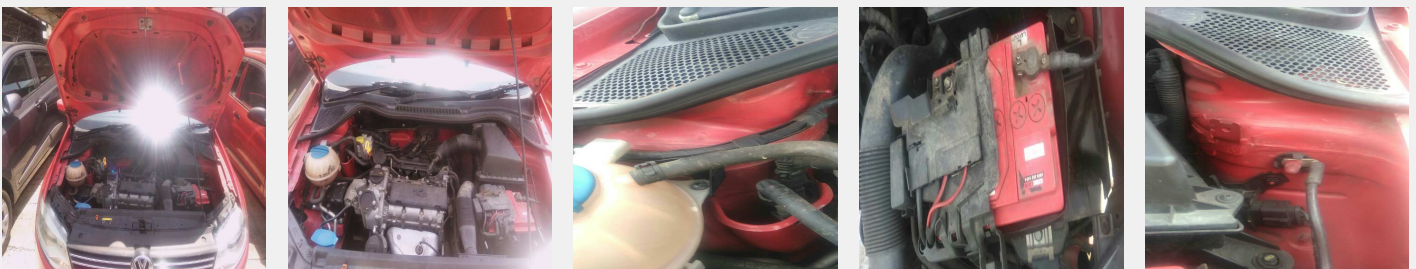
IMAGES

INSPECTION CHECKPOINTS	SCORE(X/10)	REMARKS/COMMENTS	OPTIONAL SPEND EST. (RS)
LH APRON	8		0
RH APRON	8		0
RADIATOR	8		0
WIRING	7		0
BATTERY	8		0
BRAKE FLUID LEVEL	7		0
ENGINE OIL	8		0
COOLANT LEVEL	8		0
BRAKE & COOLANT HOSE PIPES	8		0
UNDERCARRIAGE	7		0
EXHAUST SYSTEM	8		0

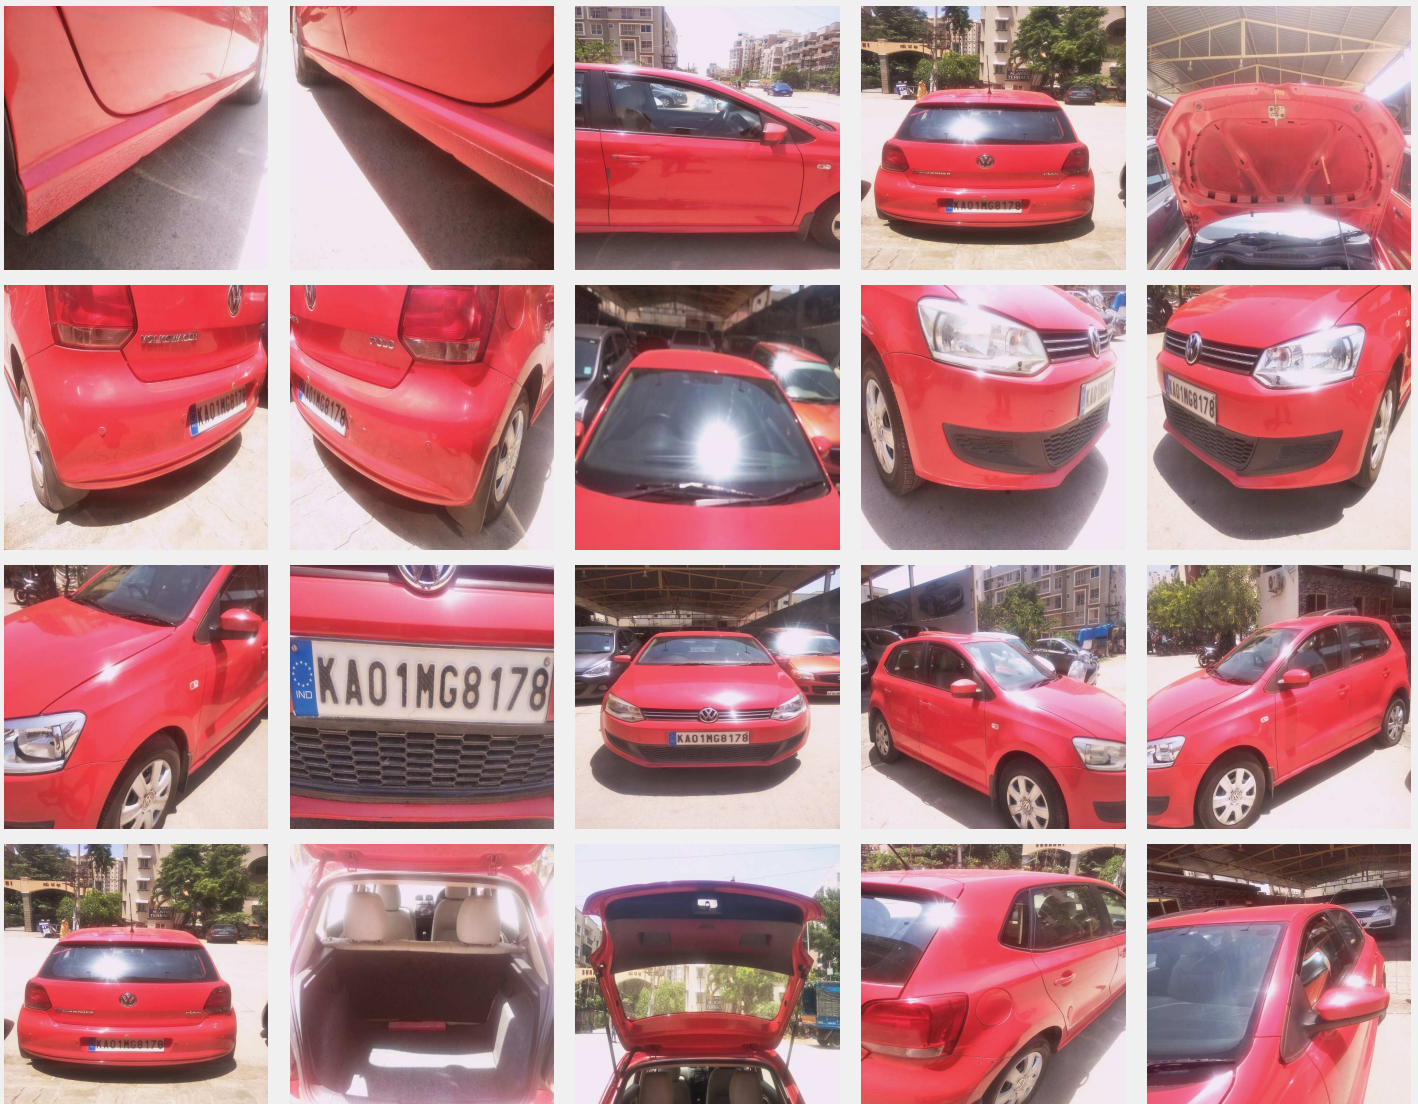
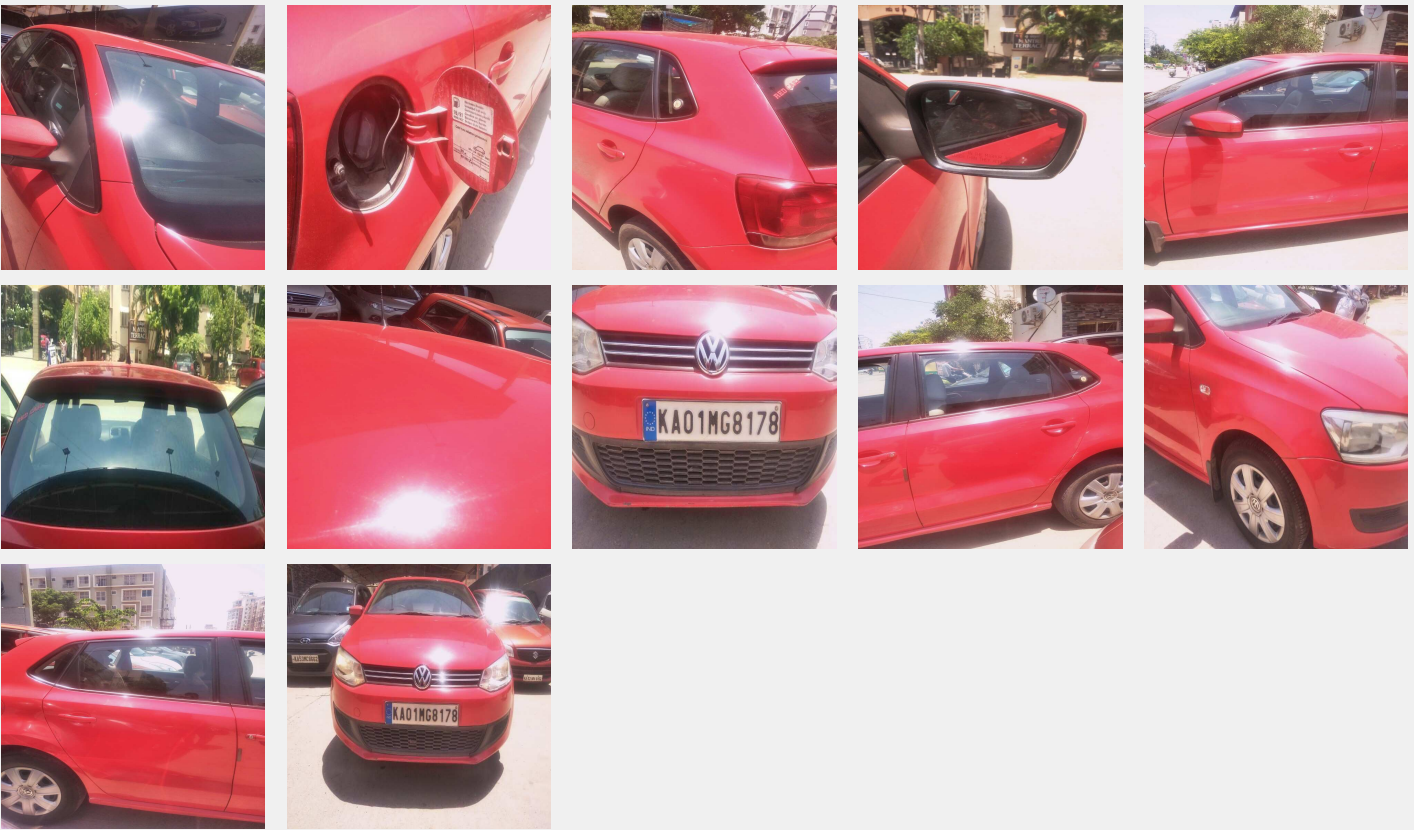
## IMAGES

INSPECTION CHECKPOINTS	SCORE(X/10)	REMARKS/COMMENTS	OPTIONAL SPEND EST. (RS)
LICENSE PLATE	8		0
FRONT BUMPER	7		0
HEAD LIGHTS	8		0
GRILLE	6		0
TURN SIGNAL	8		0
HOOD	8		0
PILLAR	8		0
FRONT WINDSHIELD	8		0
SIDE VIEW MIRRORS	8		0
LH FENDER	8		0
LH FRONT DOOR	8		0
LH REAR DOOR	6		0
LH RUNNING BOARD	6		0
LH QUARTER PANEL	6		0
FUEL LID	8		0
REAR WINDSHIELD	8		0
REAR BUMPER	7		0
TAIL LIGHT	7		0
TRUNK LID/TAIL GATE	6		0
LUGGAGE COMPARTMENT LIGHT	8		0
RH QUARTER PANEL	7		0
RH RUNNING BOARD	6		0
RH REAR DOOR	7		0
RH FRONT DOOR	6		0

INSPECTION CHECKPOINTS	SCORE(X/10)	REMARKS/COMMENTS	OPTIONAL SPEND EST. (RS)
RH FENDER	7		0
BODY RUST	8		0
ROOF (REGULAR)	8		0
PAINT CONDITION	7		0
FOG LAMPS	0	NO FOG LAMP	4000
