ECO INSPECTION CERTIFICATE

121 Points Vehicle Inspection Certificate

Inspection Date :
2019-05-28

Toyota Etios G, 2016

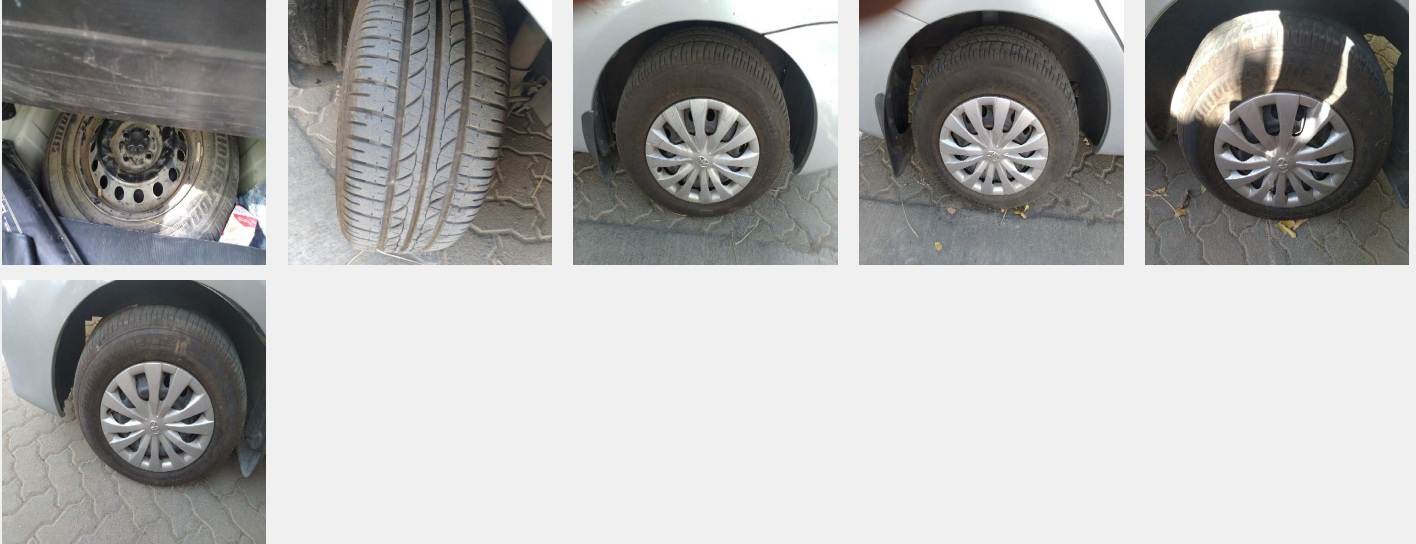
IMAGES

INSPECTION CHECKPOINTS	SCORE(X/10)	REMARKS/COMMENTS	OPTIONAL SPEND EST. (RS)
TYRES	6	NORMAL WEAR & TEAR	0
SPARE TYRE (YES)	6	NO DAMAGE	0
WHEEL ASSEMBLY (STEEL RIM)	6	NO DAMAGE	0

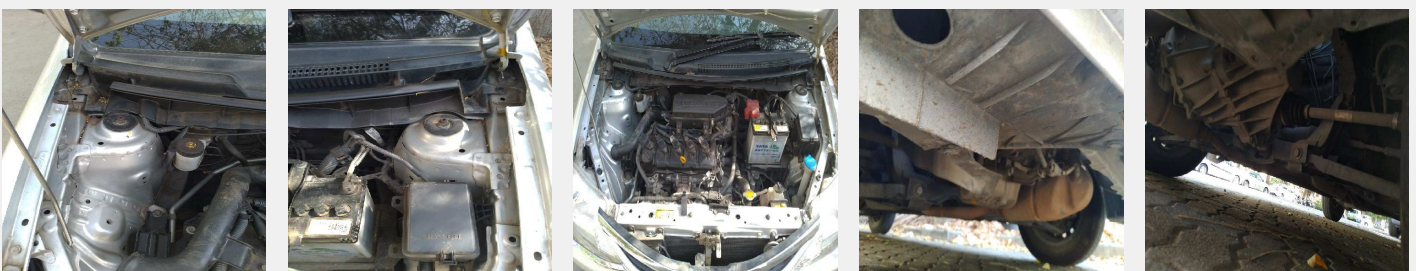
IMAGES

INSPECTION CHECKPOINTS	SCORE(X/10)	REMARKS/COMMENTS	OPTIONAL SPEND EST. (RS)
LH APRON	6	NO DAMAGE	0
RH APRON	6	NO DAMAGE	0
RADIATOR	6	WORKING CONDITION	0
WIRING	6	NO DAMAGE	0
BATTERY	6	GOOD CONDITION	0
BRAKE FLUID LEVEL	6	MAXIMUM	0
ENGINE OIL	6	GOOD CONDITION	0
COOLANT LEVEL	6	MAXIMUM	0
BRAKE & COOLANT HOSE PIPES	6	NO DAMAGE	0
UNDERCARRIAGE	6	WORKING CONDITION	0
EXHAUST SYSTEM	6	WORKING CONDITION	0

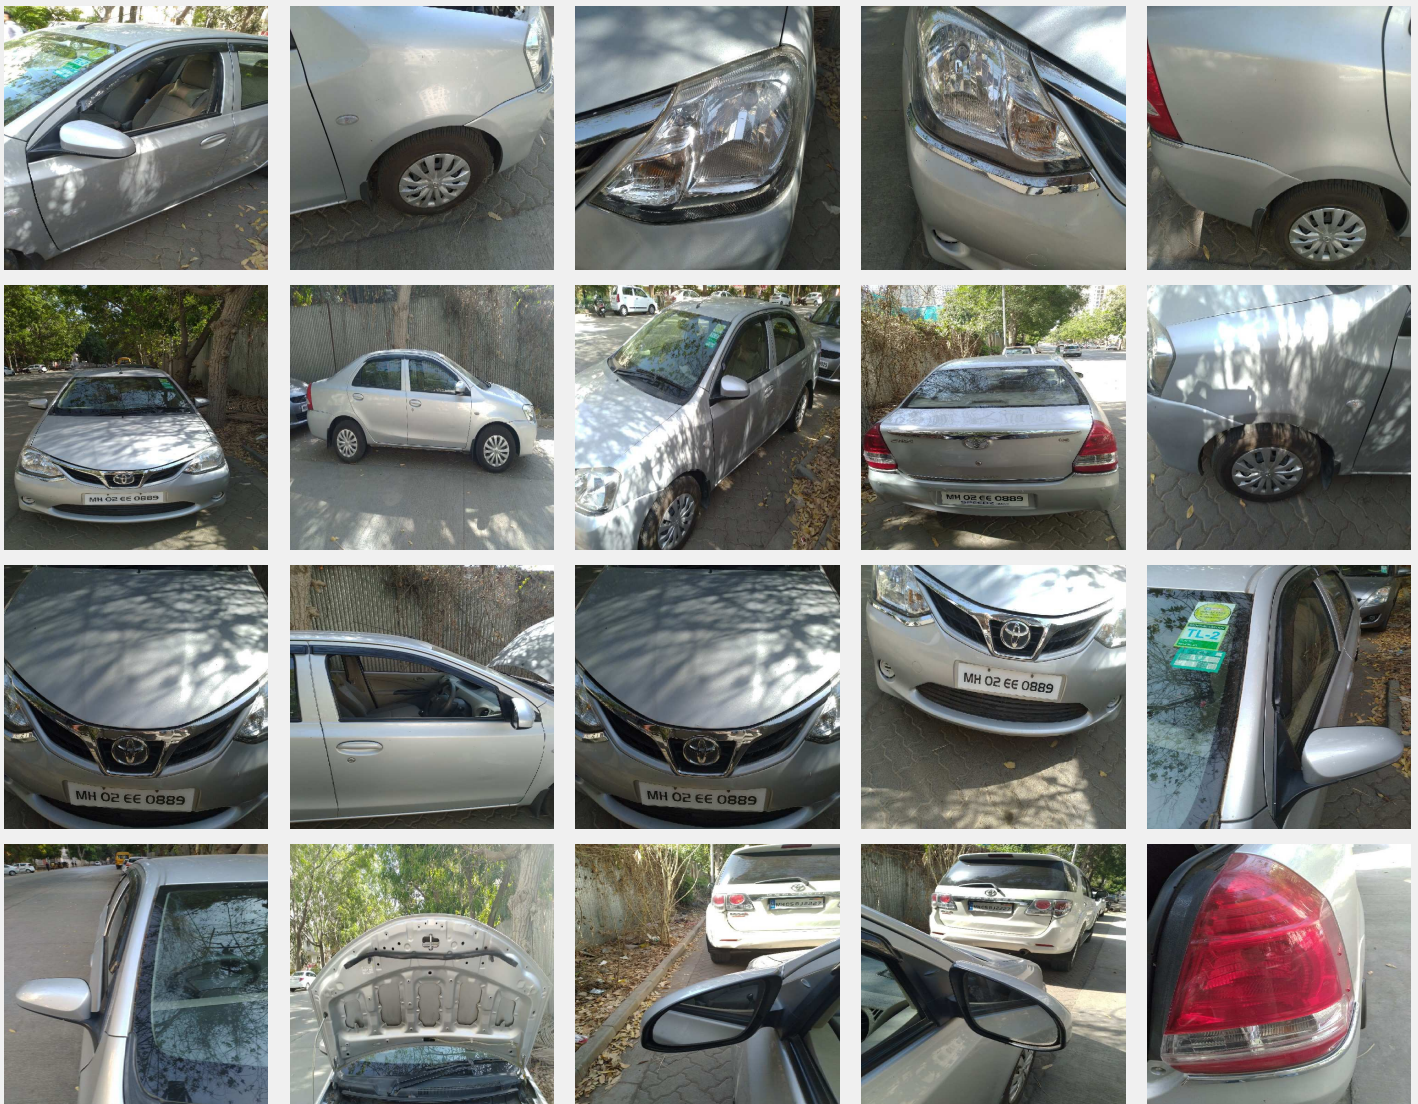
IMAGES

INSPECTION CHECKPOINTS	SCORE(X/10)	REMARKS/COMMENTS	OPTIONAL SPEND EST. (RS)
BODY RUST	6	NOT AVAILABLE	0
ROOF (REGULAR)	6	NO DAMAGE	0
PAINT CONDITION	6	GOOD CONDITION	0
LH QUARTER PANEL	5	AVERAGE CONDITION	0
REAR BUMPER	5	AVERAGE CONDITION	0
