ECO INSPECTION CERTIFICATE

Order ID : 74952

121 Points Vehicle Inspection Certificate

Tata Safari 4X2 LX, 2005

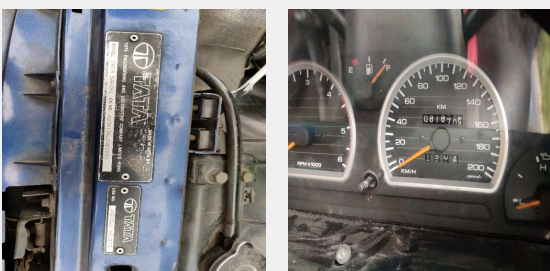
IMAGES

INSPECTION CHECKPOINTS	SCORE(X/10)	REMARKS/COMMENTS	OPTIONAL SPEND EST. (RS)
STEERING PERFORMANCE	7		0
BRAKE PERFORMANCE	7		0
CLUTCH PERFORMANCE	6		0
ENGINE NOISE	7		0
IGNITION SYSTEM	6		0
SUSPENSION PERFORMANCE	6		0
SUSPENSION FRONT SHOCKS	7		0
SUSPENSION REAR SHOCKS	6		0
TRANSMISSION ENGAGE	7		0
CRUISE CONTROL (NO)	10		0
REAR PARKING SENSORS (NO)	10		0
REAR VIEW CAMERA (NO)	10		0

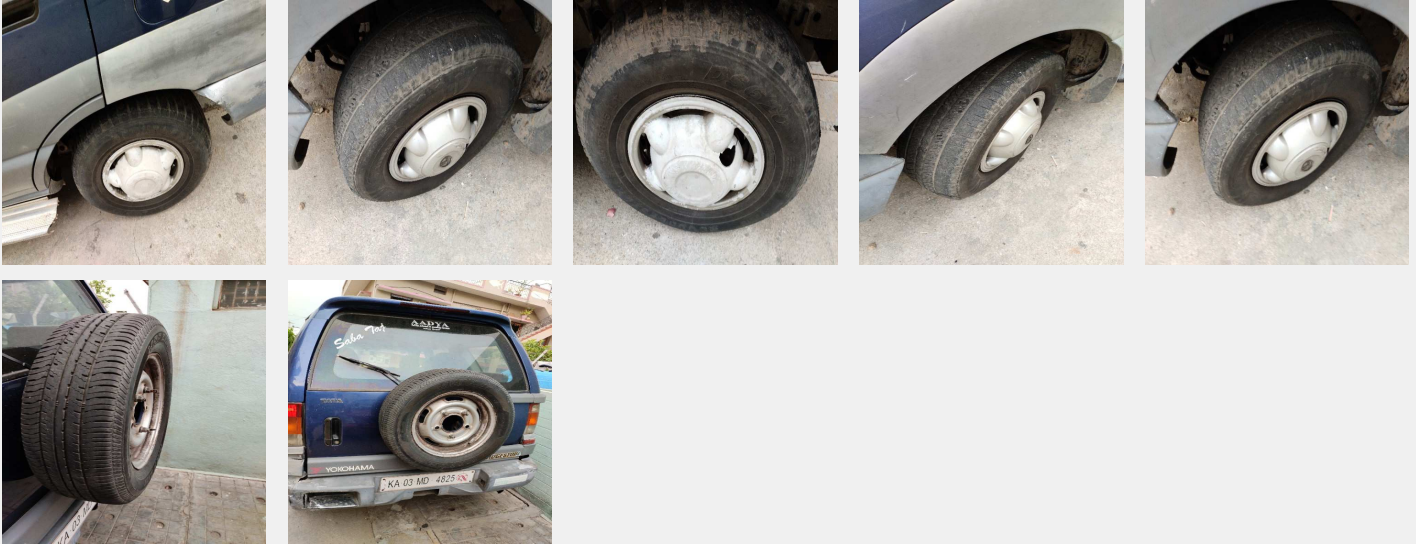
IMAGES

INSPECTION CHECKPOINTS	SCORE(X/10)	REMARKS/COMMENTS	OPTIONAL SPEND EST. (RS)
TYRES	7		0
SPARE TYRE (YES)	7		0
WHEEL ASSEMBLY (STEEL RIM)	7		0

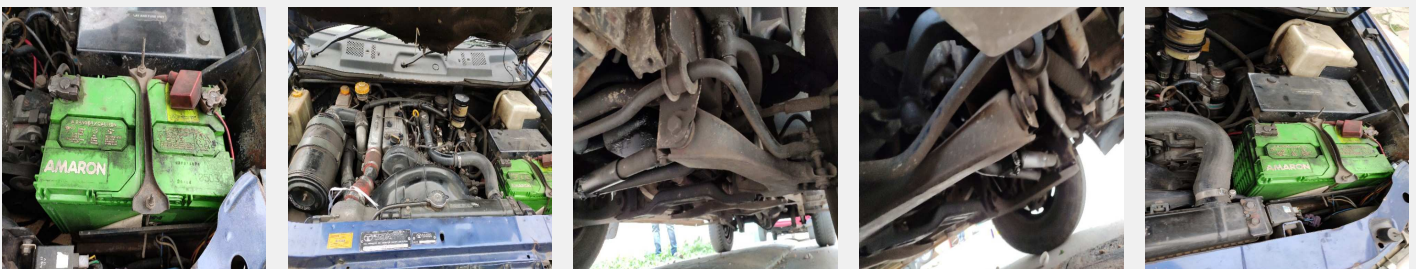
IMAGES

INSPECTION CHECKPOINTS	SCORE(X/10)	REMARKS/COMMENTS	OPTIONAL SPEND EST. (RS)
LH APRON	7		0
RH APRON	7		0
RADIATOR	7		0
WIRING	7		0
BATTERY	7		0
BRAKE FLUID LEVEL	7		0
ENGINE OIL	6		0
COOLANT LEVEL	7		0
BRAKE & COOLANT HOSE PIPES	7		0
UNDERCARRIAGE	7		0
EXHAUST SYSTEM	7		0

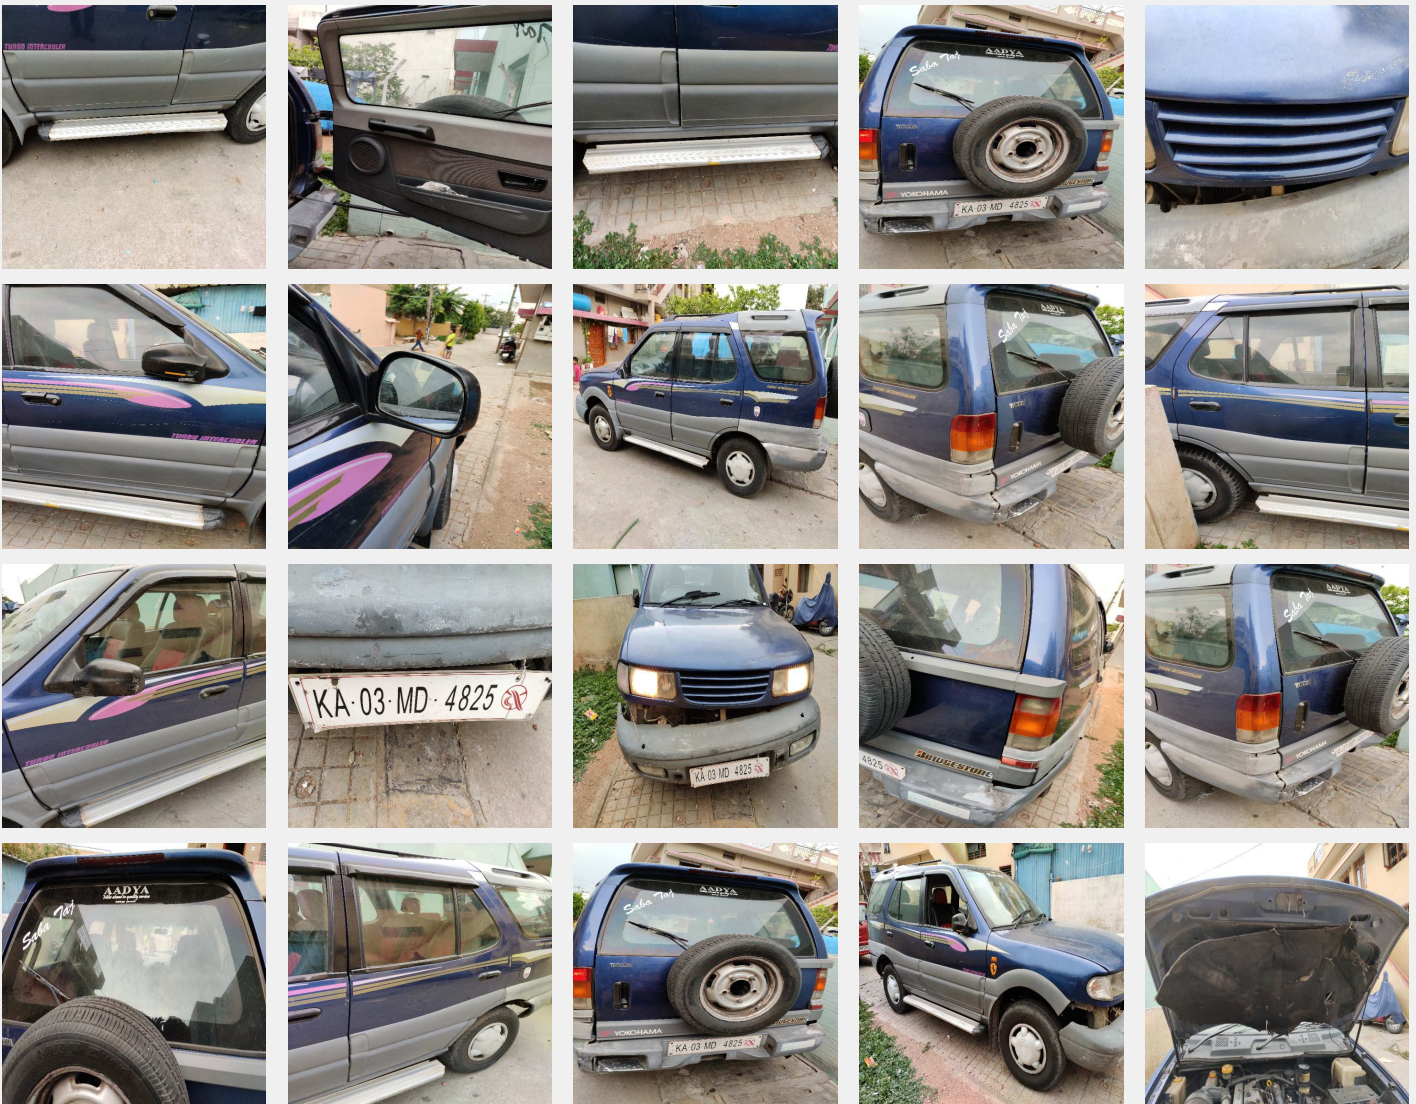
IMAGES

INSPECTION CHECKPOINTS	SCORE(X/10)	REMARKS/COMMENTS	OPTIONAL SPEND EST. (RS)
RH FENDER	7		0
BODY RUST	7		0
ROOF (REGULAR)	7		0
PAINT CONDITION	6		0
FRONT BUMPER	3	BUMPER NEED TO BE REPLACED	5000
