ECO INSPECTION CERTIFICATE

Order ID : 73242

121 Points Vehicle Inspection Certificate

Bajaj Pulsar 150cc, 2004

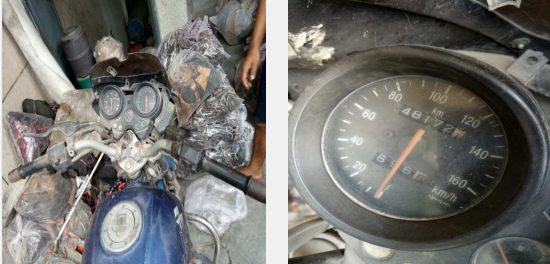
CONTROL

INSPECTION CHECKPOINTS	SCORE(X/10)	REMARKS/COMMENTS	OPTIONAL SPEND EST. (RS)
HANDLEBARS CONDITION	7	GOOD	0
LEVERS & PEDAL CONDITION	7	GOOD	0
PIVOTS	7	GOOD	0
CABLES CONDITION	6	FAIR	0
CABLES ROUTING	6	FAIR	0
HOSES CONDITION	6	FAIR	0
HOSES ROUTING	6	FAIR	0
THROTTLE OPERATION	7	GOOD	0

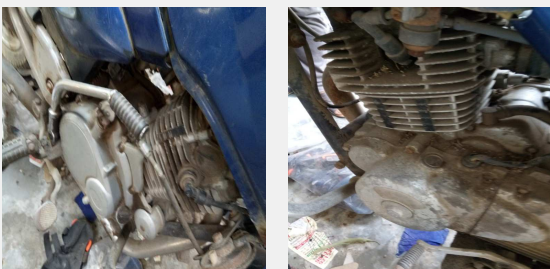
INSPECTION CHECKPOINTS	SCORE(X/10)	REMARKS/COMMENTS	OPTIONAL SPEND EST. (RS)
LEVELS - ENGINE OIL	6	FAIR	0
LEVELS - GEAR OIL/SHAFT DRIVE (YES)	6	FAIR	0
LEVELS - HYDRAULIC FLUID (NO)	10		0
LEVELS - COOLANT (NO)	10		0
LEVELS - FUEL	6	FAIR	0
LEAKS - ENGINE OIL	6	FAIR	0
LEAKS - GEAR OIL	6	FAIR	0
LEAKS - FUEL	6	FAIR	0
LEAKS - HYDRAULIC FLUID	0	NA	0
LEAKS - COOLANT	0	NA	0

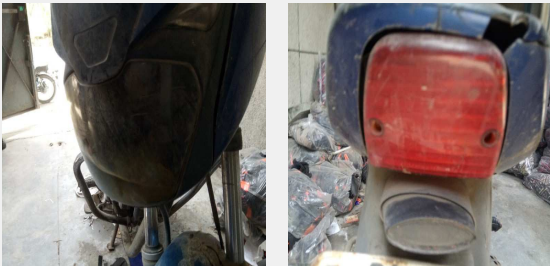
INSPECTION CHECKPOINTS	SCORE(X/10)	REMARKS/COMMENTS	OPTIONAL SPEND EST. (RS)
BATTERY VENT TUBE	6	FAIR	0
SWITCHES OPERATION	7	GOOD	0
LENSES & REFLECTORS CONDITION	7	GOOD	0
WIRING CONDITION	7	GOOD	0
WIRING ROUTING	7	GOOD	0
BATTERY CONDITION	4	DISCHARGE NEED TO CHARGE	300
HEADLAMP CONDITION	5	NOT WORKING NEED TO CHANGE BULB	100
TAILLAMP/BRAKELAMP CONDITION	5	NOT WORKING NEED TO CHANGE BULB	100
TAILLAMP/BRAKELAMP OPERATION	0	NOT WORKING NEED TO CHANGE BULB	0
TURN SIGNALS OPERATION FRONT LEFT	4	NOT WORKING NEED TO CHANGE	50
TURN SIGNALS OPERATION FRONT RIGHT	3	NOT WORKING NEED TO CHANGE	50
TURN SIGNALS OPERATION REAR LEFT	3	NOT WORKING NEED TO CHANGE	50
TURN SIGNALS OPERATION REAR RIGHT	3	NOT WORKING NEED TO CHANGE	50
MIRRORS CONDITION	0	NOT FIX MIRROR NEED TO FIX NEW MIRROR FIX	300
MIRRORS AIM	0	NOT FIX MIRROR NEED TO FIX NEW MIRROR FIX	0
