ECO INSPECTION CERTIFICATE

121 Points Vehicle Inspection Certificate

Ordered By : SUDHIR KUMAR MANOCHA	Inspection Date : 2019-06-03	Location : FARIDABAD
---	--	--------------------------------

Fiat Punto EMOTION 1.2, 2009

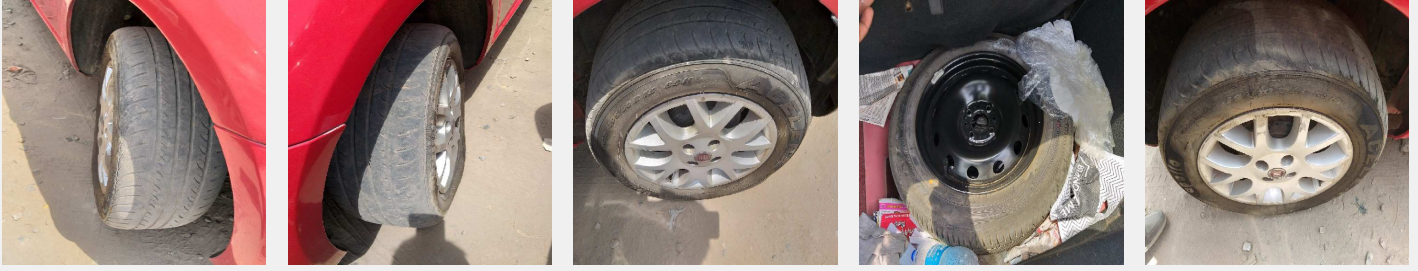
IMAGES

INSPECTION CHECKPOINTS	SCORE(X/10)	REMARKS/COMMENTS	OPTIONAL SPEND EST. (RS)
TYRES	7	GOOD	0
SPARE TYRE (YES)	6	FAIR	0
WHEEL ASSEMBLY (ALLOY RIM)	6	FAIR	0

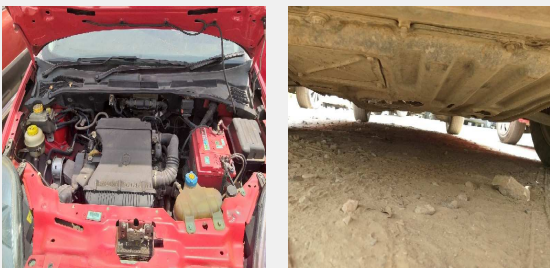
IMAGES

INSPECTION CHECKPOINTS	SCORE(X/10)	REMARKS/COMMENTS	OPTIONAL SPEND EST. (RS)
LH APRON	6	FAIR	0
RH APRON	6	FAUR	0
RADIATOR	6	FAIR	0
WIRING	6	FAIR	0
BATTERY	6	FAIR	0
BRAKE FLUID LEVEL	6	FAIR	0
ENGINE OIL	6	FAIR	0
COOLANT LEVEL	6	FAIR	0
BRAKE & COOLANT HOSE PIPES	6	FAIR	0
UNDERCARRIAGE	6	FAIR	0
EXHAUST SYSTEM	6	FAIR	0

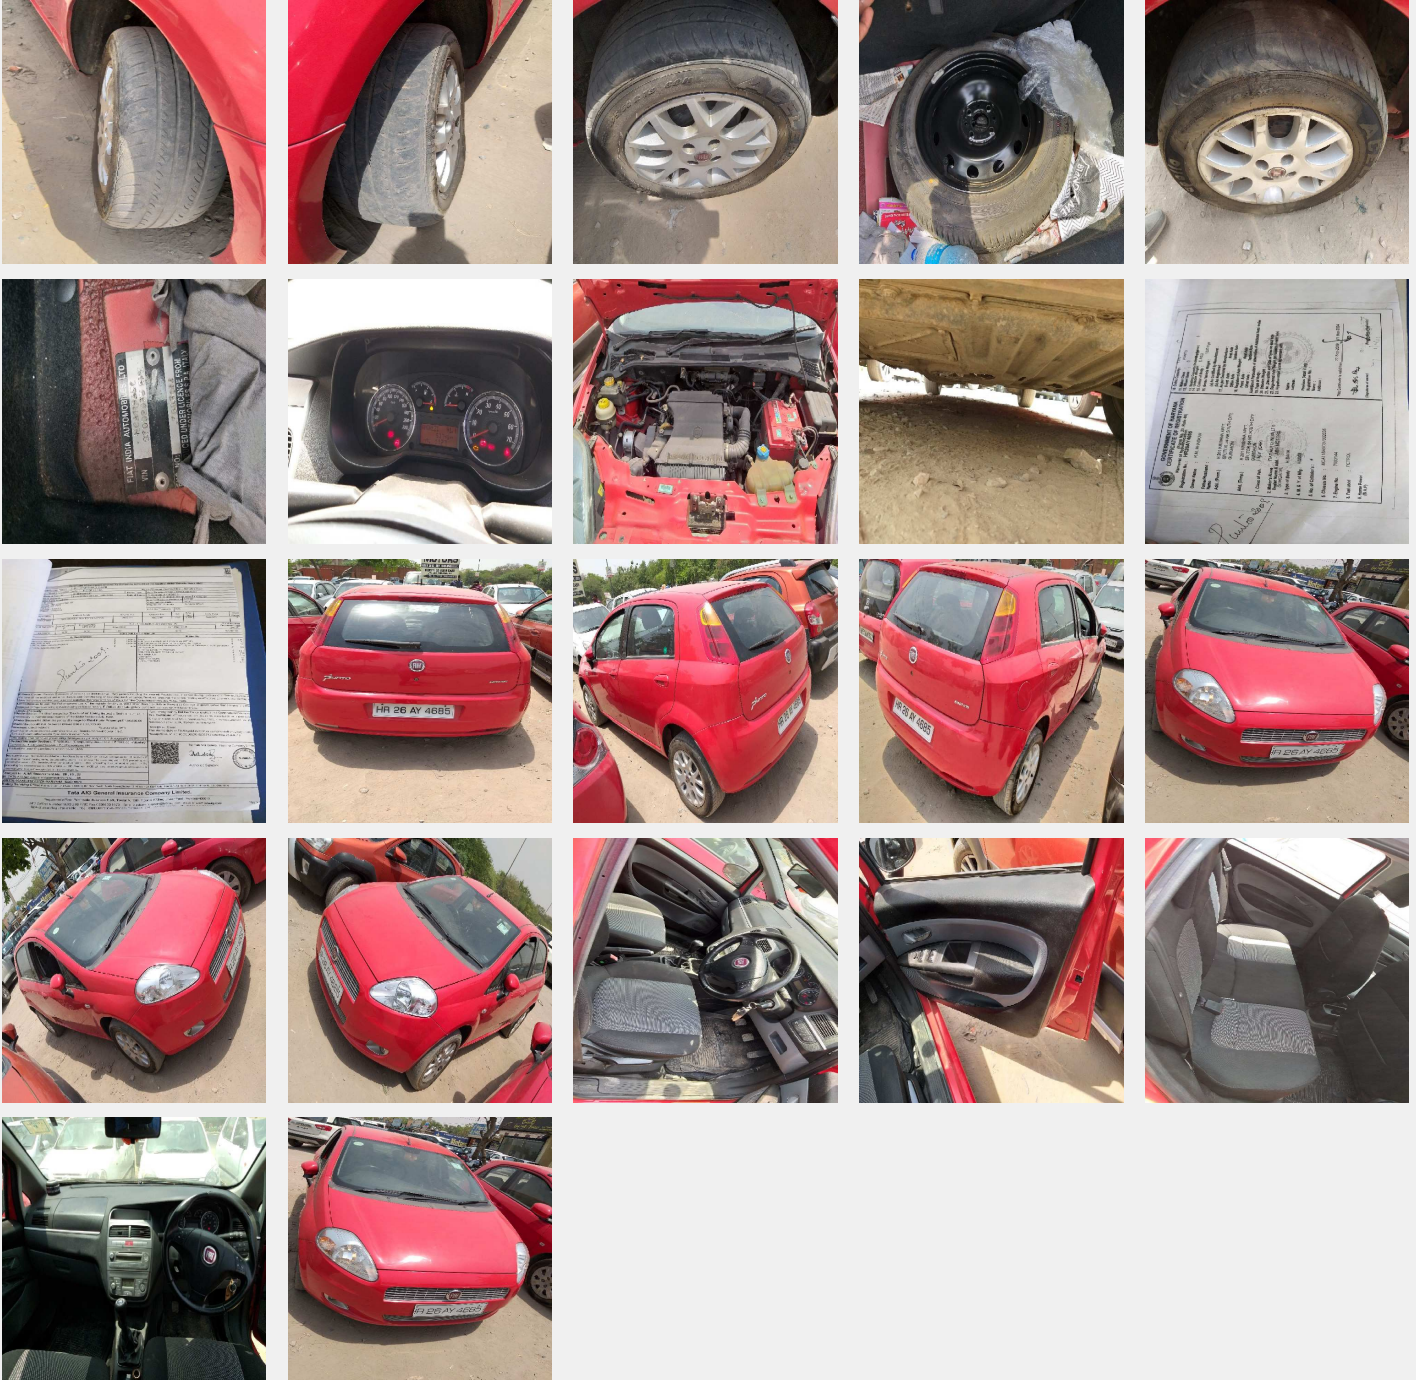
IMAGES

fair condition,, minor scratch,, interior and exterior dirty
