ECO INSPECTION CERTIFICATE

Order ID : 76795

121 Points Vehicle Inspection Certificate

Hyundai I10 Sportz 1.2 Kappa2, 2011

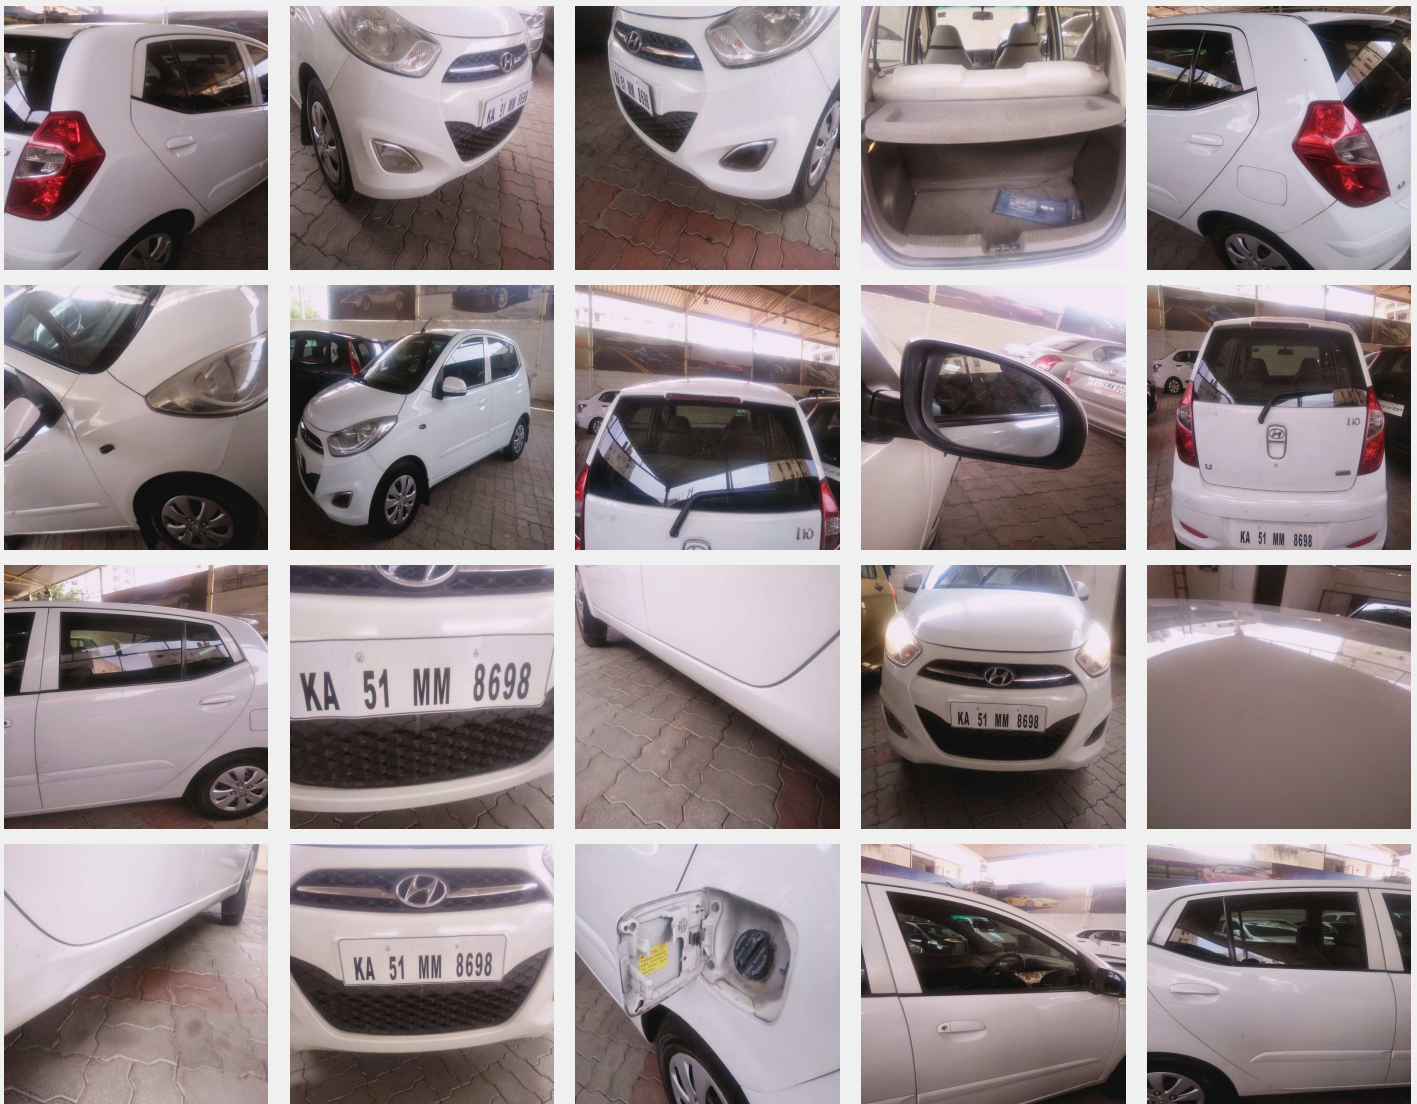
EXTERIOR (CONTINUED)

INSPECTION CHECKPOINTS	SCORE(X/10)	REMARKS/COMMENTS	OPTIONAL SPEND EST. (RS)
BODY RUST	8		0
ROOF (REGULAR)	8		0
PAINT CONDITION	8		0
FOG LAMPS	2	NOT WORKING	2500
TRUNK LID/TAIL GATE	5	SHOCKS WEEK	4000
