# ECO INSPECTION CERTIFICATE

Order ID : 78566

121 Points Vehicle Inspection Certificate

## Audi Q5 2.0 TDI TECHNOLOGY, 2013

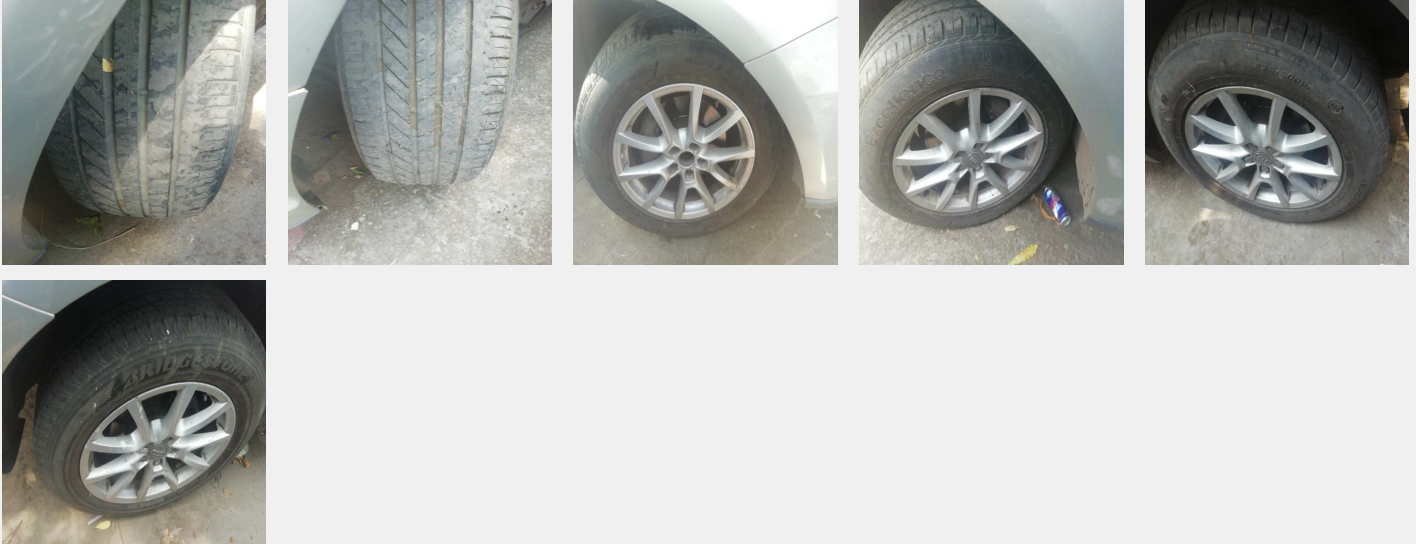
IMAGES

INSPECTION CHECKPOINTS	SCORE(X/10)	REMARKS/COMMENTS	OPTIONAL SPEND EST. (RS)
TYRES	6		0
SPARE TYRE (NO)	10		0
WHEEL ASSEMBLY (ALLOY RIM)	6		0

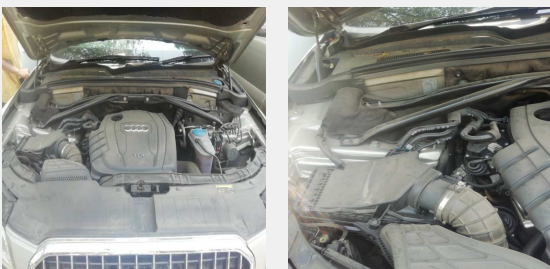
IMAGES

INSPECTION CHECKPOINTS	SCORE(X/10)	REMARKS/COMMENTS	OPTIONAL SPEND EST. (RS)
LH APRON	7		0
RH APRON	7		0
RADIATOR	7		0
WIRING	7		0
BATTERY	7		0
BRAKE FLUID LEVEL	7		0
ENGINE OIL	7		0
COOLANT LEVEL	7		0
BRAKE & COOLANT HOSE PIPES	7		0
UNDERCARRIAGE	7		0
EXHAUST SYSTEM	7		0

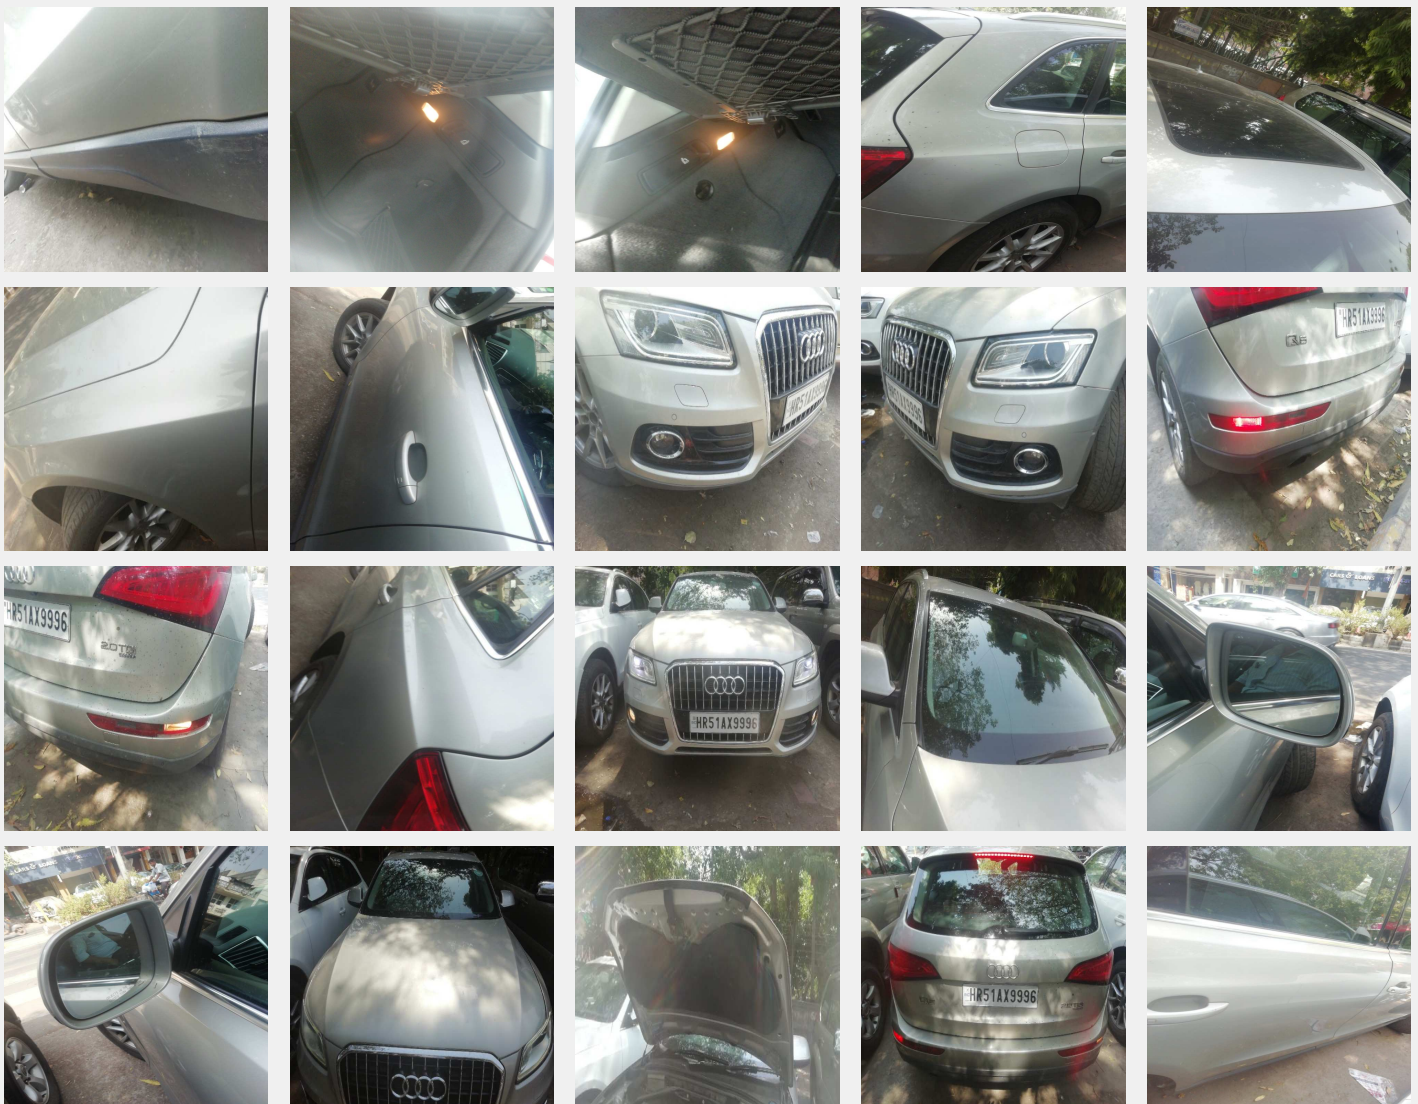
## IMAGES

INSPECTION CHECKPOINTS	SCORE(X/10)	REMARKS/COMMENTS	OPTIONAL SPEND EST. (RS)
RH FRONT DOOR	7		0
RH FENDER	7		0
BODY RUST	7		0
ROOF (SUN ROOF)	7		0
PAINT CONDITION	7		0
