ECO INSPECTION CERTIFICATE

121 Points Vehicle Inspection Certificate

Ordered By : Sourabh	Inspection Date : 2019-06-07	Location : PUNE

Renault Kwid RXT OPT, 2016

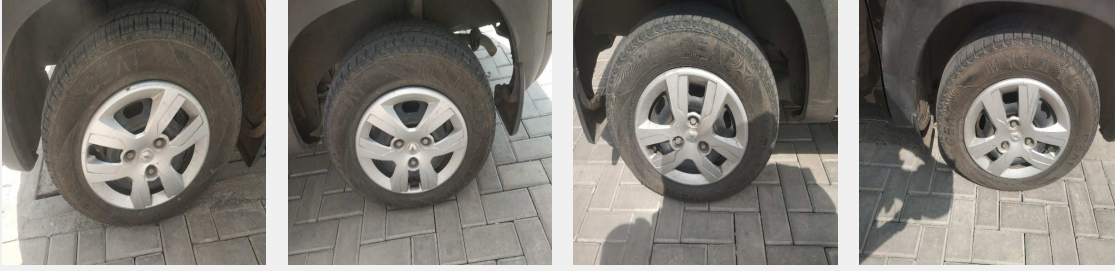
IMAGES

INSPECTION CHECKPOINTS	SCORE(X/10)	REMARKS/COMMENTS	OPTIONAL SPEND EST. (RS)
TYRES	7	BETTER CONDITION	0
SPARE TYRE (YES)	7	GOOD	0
WHEEL ASSEMBLY (STEEL RIM)	7	GOOD CONDITION	0

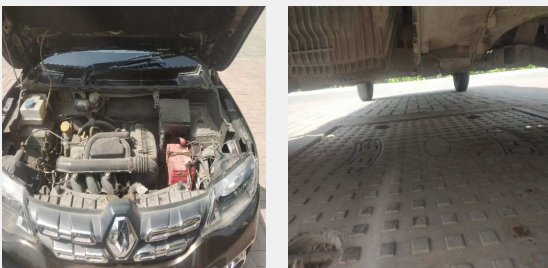
IMAGES

INSPECTION CHECKPOINTS	SCORE(X/10)	REMARKS/COMMENTS	OPTIONAL SPEND EST. (RS)
LH APRON	7	GOOD	0
RH APRON	7	GOOD	0
RADIATOR	7	GOOD	0
WIRING	7	GOOD	0
BATTERY	7	GOOD	0
BRAKE FLUID LEVEL	7	MAX	0
ENGINE OIL	8	MAX	0
COOLANT LEVEL	7	MAX	0
BRAKE & COOLANT HOSE PIPES	7	GOOD	0
UNDERCARRIAGE	7	NO RUSTY	0
EXHAUST SYSTEM	7	NO SMOKE	0

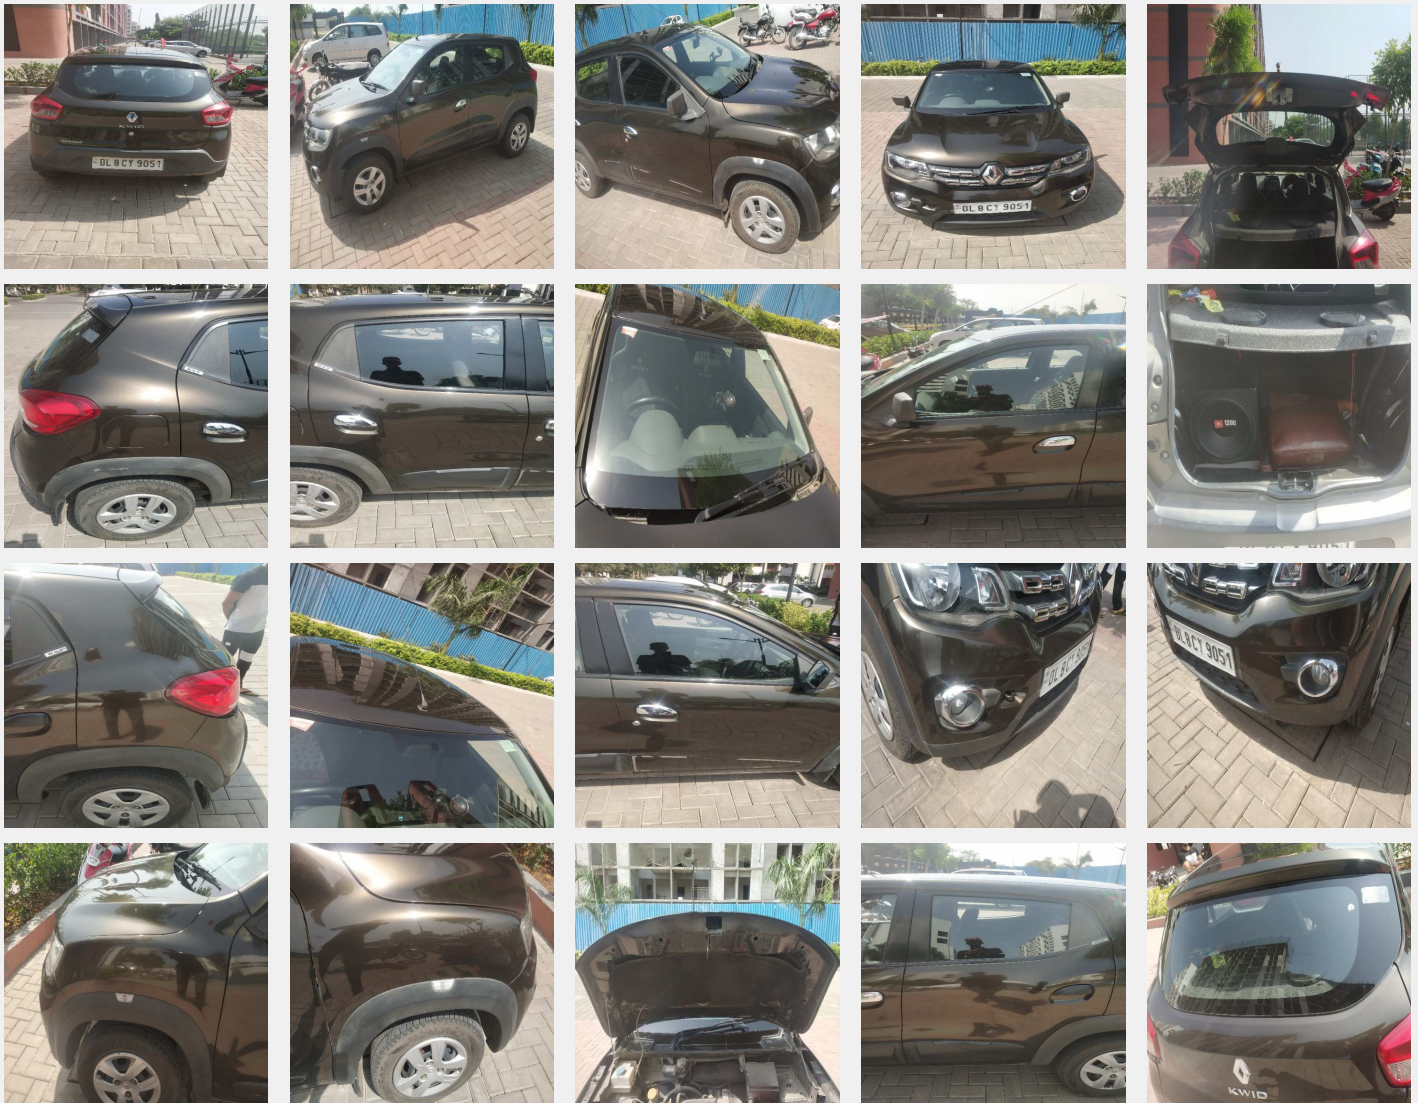
IMAGES

INSPECTION CHECKPOINTS	SCORE(X/10)	REMARKS/COMMENTS	OPTIONAL SPEND EST. (RS)
RH FRONT DOOR	8	GOOD CONDITION	0
RH FENDER	7	GOOD CONDITION	0
BODY RUST	8	NO BODY RUST	0
ROOF (REGULAR)	8	GOOD CONDITION	0
PAINT CONDITION	7	GOOD CONDITION	0
