# ECO INSPECTION CERTIFICATE

121 Points Vehicle Inspection Certificate

## Mahindra Kuv100 Nxt K6 PLUS 5 STR, 2017

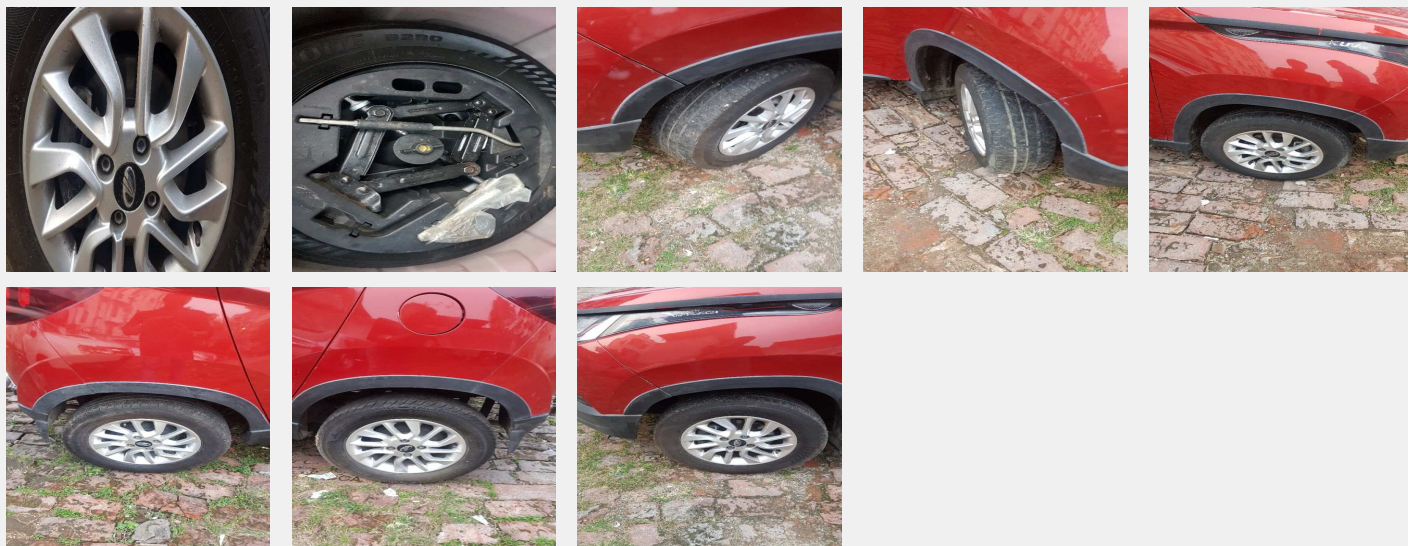
## IMAGES

INSPECTION CHECKPOINTS	SCORE(X/10)	REMARKS/COMMENTS	OPTIONAL SPEND EST. (RS)
TYRES	6	OK	0
SPARE TYRE (YES)	6	OK	0
WHEEL ASSEMBLY (ALLOY RIM)	6	OK	0

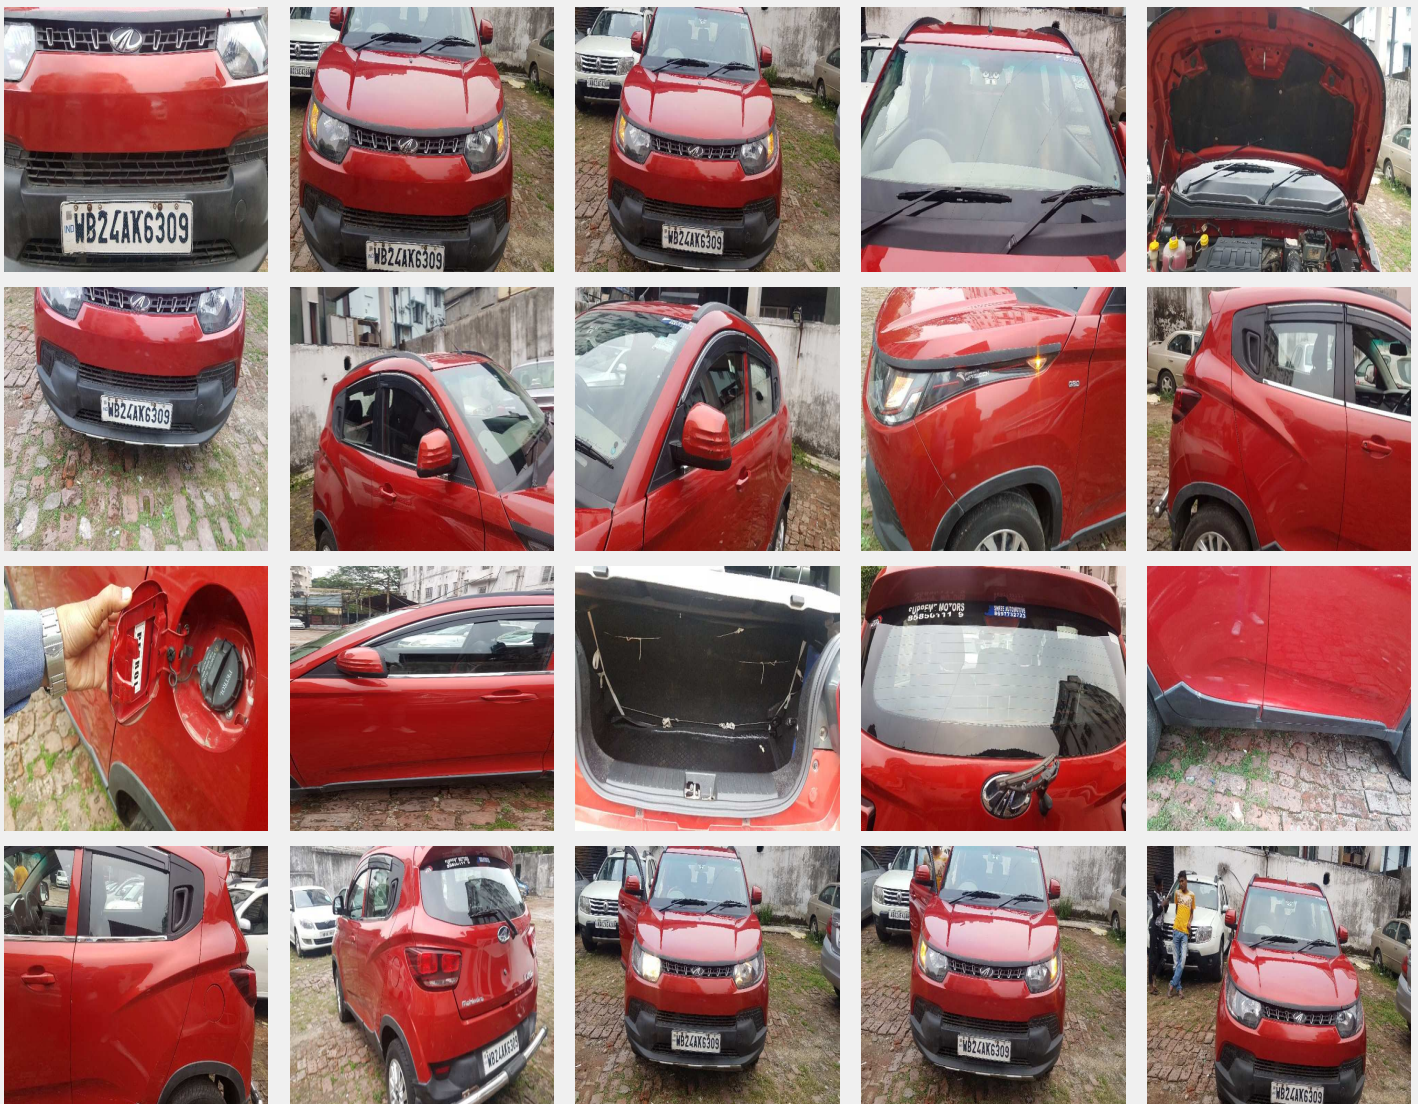
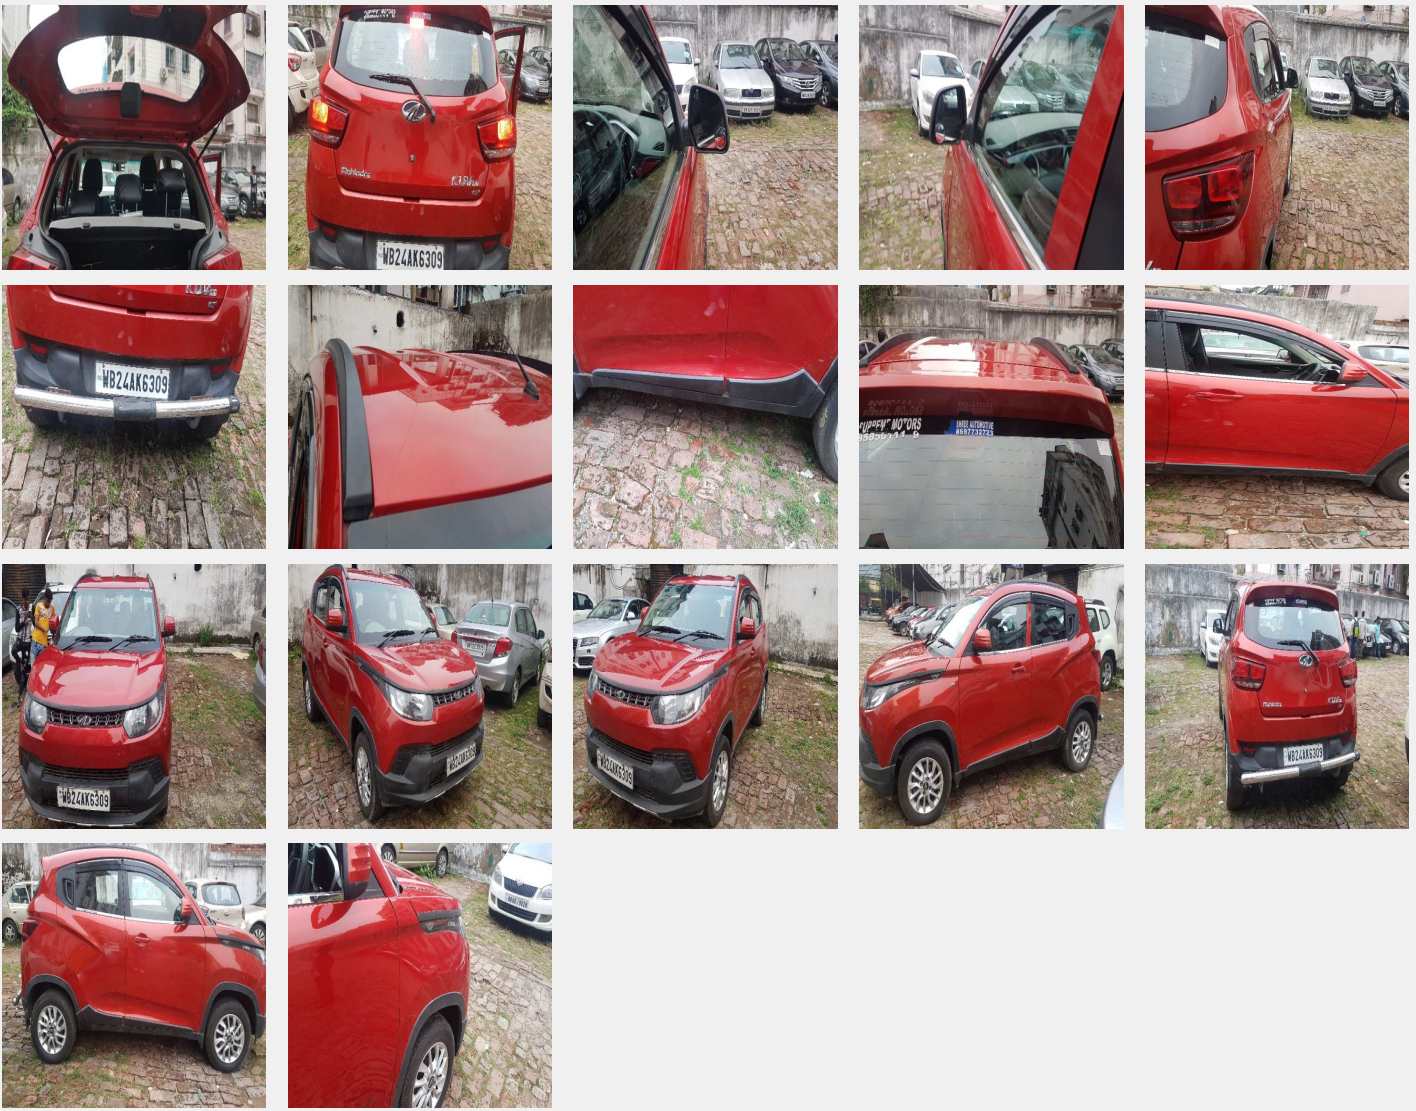
## IMAGES

INSPECTION CHECKPOINTS	SCORE(X/10)	REMARKS/COMMENTS	OPTIONAL SPEND EST. (RS)
RH FRONT DOOR	6	OK	0
RH FENDER	6	OK	0
BODY RUST	6	NA	0
ROOF (REGULAR)	6	OK	0
PAINT CONDITION	6	GOOD	0
