ECO INSPECTION CERTIFICATE

Order ID : 52892

121 Points Vehicle Inspection Certificate

Mahindra Bolero SLE BS IV, 2018

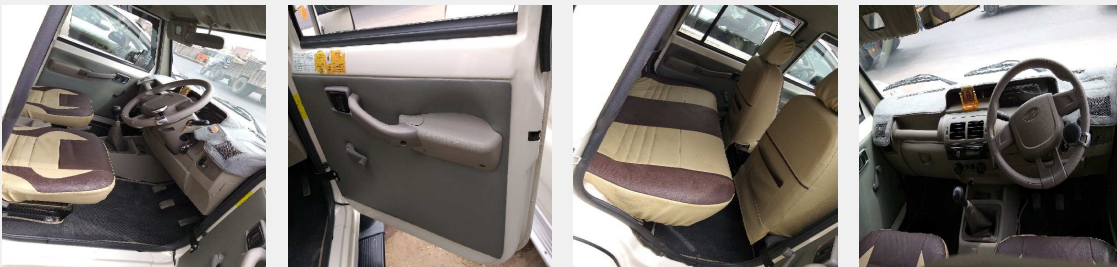
INTERIOR

INSPECTION CHECKPOINTS	SCORE(X/10)	REMARKS/COMMENTS	OPTIONAL SPEND EST. (RS)
DOOR PANEL	7	GOOD	0
DOOR HINGES	6	FAIR	0
CARPET & FLOOR MAT	6	FAIR	0
SEAT & SEAT BELT	7	GOOD	0
DASHBOARD & INSTRUMENT PANEL	7	GOOD	0
HORN	6	FAIR	0
SPEAKERS & MUSIC SYSTEM	6	FAIR	0
HANDBRAKE	6	FAIR	0
STEERING-MOUNTED CONTROLS	6	FAIR	0
PEDALS	6	FAIR	0
CENTRAL LOCK	6	FAIR	0
A/C VENTS & HEATER	7	GOOD	0
CUP HOLDERS	6	FAIR	0
NAVIGATION (NO)	10		0
ODOMETER	6	FAIR	0
POWER WINDOWS (NO)	10		0
HAZARD LIGHT	6	FAIR	0

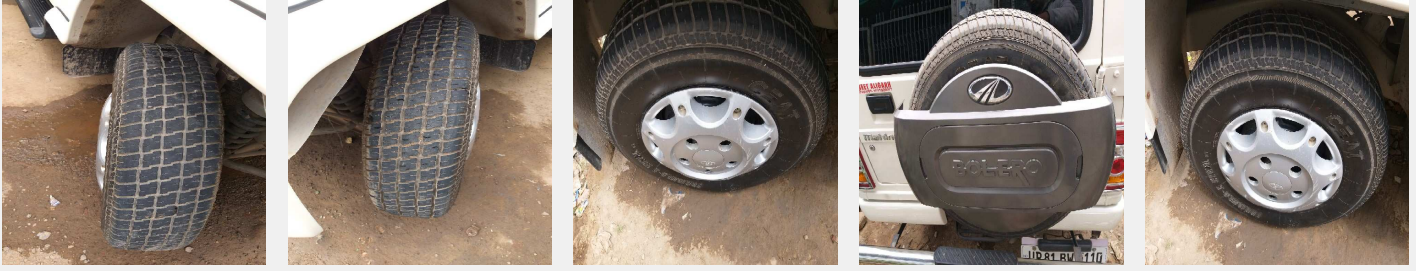
INSPECTION CHECKPOINTS	SCORE(X/10)	REMARKS/COMMENTS	OPTIONAL SPEND EST. (RS)
TYRES	7	GOOD	0
SPARE TYRE (YES)	7	GOOD	0
WHEEL ASSEMBLY (STEEL RIM)	6	FAIR	0

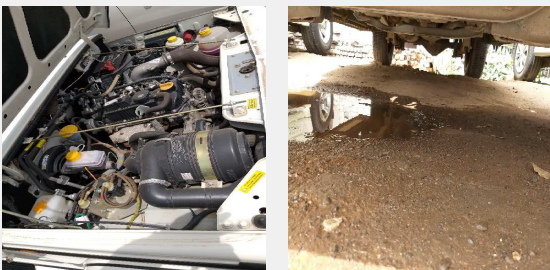
HOOD

INSPECTION CHECKPOINTS	SCORE(X/10)	REMARKS/COMMENTS	OPTIONAL SPEND EST. (RS)
LH APRON	6	FAIR	0
RH APRON	6	FAIR	0
RADIATOR	6	FAIR	0
WIRING	6	FAIR	0
BATTERY	6	FAIR	0
BRAKE FLUID LEVEL	6	FAIR	0
ENGINE OIL	6	FAIR	0
COOLANT LEVEL	6	FAIR	0
BRAKE & COOLANT HOSE PIPES	6	FAIR	0
UNDERCARRIAGE	6	FAIR	0
EXHAUST SYSTEM	6	FAIR	0

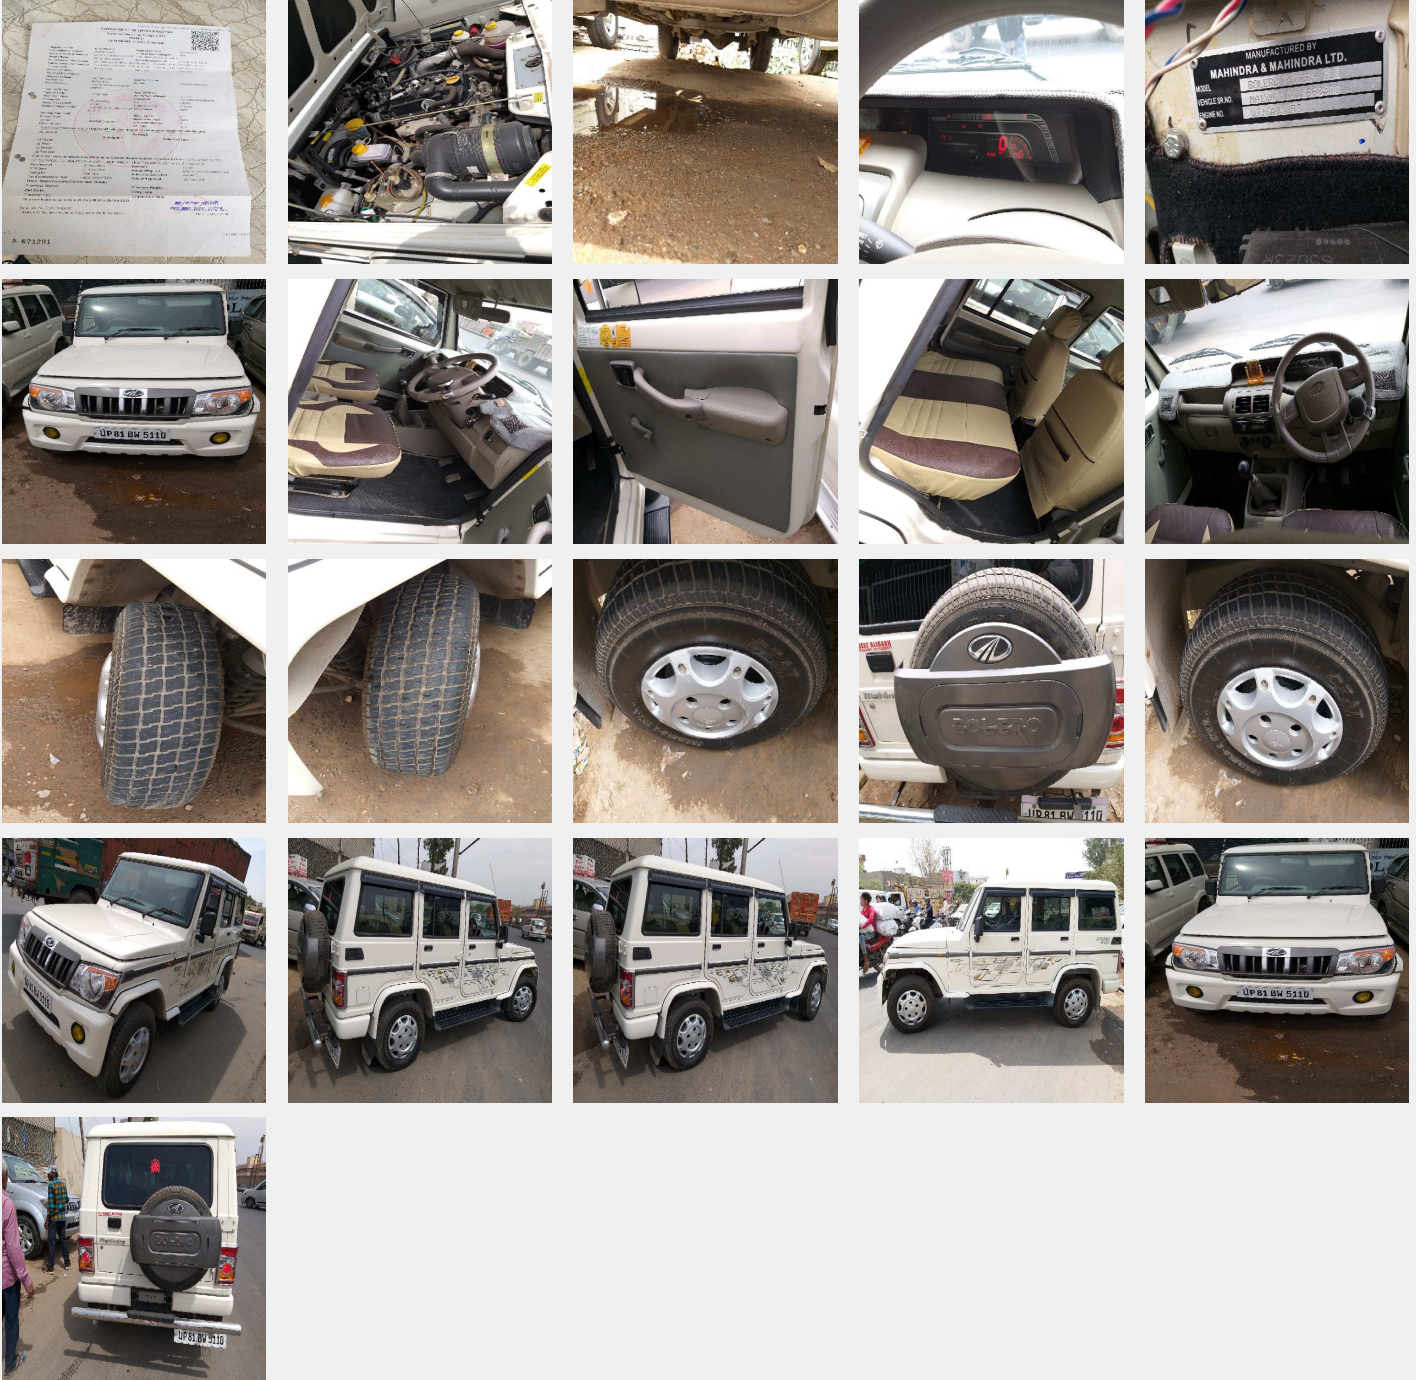
INSPECTION CHECKPOINTS	SCORE(X/10)	REMARKS/COMMENTS	OPTIONAL SPEND EST. (RS)
LICENSE PLATE	6	FAIR	0
FRONT BUMPER	6	MINOR SCRATCH	0
HEAD LIGHTS	6	FAIR	0
GRILLE	6	FAIR	0
TURN SIGNAL	6	FAIR	0
FOG LAMPS	6	NOT WORKING	1000
HOOD	6	FAIR	0
PILLAR	6	FAIR	0
FRONT WINDSHIELD	6	FAIR	0
SIDE VIEW MIRRORS	6	FAIR	0
LH FENDER	6	FAIR	0
LH FRONT DOOR	6	FAIR	0
LH REAR DOOR	6	FAIR	0
LH RUNNING BOARD	6	FAIR	0
LH QUARTER PANEL	6	FAIR	0
FUEL LID	6	FAIR	0
REAR WINDSHIELD	6	FAIR	0
REAR BUMPER	6	FAIR	0
TAIL LIGHT	6	FAIR	0
TRUNK LID/TAIL GATE	6	FAIR	0
LUGGAGE COMPARTMENT LIGHT	6	FAIR	0
RH QUARTER PANEL	6	MINOR SCRATCH	0
RH RUNNING BOARD	6	FAIR	0
RH REAR DOOR	6	MINOR SCRATCH	0

INSPECTION CHECKPOINTS	SCORE(X/10)	REMARKS/COMMENTS	OPTIONAL SPEND EST. (RS)
RH FRONT DOOR	6	FAIR	0
RH FENDER	6	FAIR	0
BODY RUST	6	MINOR	0
ROOF (REGULAR)	6	FAIR	0
PAINT CONDITION	6	FAIR	0

good condition ,,minor scratch
