ECO INSPECTION CERTIFICATE

Order ID : 47275

121 Points Vehicle Inspection Certificate

Fiat Punto DYNAMIC 1.2, 2010

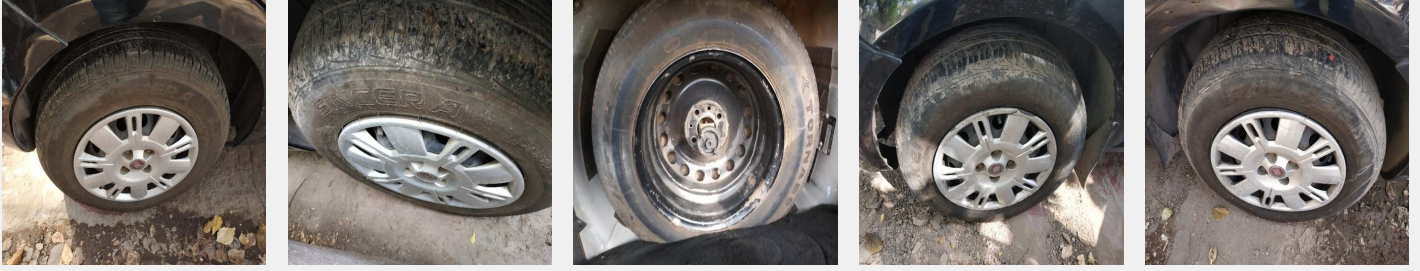
IMAGES

| INSPECTION CHECKPOINTS | SCORE(X/10) | REMARKS/COMMENTS | OPTIONAL SPEND EST. (RS) |
|---|---|---|---|
| TYRES | 7 | GOOD | 0 |
| SPARE TYRE (YES) | 7 | GOOD | 0 |
| WHEEL ASSEMBLY (STEEL RIM) | 7 | GOOD | 0 |

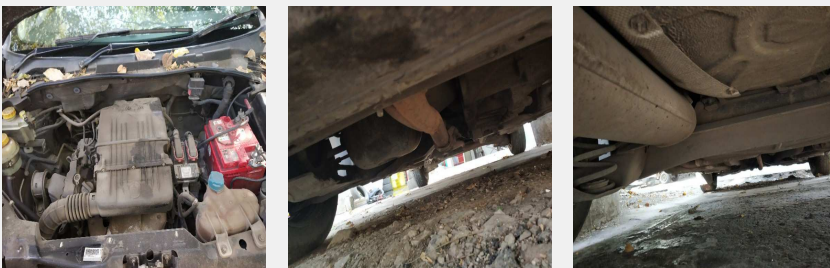
IMAGES

| INSPECTION CHECKPOINTS | SCORE(X/10) | REMARKS/COMMENTS | OPTIONAL SPEND EST. (RS) |
|---|---|---|---|
| LH APRON | 7 | GOOD | 0 |
| RH APRON | 7 | GOOD | 0 |
| RADIATOR | 7 | GOOD | 0 |
| WIRING | 7 | GOOD | 0 |
| BATTERY | 7 | GOOD | 0 |
| BRAKE FLUID LEVEL | 7 | GOOD | 0 |
