ECO INSPECTION CERTIFICATE

Order ID : 48393

121 Points Vehicle Inspection Certificate

Honda City 1.5 V Mt, 2010

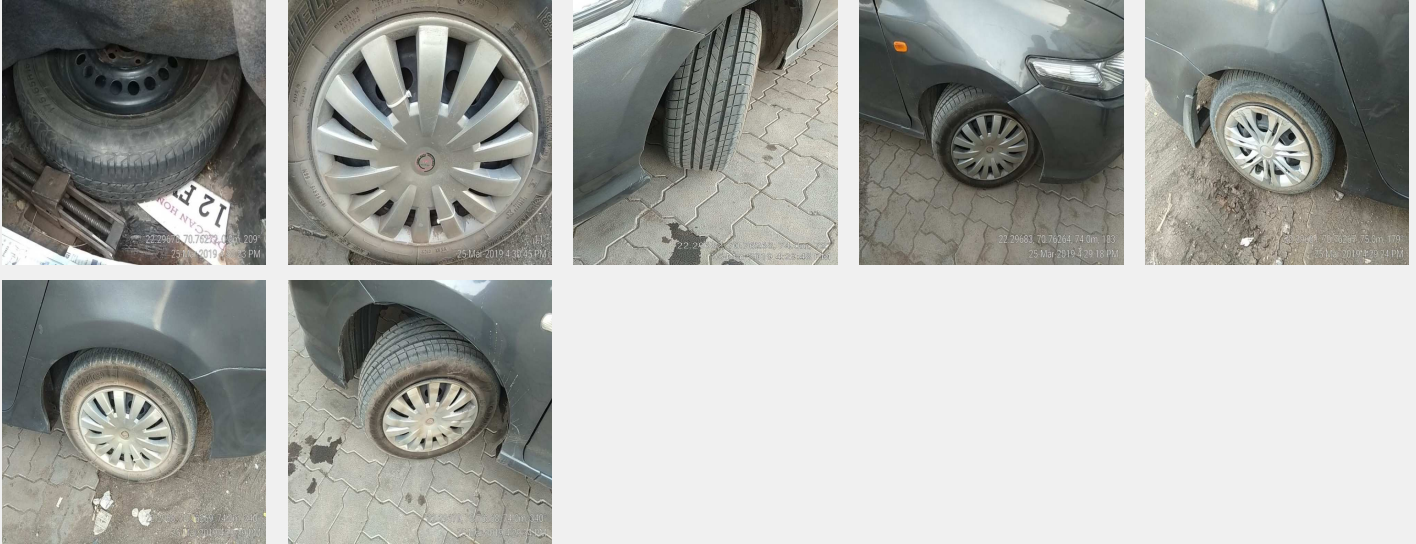
INSPECTION CHECKPOINTS	SCORE(X/10)	REMARKS/COMMENTS	OPTIONAL SPEND EST. (RS)
TYRES	6		0
SPARE TYRE (YES)	6		0
WHEEL ASSEMBLY (ALLOY RIM)	6		0

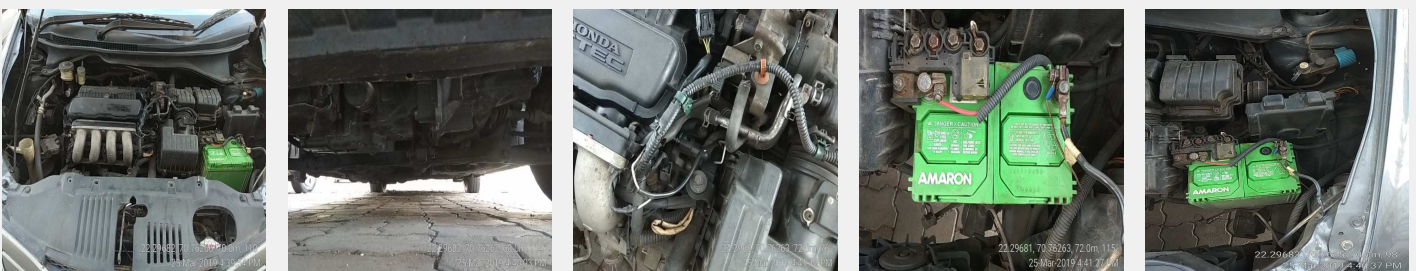
HOOD

INSPECTION CHECKPOINTS	SCORE(X/10)	REMARKS/COMMENTS	OPTIONAL SPEND EST. (RS)
LH APRON	6		0
RH APRON	6		0
RADIATOR	6		0
WIRING	6		0
BATTERY	7		0
BRAKE FLUID LEVEL	6		0
ENGINE OIL	6		0
COOLANT LEVEL	6		0
BRAKE & COOLANT HOSE PIPES	6		0
UNDERCARRIAGE	6		0
EXHAUST SYSTEM	6		0

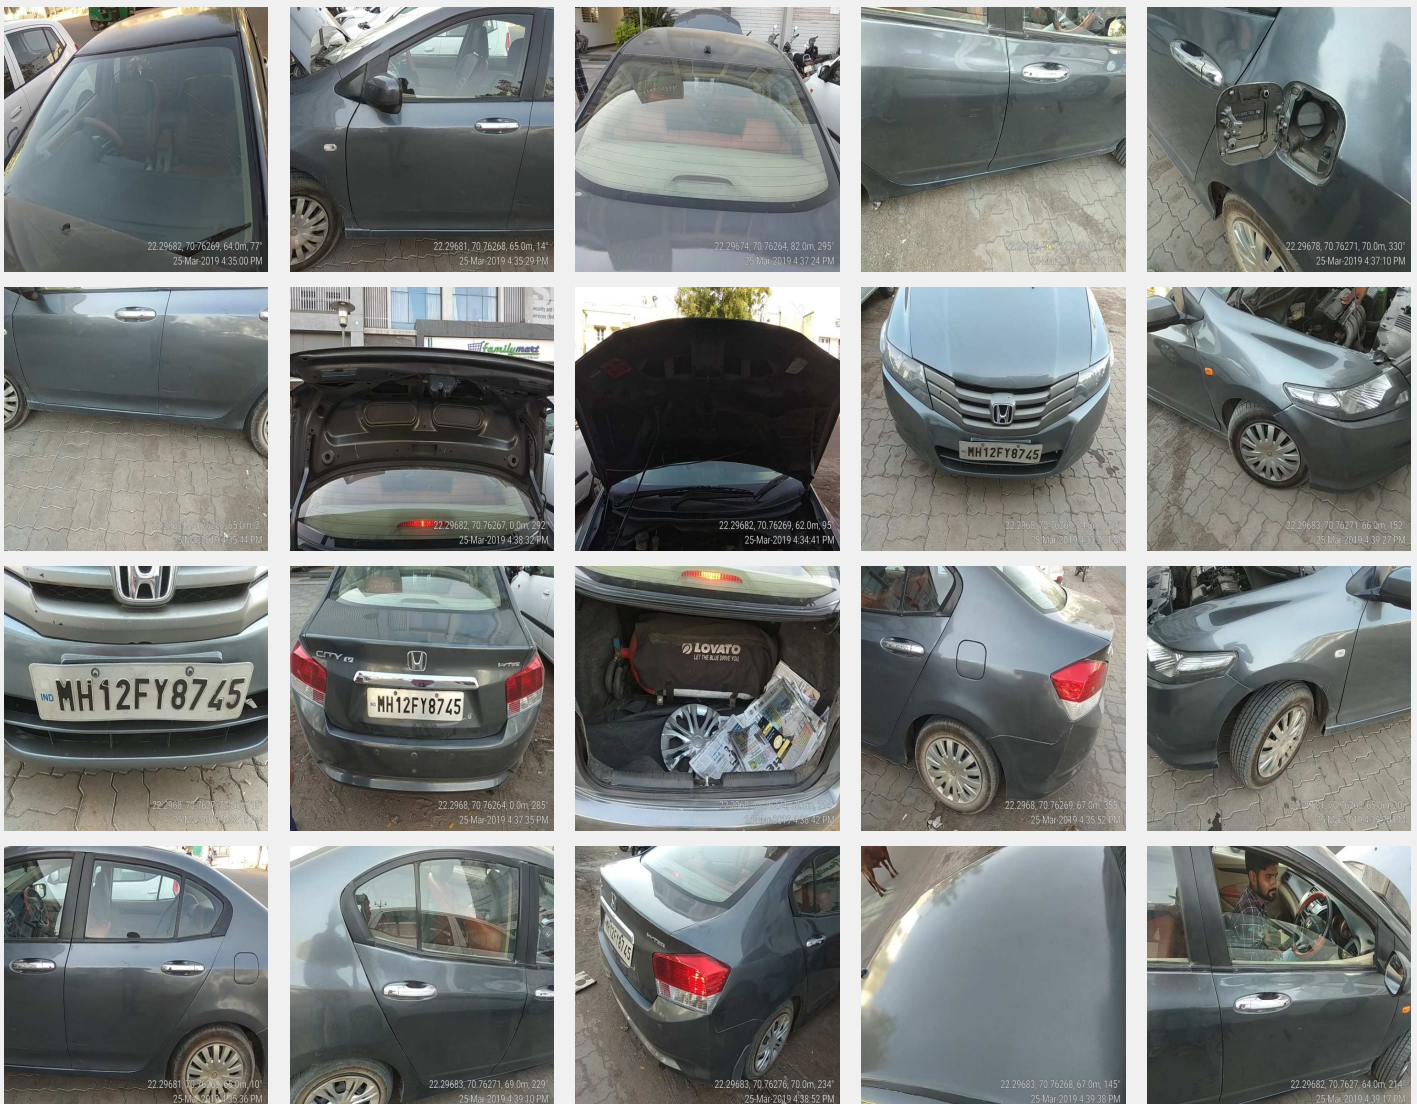
EXTERIOR (CONTINUED)

INSPECTION CHECKPOINTS	SCORE(X/10)	REMARKS/COMMENTS	OPTIONAL SPEND EST. (RS)
RH FRONT DOOR	6		0
RH FENDER	6		0
BODY RUST	6		0
ROOF (REGULAR)	6		0
PAINT CONDITION	6		0
