# ECO INSPECTION CERTIFICATE

Order ID : 46059

121 Points Vehicle Inspection Certificate

## Mahindra Tuv300 T8 AMT, 2015

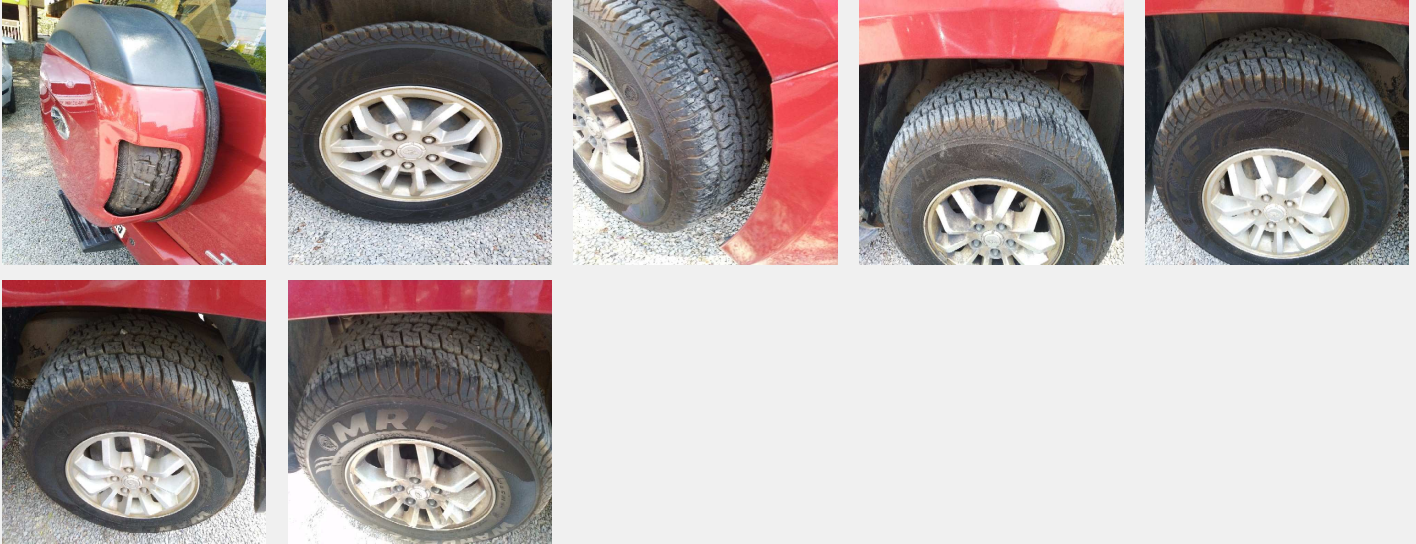
INSPECTION CHECKPOINTS	SCORE(X/10)	REMARKS/COMMENTS	OPTIONAL SPEND EST. (RS)
TYRES	10		0
SPARE TYRE (YES)	10		0
WHEEL ASSEMBLY (ALLOY RIM)	9		0

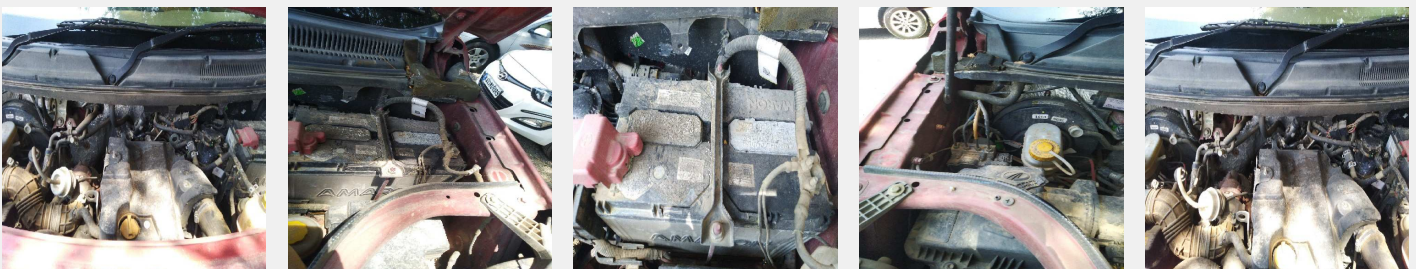
INSPECTION CHECKPOINTS	SCORE(X/10)	REMARKS/COMMENTS	OPTIONAL SPEND EST. (RS)
LH APRON	10		0
RH APRON	10		0
RADIATOR	10		0
WIRING	10		0
BATTERY	8		0
BRAKE FLUID LEVEL	10		0
ENGINE OIL	9		0
COOLANT LEVEL	9		0
BRAKE & COOLANT HOSE PIPES	10		0
UNDERCARRIAGE	10		0
EXHAUST SYSTEM	10		0

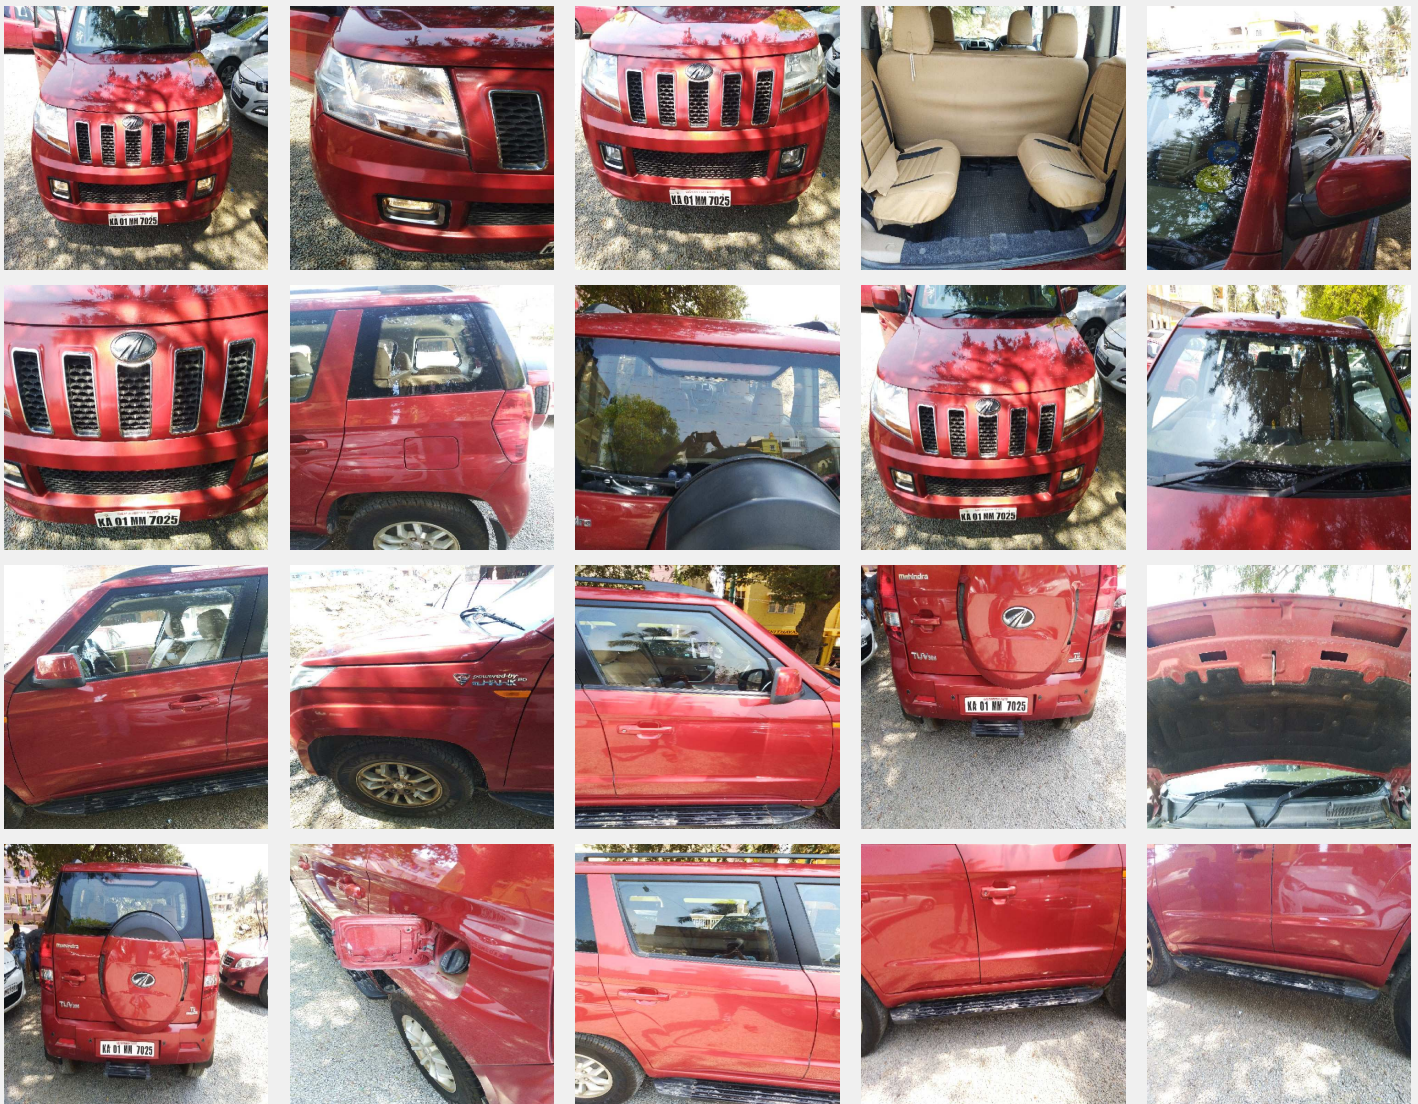
INSPECTION CHECKPOINTS	SCORE(X/10)	REMARKS/COMMENTS	OPTIONAL SPEND EST. (RS)
RH FENDER	8		0
BODY RUST	10		0
ROOF (REGULAR)	10		0
PAINT CONDITION	10		0
LICENSE PLATE	5	BROKEN	250
