ECO INSPECTION CERTIFICATE

121 Points Vehicle Inspection Certificate

Inspection Date :
2019-03-11

Harley-Davidson Forty Eight 1200cc, 2018

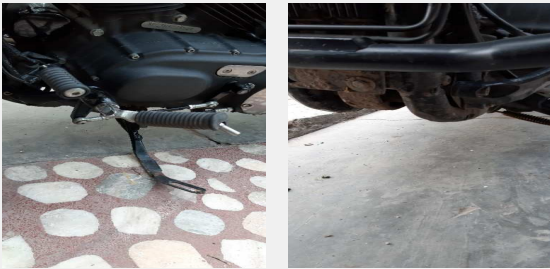
INSPECTION CHECKPOINTS	SCORE(X/10)	REMARKS/COMMENTS	OPTIONAL SPEND EST. (RS)
SIDE STAND CONDITION	7	GOOD	0
SIDE STAND RETENTION	7	GOOD	0
CENTRE STAND CONDITION	0	NA	0
CENTRE STAND RETENTION	0	NA	0

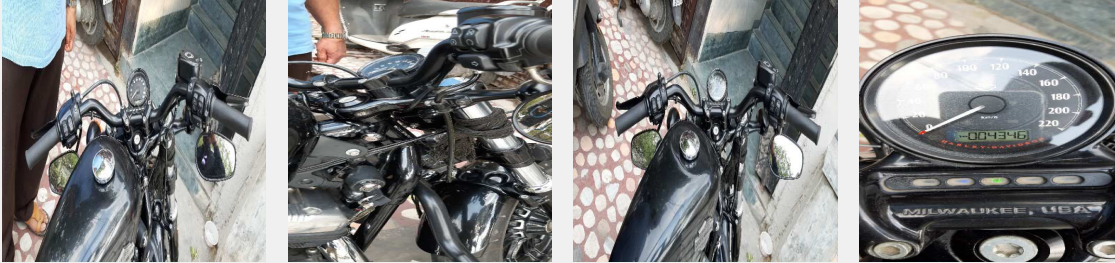
CONTROL

INSPECTION CHECKPOINTS	SCORE(X/10)	REMARKS/COMMENTS	OPTIONAL SPEND EST. (RS)
HANDLEBARS CONDITION	7	GOOD	0
LEVERS & PEDAL CONDITION	8	GOOD	0
PIVOTS	8	GOOD	0
CABLES CONDITION	8	GOOD	0

CABLES ROUTING	8	GOOD	0
HOSES CONDITION	8	GOOD	0
HOSES ROUTING	8	GOOD	0
THROTTLE OPERATION	8	GOOD	0

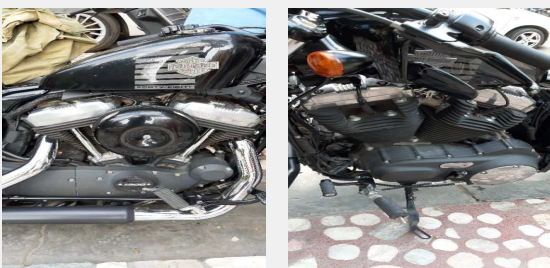
INSPECTION CHECKPOINTS	SCORE(X/10)	REMARKS/COMMENTS	OPTIONAL SPEND EST. (RS)
LEVELS - ENGINE OIL	7	GOOD	0
LEVELS - GEAR OIL/SHAFT DRIVE (YES)	8	GOOD	0
LEVELS - HYDRAULIC FLUID (YES)	8	GOOD	0
LEVELS - COOLANT (NO)	10		0
LEVELS - FUEL	7	GOOD	0
LEAKS - ENGINE OIL	8	GOOD	0
LEAKS - GEAR OIL	8	GOOD	0
LEAKS - HYDRAULIC FLUID	8	GOOD	0
LEAKS - COOLANT	8	NA	0
LEAKS - FUEL	8	GOOD	0
